U.S. PUBLIC LAND SURVEY MONUMENT RECORD

T. 1 N. - R. 14 E. of the 4th P.M.

CLINTON TWP
ROCK COUNTY WI

CORNER CODE A-21(1)

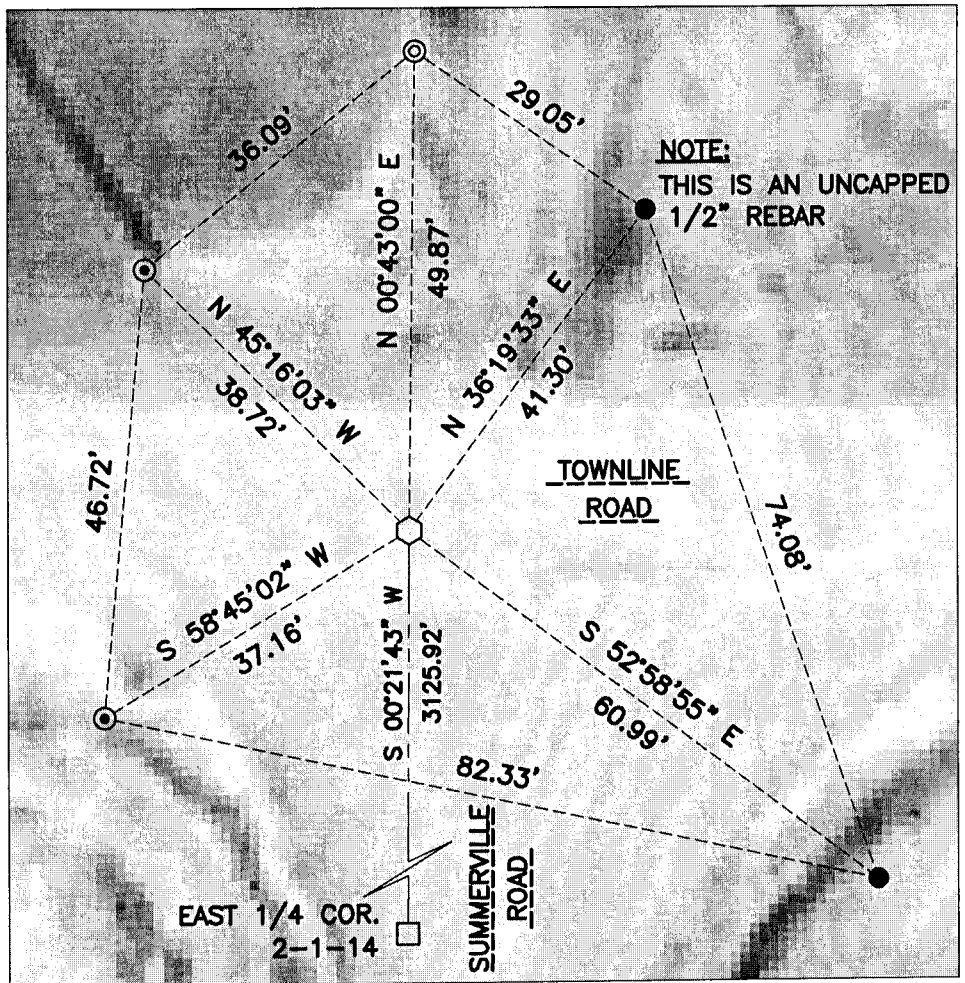
I recovered and accepted cast iron monument with the top broken off as called for on the 1985 A-21 tie-sheet prepared by Don Barnes. Also, I found 3 existing ties and 2 appeared disturbed, (rebar). I straightened and firmed up the ground around them and surveyed them as new ties. The Southwest tie, (rebar), is in an area that appears to be frequently washed out and gets repaired so, I set a 5th tie in the SE quadrant of the intersection. I surveyed the "T" location on the top of the monument, it checks reasonably well with existing the ties and the distance to the E1/4 corner is within 0.04' of Barnes previous measurement.

Found perpetuated location.
