U.S. PUBLIC LAND SURVEY MONUMENT RECORD

T. 3 N. - R.10 E. of the 4th P.M.

MAGNOLIA TWP
ROCK COUNTY WI

CORNER CODE: G-17
(A.E. 7.08 REQUIREMENT)

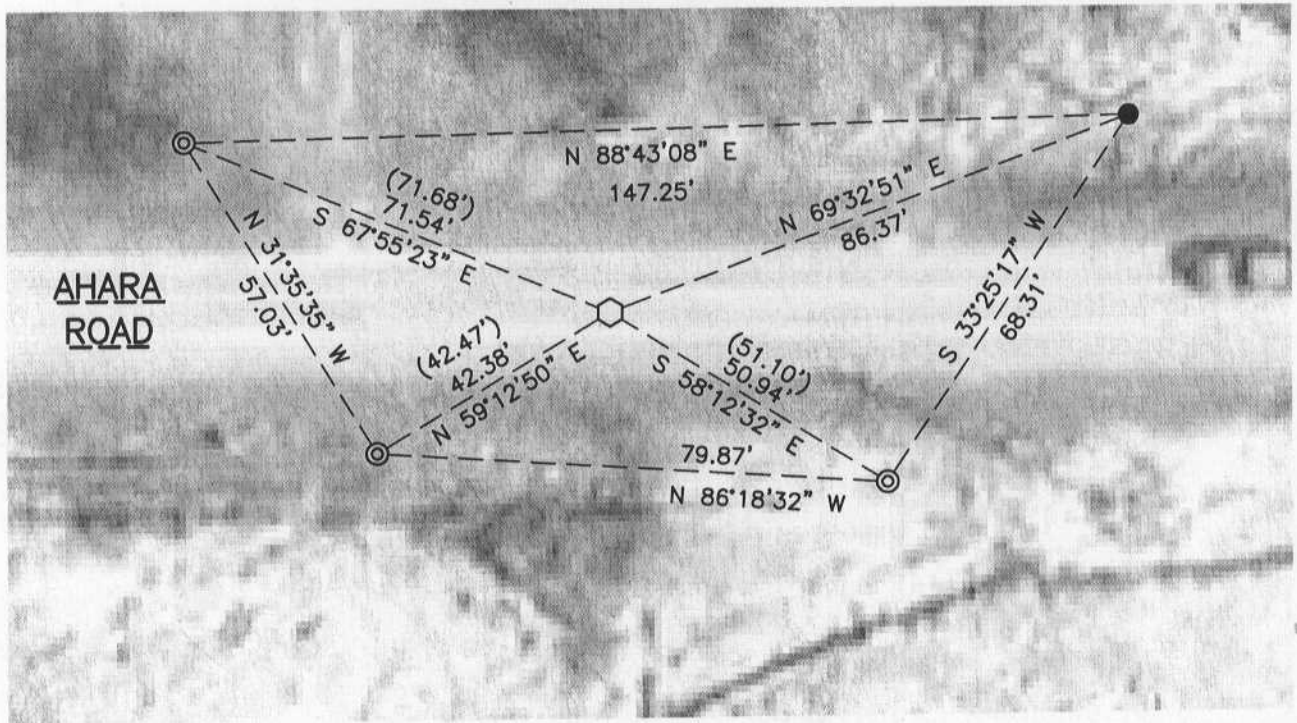
(a) **LEGEND**

I found and accepted the found cast iron monument as shown in Volume 5, Page 156. Also, I found 3 of the 4 witness pipes however; I adjusted some due to them being 5", +/-, out of the ground. The 2 Southerly pipes were out of the ground approximately 5" with the S.E. leaning slightly north; I straightened and reset the S.E. I set the S.W. pipe flush and the N.W. pipe was already flush and formerly near a power pole. I surveyed all pipe in addition to the new capped rebar, per the sketch.

N/A – Found witness pipe were adjusted so as to be plumb and flush with the ground.
