U.S. PUBLIC LAND SURVEY MONUMENT RECORD

T. 1 N. - R. 14 E. of the 4th P.M.

CLINTON TWP
ROCK COUNTY WI

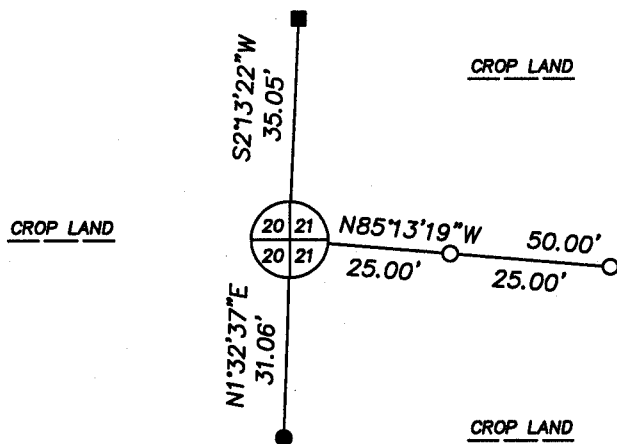
(a) LEGEND

This monument location was previously established by Rock County Surveyor Donald Barnes on 7-4-1976. I found a Berntsen Cast Aluminum monument 10" out of the ground and discovered that the monument was broken at the lower shear point. I had the monument repaired and reset the monument from the (2) existing witness monuments as found and from information obtained from County Surveyor Jason Houle from the neighboring section corners. I set (2) new witness monuments as shown and the top of the monument was set flush with the existing grade.
