U.S. PUBLIC LAND SURVEY MONUMENT RECORD

T. 3 N. - R. 10 E. of the 4th P.M.

MAGNOLIA TWP
ROCK COUNTY WI

CORNER CODE: E-13
(A.E. 7.08 REQUIREMENT)

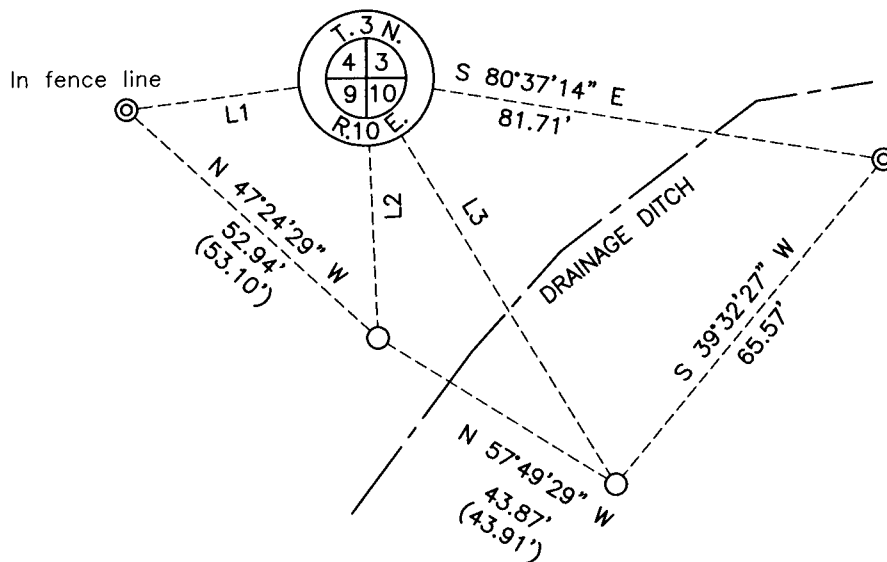
(a) LEGEND

I found and accepted the aluminum monument as shown on the Vol. 5, Pg. 157 Surveyor Record, (Barnes - 1976). The monument was disturbed/leaning and the monument was cracked near a break-off point. While adjusting the monument, the cap broke completely off. The break-off location was at/near grade so I set flush and surveyed the "T" of the monument. The dimensions to nearby monuments fit to under 0.05'; knowing that the monument had cracked and been set flush/backfilled, I adjusted the monument by way of distance/distance intersection from witnesses found 81.71' and 40.56 feet away. After doing this, a 3rd witness checked to 0.04' and a 4th to 0.08'. I set an orange carsonite post at the aluminum monument and accepted all monuments found.

I did not find a discrepancy between the corner restored and a previously documented corner location. *Discrepancy* being defined as *disagreeing* with a corner location, *not* as noting dimensional differences between current/former tie sheets due to measuring methods. The current and *most recent* tie-sheet dimensions filed for the corner are noted.
