# U.S. PUBLIC LAND SURVEY MONUMENT RECORD

For Public Land Survey Corners In: WI ADMINISTRATIVE CODE A-E 7.08 REQUIREMENT  
**T. 3 N. - R. 10 E. of the 4th P.M.**

MAGNOLIA TWP  
ROCK COUNTY WI

CORNER CODE: T-13(1)  
(A.E. 7.08 REQUIREMENT)

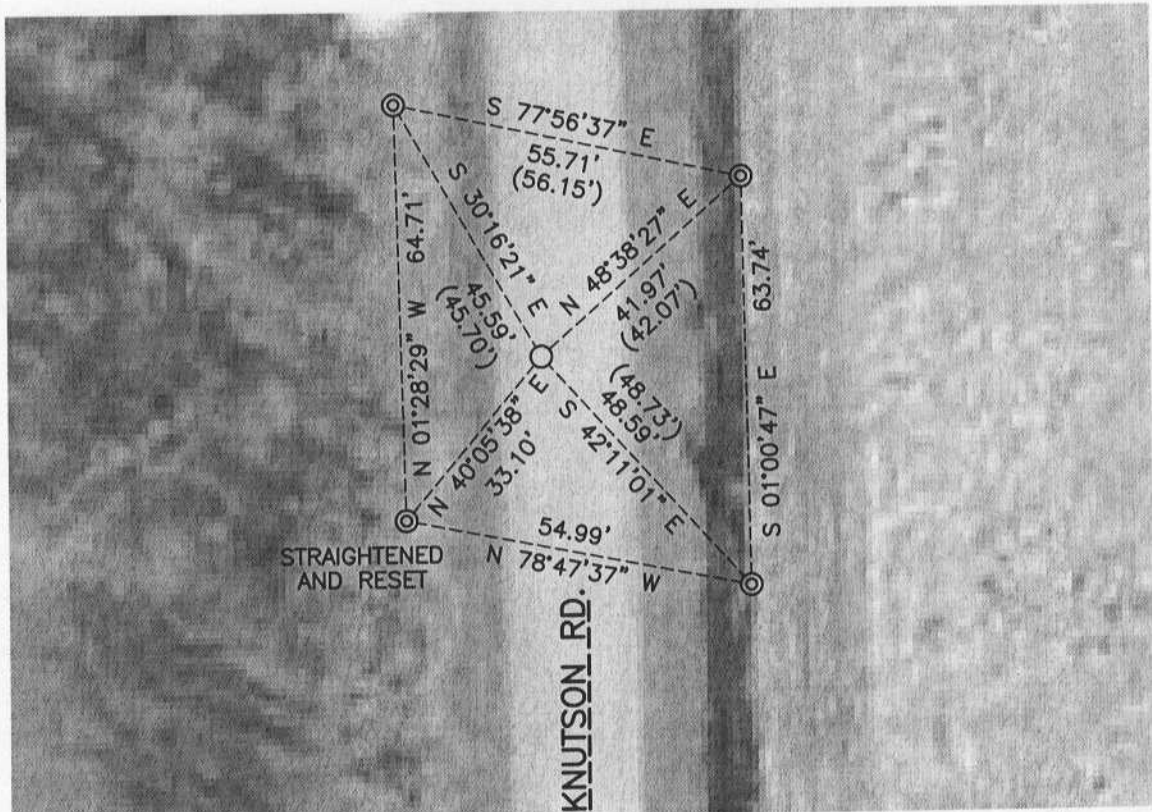
I found the aluminum monument and ties as shown on a Volume 5, Page 17 tie-sheet filed in 1974. Those same monuments were referenced on tie sheet T-13 in 1988. The '88 sheet does not note any distances and simply refers to the '74 record. I accepted the aluminum monument and three pipes as found; the fourth witness was straightened and resurveyed. This location is a cut area with the aluminum monument at the road grade and witnesses in steep backslopes and/or at the top of slope; tie-distance discrepancies exist as noted.

I did not find a discrepancy between the corner restored and a previously documented corner location. *Discrepancy* being defined as *disagreeing* with a corner location, *not* as noting dimensional differences between current/former tie sheets due to measuring methods. The current and *most recent* tie-sheet dimensions filed for the corner are noted.
