# U.S. PUBLIC LAND SURVEY MONUMENT RECORD

T. 4 N., R. 10 E.

UNION TWP  
ROCK COUNTY WI

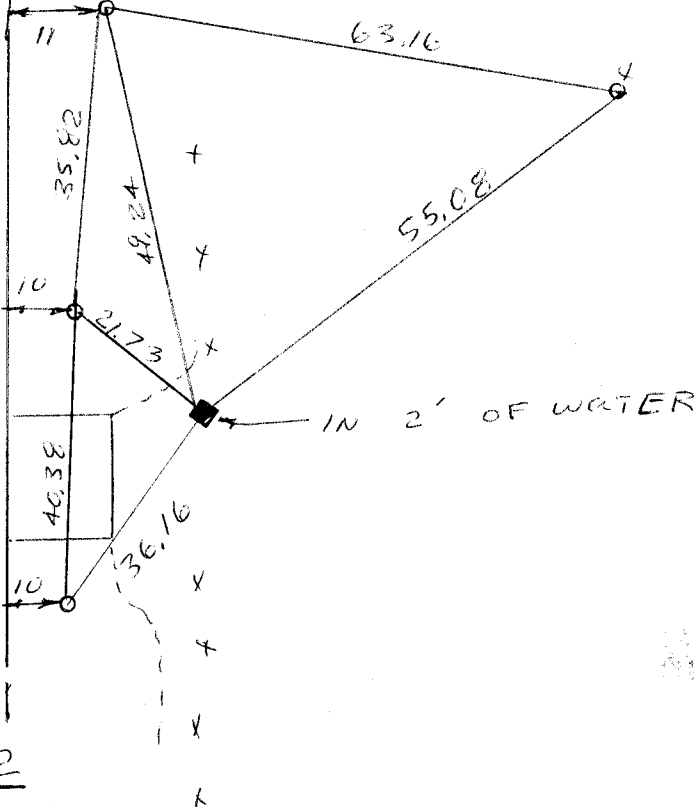
(a)

Fd 2" IRON PIPE  
SET CONCRETE POST

1 1/2" (CD) x 24" PIPE

IT APPEARS THAT CHURCH'S AND BLEEDHORN'S MONUMENTS WERE DESTROYED. I ACCEPTED SHIMEALL'S PIPE BECAUSE:

1) SHIMEALL'S PIPE IS IN HARMONY WITH CHURCH'S. EVEN THOUGH THE METHODS ARE DIFFERENT. THE ALLOWABLE ERROR IN 1855 WAS SUCH THAT THE 2" PIPE ALSO COMPLIES WITH THAT PROCEDURE.

2) THE LOCATION OF CHURCH'S MONUMENT COULD NOT BE DETERMINED SINCE THE EAST QUARTER CORNER AND 1/16th CORNERS WERE NOT PERPETUATED AS CHURCH FOUND THEM.
