## U.S. PUBLIC LAND SURVEY MONUMENT RECORD

J-15(1)

## FU548^

CORNER CODE J-15(1)

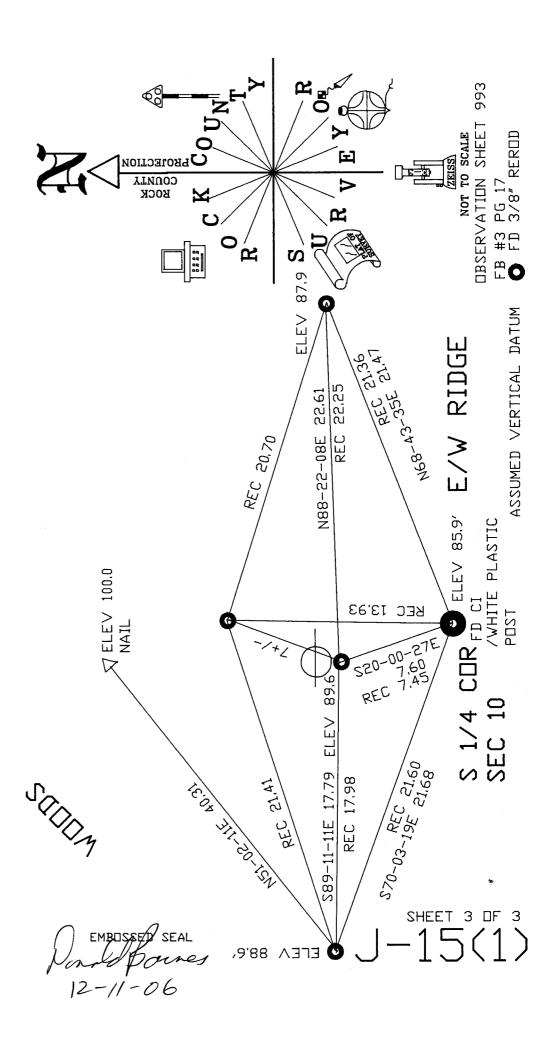
FD CI MON. WITH WHITE PLASTIC POST AND REFERENCE PINS. MON IS ON SOUTH FACE OF AN EXTREME SLOPE.

ACCEPTED FD CI.
