U.S. PUBLIC LAND SURVEY MONUMENT RECORD

T. 3 N. - R. 11 E. of the 4th P.M.

_____ CENTER _____ TWP
ROCK COUNTY WI

Corner code: E-13

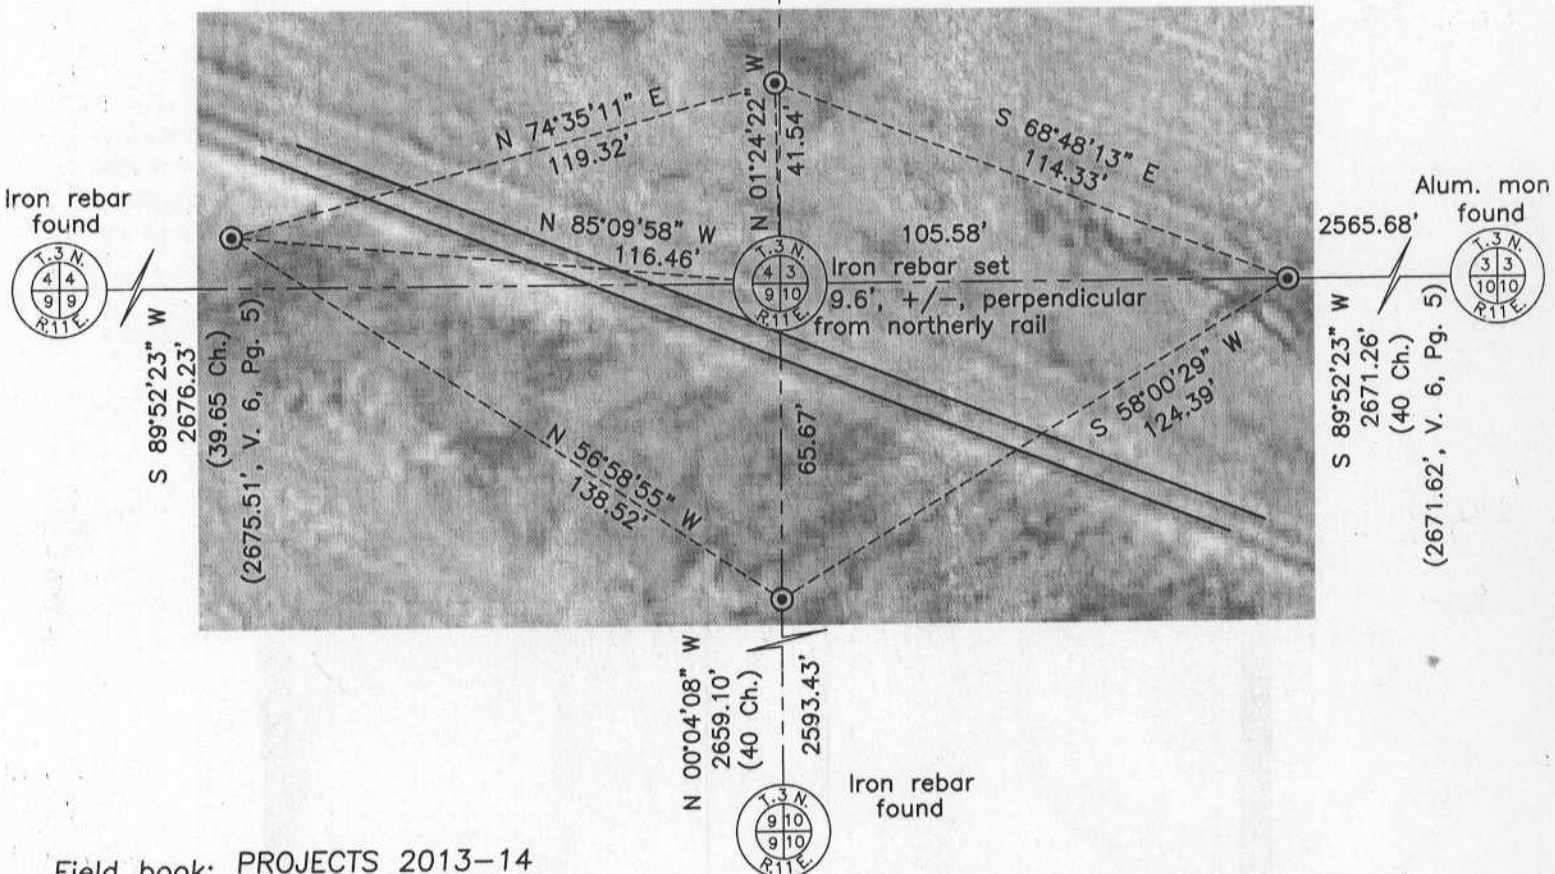
A leaning/bent bolt was found as set by Barnes, (V. 6, and Pg. 6), approximately 1 foot from the existing County coordinates for the corner. As this corner was set based on "the intersection of fences projected from the South, East, and North", there is some leeway in this location. At the location where it appears the bolt would come out straight, I set a flasher and survey nail in an existing railroad tie. Ultimately, I will not accept this nail as detailed further on.

I question the location of the Barnes bolt based on the following:

- It was installed based on fence line projections, not an actual fence corner
- The corner falls roughly 8-9 feet South of a line between the N1/4 corners of Sections 9 & 10
- A pro-ration between the SW of 10-3-11 and W1/4 of 3-10-11 computes roughly 8-9 feet north of the bolt.
- The resulting West ¼ corner of 10-3-11 would compute 4-6 feet further south of an existing fence

Per a method not in the instructions but, in my opinion, more valid than proportioning from suspect corners, is a bearing/bearing intersection between the previously mentioned controlling corners. This method produces a corner that matches the N/S occupation but, is 8-9 feet north of the bolt location determined by Barnes. I used the bearing/bearing solution based on the following:

- It matches the North/South occupation
- The solution is within 0.6 feet of the same arrived at by prorating along the same N/S line between the SW corner of section 10 and West ¼ of section 3.
- The solution results in the North lines of the NW and NE quarters of section 10 being with 0.31 feet of each other; they would have been a "split" during the original survey
- The solution pulls the West-quarter corner location of the section 4 feet north, +/-, and consistent with occupation, more or less
- The N/S location is consistent with old Railroad right-of-way maps for this location. Although not dimensioned, the PLSS corner falls in the Northerly half of what is the right-of-way on the map.
