U.S. PUBLIC LAND SURVEY MONUMENT RECORD

T. 3 N. - R. 10 E. of the 4th P.M.

MAGNOLIA TWP
ROCK COUNTY WI

CORNER CODE: Z-9
(A.E. 7.08 REQUIREMENT)

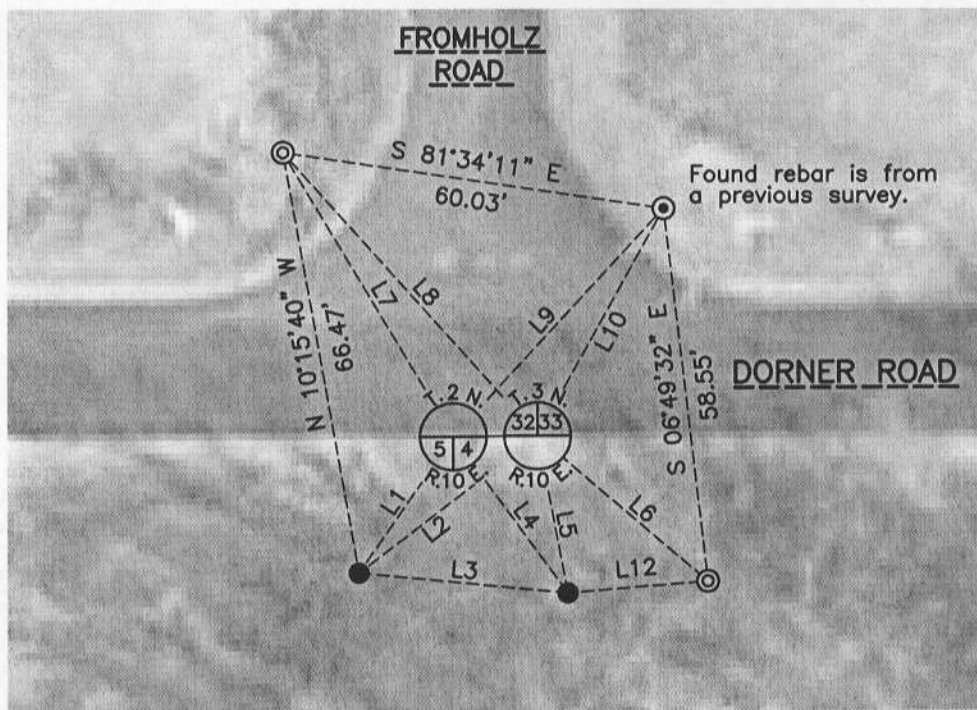
(a) LEGEND

I found a polystyrene monument with the aluminum top separated, along with the aluminum monument at the NE corner of 5-2-10 and two additional witnesses per the 1985 Z-9 monument record, (Barnes). By distance/distance intersection from the aluminum monument and SE witness, I calculated the position of the SE corner of Sec 32-3-10 and set a ¾"x24" iron rebar at the PLSS corner location; the monument went alongside the polystyrene base which still exists. Two additional witnesses were set per the sketch. The SW rebar set closely approximates the hole in which a bent pipe found spun out of; the rebar matches prior monument record distances.

I did not find a discrepancy between the corner restored and a previously documented corner location. *Discrepancy* being defined as *disagreeing* with a corner location, *not* as noting dimensional differences between current/former tie sheets due to measuring methods. The current and *most recent* tie-sheet dimensions filed for the corner are noted.
