ROCK COUNTY, WISCONSIN

**GENERAL SERVICES COMMITTEE
TUESDAY, NOVEMBER 2, 2021 – 7:30 A.M.**

**Retaining Edge Consulting Engineers Inc. for Consulting Services for
the New 911 Communications Tower**

**SUBJECT: TOWER CONDITION ASSESSMENT & MAINTENANCE INSPECTION
ROCK CO. (SHERIFF'S OFFICE TOWER)
ASR#: NONE
LAT/LONG: N42° 43' 39.7", W89° 01' 49.3"
JANESVILLE, WI**

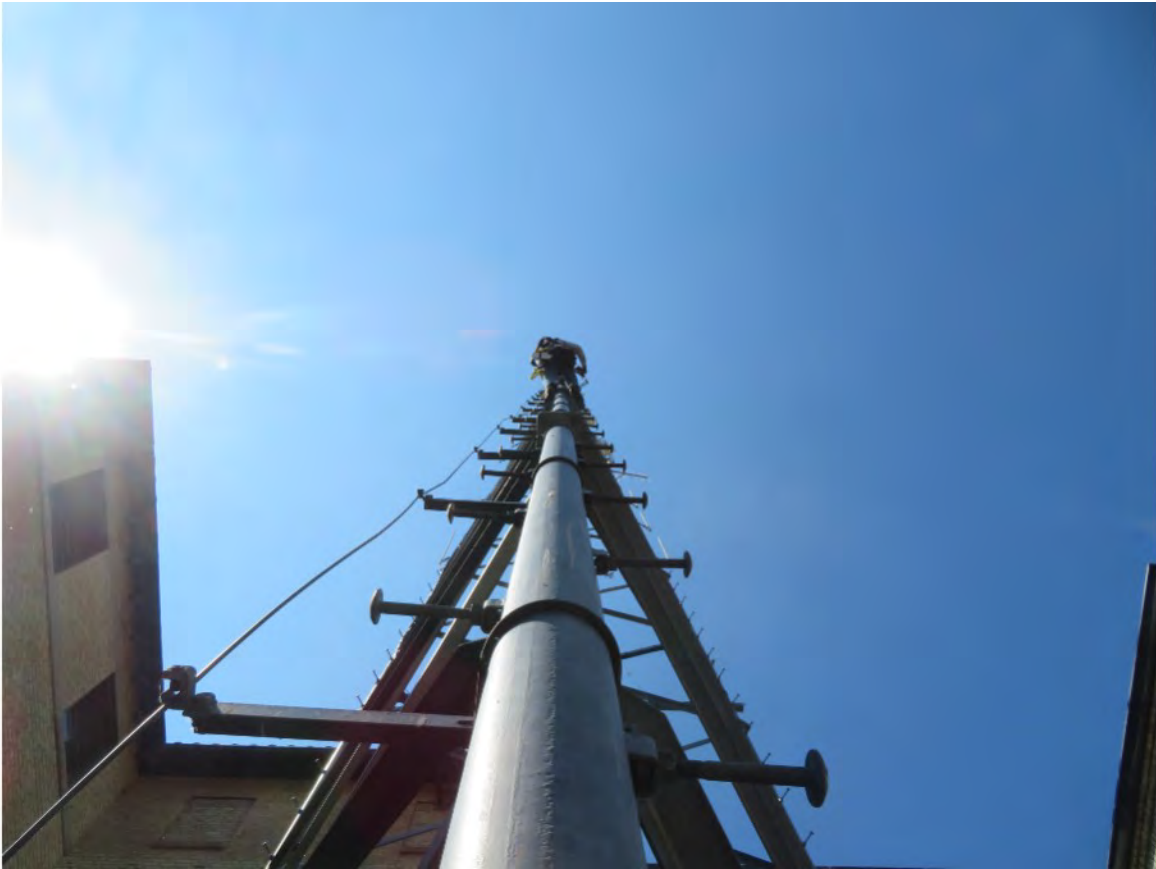
1.JPG

Item #	Category	Issue	Status & Recommendation	Photo #
1	Tower Climbing Facilities	Safety Climb Missing	A safety climb cable was not installed on the tower. Recommended to install a safety climb system for future work on the tower.	1
2	Structure Finish	Galvanizing Condition	Entire tower galvanizing is starting to show signs of wear. In Particular, cross members from 160' to 165' on face A-B and face B-C where rust/corrosion is present on crossmembers. It is recommended that all tower members exhibiting rust/corrosion be cleaned and coated with cold galvanizing compound.	2
3	Structure Finish	Tower Hardware	Rust/Corrosion is currently present on nearly all tower member hardware. It is recommended that all tower member hardware be replaced within the next 3-5 years.	3
4	Mount Finish	Antenna Mount	Rust/corrosion is present on antenna mount for dipole located on leg B at 189.2' (A2). It is recommended that antenna mount be cleaned of all rust/corrosion and coated with cold galvanizing compound.	4

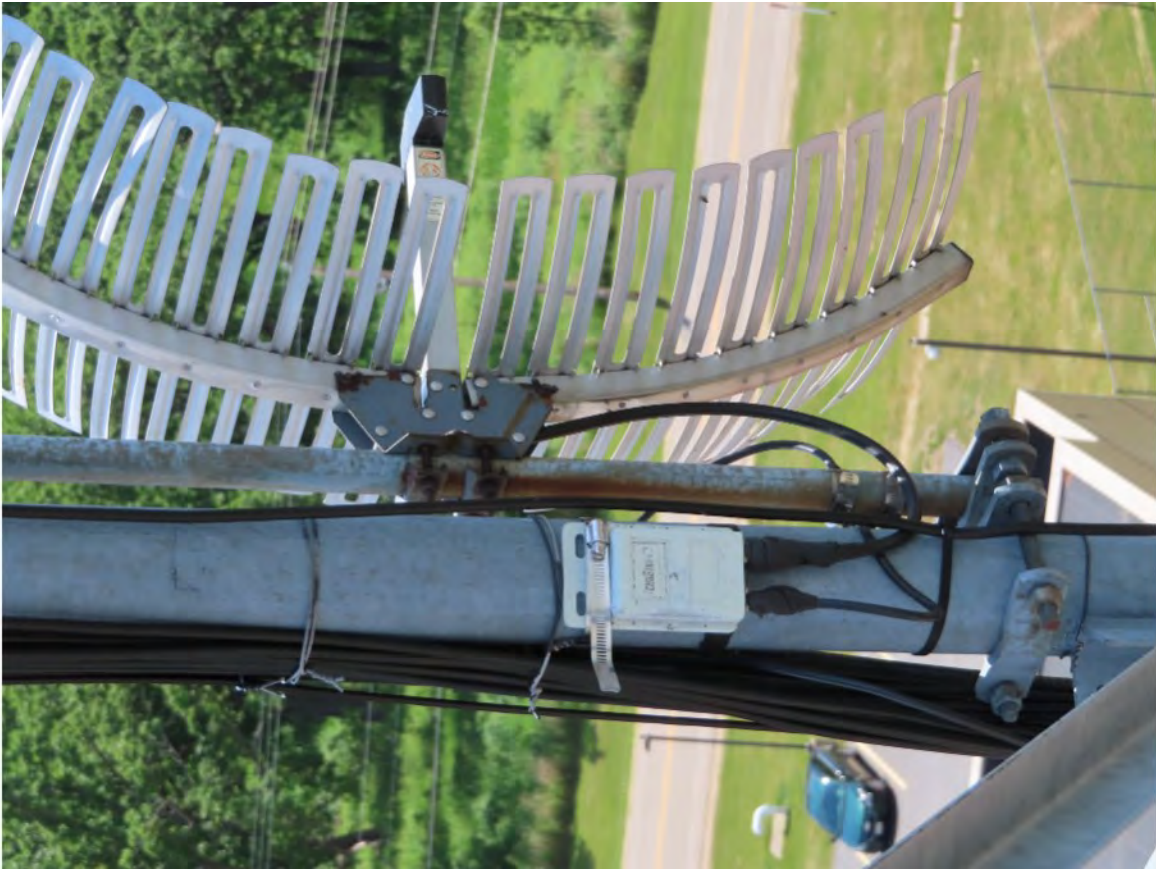
5.JPG

5	Mount Finish	Antenna Mount	Rust/corrosion is present on antenna mount for grid dish located on leg C at 103.0' (A17). It is recommended that antenna mount be cleaned of all rust/corrosion and coated with cold galvanizing compound.	5
6	Coax	Coax Mounting	All antenna coax are mounted to leg B and leg C via tap and zip-ties. It is recommended that a waveguide ladder be installed and coax be mounted to tower via snap-ins.	6
7	Coax	Kellum Grip	Coax Kellum grip for omni located on leg C at 177.9' (A3) is improperly installed and supported on tower. It is recommended that an approved mounting clamp be installed to properly support Kellum grip/coax and that the Kellum grip be taped at bottom.	7
8	Coax	Coax Mounting	Coax Kellum grip is not taped at bottom for dipole located on leg B at 189.2' (A2). It is recommended that Kellum grip be taped at base.	8

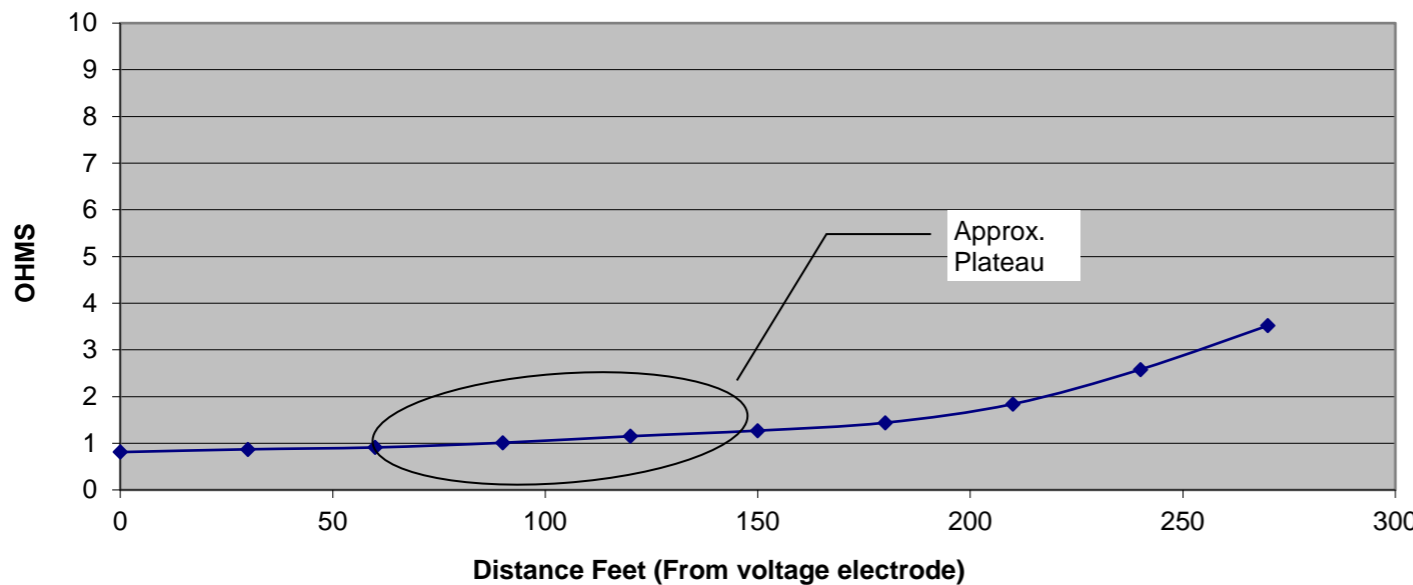
FALL OF POTENTIAL PLOT

Dist (Ft)	Resist Ohms
0	0.81
30	0.87
60	0.91 R1
90	1.01
120	1.15 R2
150	1.27
180	1.44 R3
210	1.84
240	2.58
270	3.52

Plateau evident at roughly 1.0 ohms.
