U.S. PUBLIC LAND SURVEY MONUMENT RECORD

For Public Land Survey Corners In:
T. 1 N. R. 13 E. 4th P.M.

MILTON TWP
ROCK COUNTY WI

CORNER CODE G-19(2)

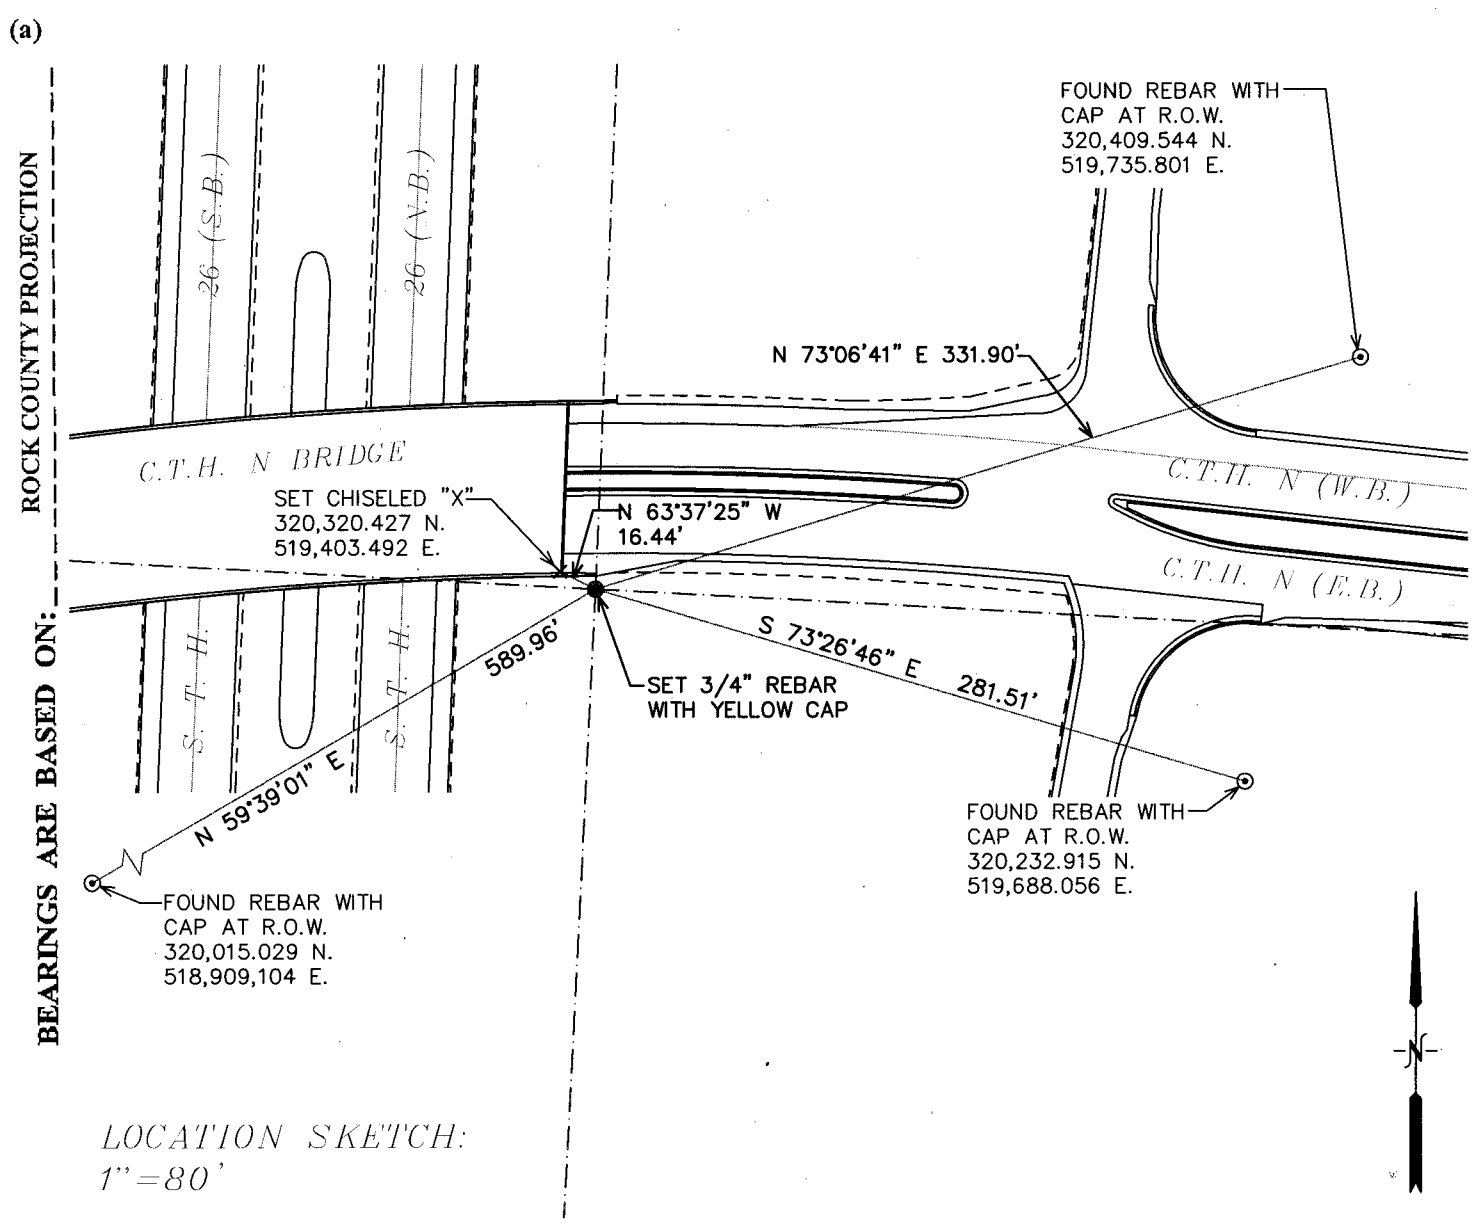
LOCATION SKETCH:
 1" = 80'

SHOW A PLAN VIEW DRAWING DEPICTING THE CORNER MONUMENT AND SURROUNDING PHYSICAL FEATURES, INCLUDING THE EXCAVATION AREA AND DEPTH.

Following highway reconstruction, set 3/4 inch rebar with yellow cap about five feet south of the east end of the southeast wing wall of the bridge for CTH N crossing STH 26, which has been perpetuated from locating a previously existing one inch pipe prior to construction as found by Donald Barnes, Rock County Surveyor, in May of 2012 as marking the location of the corner. Found three rebars with caps at the right-of way, and set one chiseled "X" at the southeast corner of the bridge deck as witnesses following highway reconstruction as shown.
