# U.S. PUBLIC LAND SURVEY MONUMENT RECORD

T. 3 N. - R. 10 E. of the 4th P.M.

MAGNOLIA TWP  
ROCK COUNTY WI

CORNER CODE: E-15  
(A.E. 7.08 REQUIREMENT)

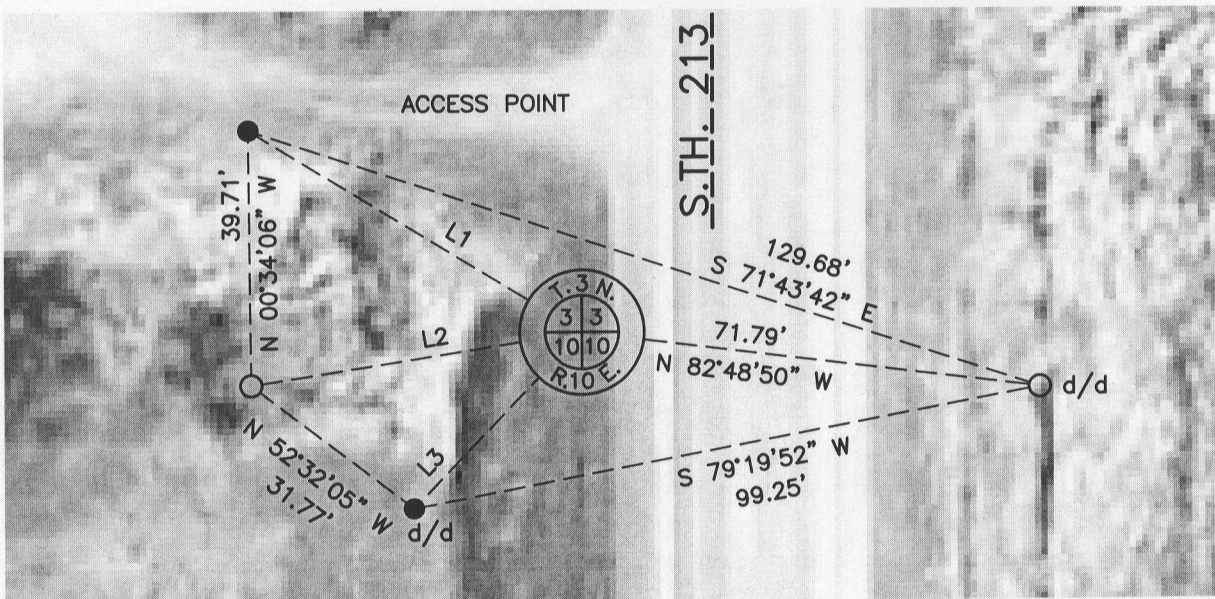
(a) LEGEND

I found two aluminum witnesses, (G-1 Piston Mon), referenced on the V. 5, Pg. 163 record, (Barnes, 1976). In addition, I found a 3<sup>rd</sup> witness that was disturbed however, I was able to spin the monument out as the bottom 2/3 was straight; I set a capped 3/4" x 24" iron rebar in its place. At the PLSS monument location, I found a corroded aluminum monument, corroded to the point that it is dissolved into a gray material absent any solid parts other than fragments.

Two of the three witnesses check well between each other. The replaced monument, (Southerly witness), checks to 0.02' to the easterly witness on the opposite side of S.T.H. 213. A distance to the 3<sup>rd</sup> witness, (westerly), is not given from either of the other 2 that were recovered. The westerly monument is 1 foot, +/-, out of the ground and appears to be leaning northeasterly. I computed the PLSS corner location by distance/distance intersection from the southerly & easterly witnesses. The solution lands in the middle, more or less, of the corroded monument material however, checks the 3<sup>rd</sup> witness to 0.56 feet; Given the 3<sup>rd</sup> witness is leaning to the NE and the solution is in the corroded material, I accept the distance/distance solution as the PLSS corner location.

I set a Berntsen 30" break-off pipe monument w/cap at the PLSS corner location. It is stamped with a "+", "PUBLIC LAND SURVEY SYSTEM CORNER" & "ROCK COUNTY SURVEYOR S-2331". One additional witness was set per the map.
