## U.S.—PUBLIC — ND SUNCEY MONUMENT RECORD

FIELD	воок	PAGI	E #	······································			SH	EET	_ OF	2
						MONUMENT		JRROUNDII	VG.	
		COMMITTEE			FORM ON	12/2/1982			4	, ()
						CORNER	COI	DE	4-2	<u>{ (                                   </u>

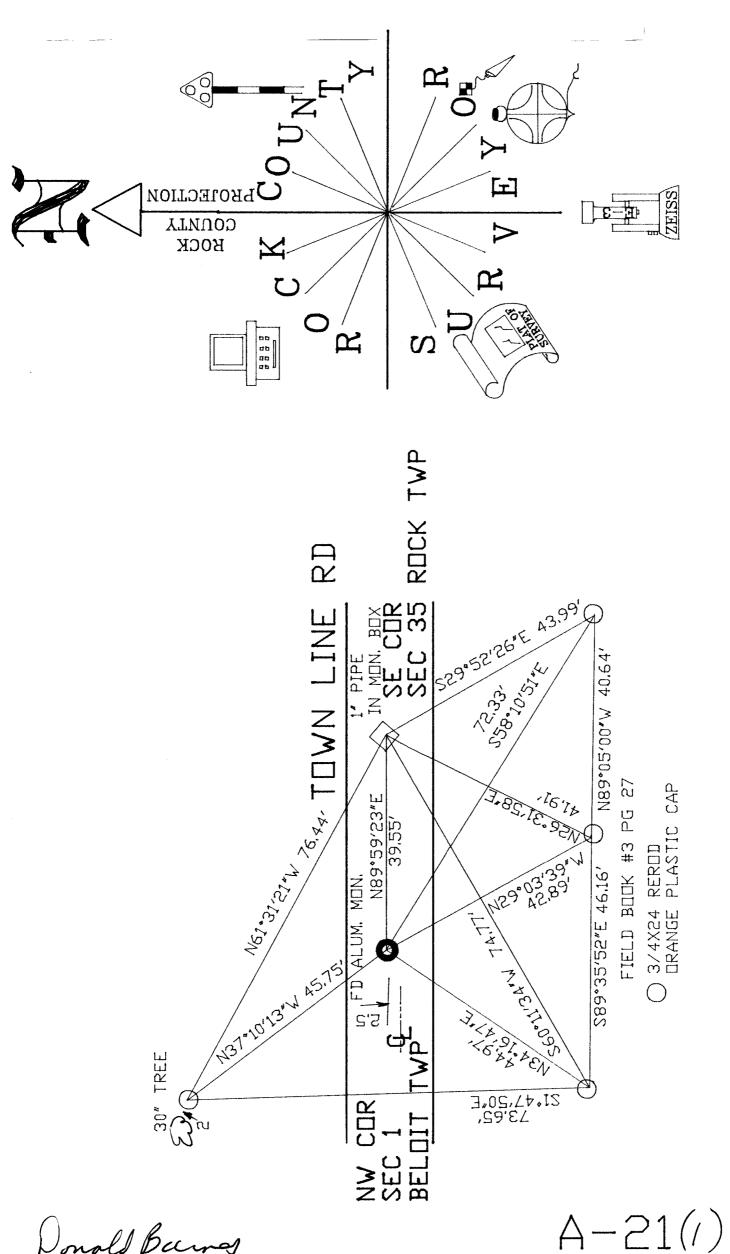
A-21 (1)

FOUND ALUM. MON.

- 1980 BARNES VOL 6 PG 15. THE MONUMENT BOX NEAR THE NE CORNER OF SECTION 2 IS NOT THE CORNER. A PROPERTY CORNER WAS ERRONEOUSLY MONUMENTED AS THE SECTION CORNER.
- 1986 BARNES VOL 6 PG 335 SHOWS 2585.71 TO N 1/4 CORNER SECTION 1, AND SAME JOGS AS IN VOL 5 PG 576. ALSO SHOWS 2638.43 BETWEEN N 1/4 CORNER OF SECTION 1 AND NORTH EAST CORNER OF
- 1989 BARNES VOL 6 PG 397 SAME INFORMATION AS IN VOL 6 P 335. 1990 BARNES A21 FOUND A PIPE IN A MONUMENT BOX AND AN ALUMINUM MONUMENT.
