U.S. PUBLIC LAND SURVEY MONUMENT RECORD

For Public Land Survey Corners in the
T. 3 N., R. 12 E.

JANESVILLE TWP
ROCK COUNTY WI

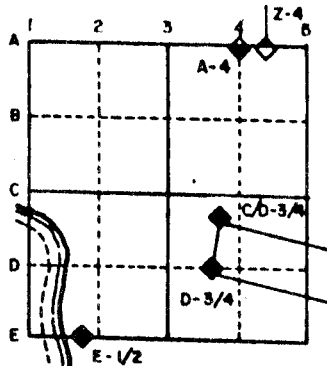
EXAMPLE

PLACE MONUMENT SYMBOL (◆) AT PROPER LOCATION ON ABOVE INDEX

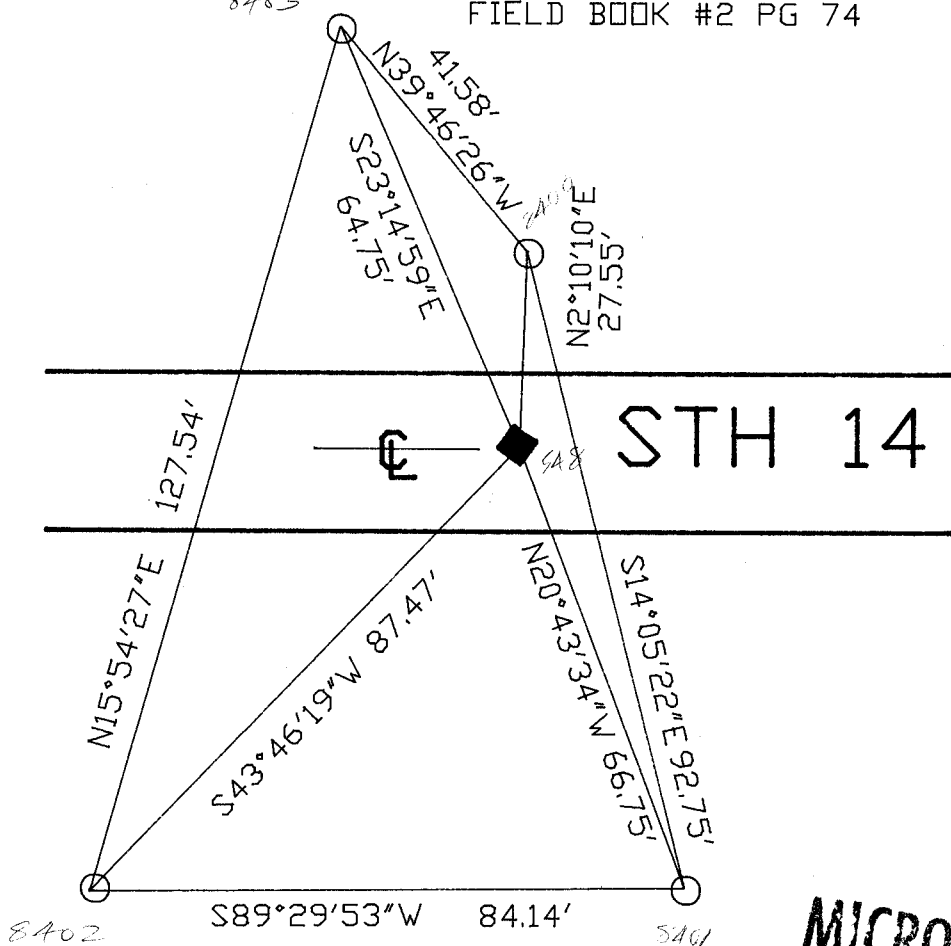
(a.)

- ◆ CORNER MONUMENT
- WITNESS MONUMENT
- 3/4X24 REROD WITH RED PLASTIC CAP
- ◆ PLACED NOTHING

SHOW A PLAN VIEW DRAWING DEPICTING THE CORNER MONUMENT AND SURROUNDING PHYSICAL FEATURES, INCLUDING THE EXCAVATION AREA AND DEPTH. THE CORNER MONUMENT SHALL HAVE THE FOLLOWING CHARACTERISTICS: 1) HAVE AT LEAST TWO PREDETERMINED BREAK-OFF POINTS. 2) IF BROKEN, LEAVE A PERMANENTLY MAGNETIZED REMNANT AT THE ORIGINAL POINT. 3) MUST BE EXTENDABLE. 4) THE CAP IS INSCRIBED: ROCK COUNTY SURVEY MONUMENT - PENALTY FOR DISTURBING MARKER. 5) OR AN EXISTING CUT LIMESTONE. AN IRON PIPE 1 1/2" x 4'0" (MINIMUM) MAY BE USED IN AREAS WHERE GROUND WATER IS WITHIN ONE FOOT OF THE SURFACE. IF THE CORNER IS OCCUPIED BY AN IMPROVEMENT (MANHOLE, BURIED CABLE, ETC.) ANY DURABLE, DISTINCT MONUMENT MAY BE USED. CORNERS SHALL BE REFERENCED WITH AT LEAST 4 DURABLE WITNESS MONUMENTS. WITNESS MONUMENTS SHALL BE MADE OF CONCRETE, NATURAL STONE, IRON OR OTHER EQUALLY DURABLE MATERIAL, EXCEPT WOOD. DESCRIBE THE CORNER AND THE WITNESS MONUMENTS.

D) Describe any material discrepancy between the location of the corner as restored or reestablished and the location of that corner as previously restored or reestablished by distance and direction. Show the discrepancy on the plan view drawing under (a), above. Show the distances between the corner as previously restored or reestablished and (1) the corner as restored or reestablished, and (2) to at least 4 of the witness monuments shown on the drawing in (a), above.
