**GENERAL SERVICES COMMITTEE
TUESDAY, DECEMBER 6, 2016 – 8:00 A.M.
CONFERENCE ROOM N-1 – FIFTH FLOOR
ROCK COUNTY COURTHOUSE-EAST**

WRC PROJECT NO. 31-8059.00

Rock County Courthouse Pedestrian and Vehicle Count

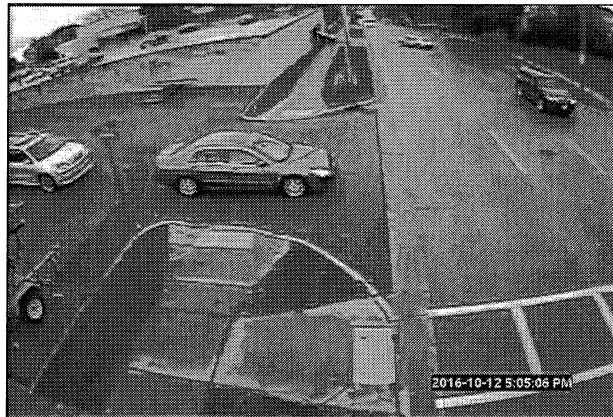
TranSmart Technologies Camera

TranSmart utilized video cameras to record traffic.

Staff then counted traffic recorded by the cameras. Mead & Hunt assisted TranSmart in locating acceptable infrastructure (such as street light poles) on which to mount the video recording equipment. The requisite permissions to utilize the utility poles was received from the City of Janesville and Alliant Energy. The traffic count results were provided in spreadsheet form utilizing 15-minute intervals.

Mead & Hunt—in conjunction with subconsultant TranSmart Technologies, Inc.—conducted ingress/egress traffic counts at the Rock County Courthouse. The one week count (seven consecutive days) was conducted from 7am-7pm at eight (8) driveway locations for the dates of October 17th through October 22nd. Counts only included vehicular traffic entering and exiting each of the eight driveways for parking in surface lots and parking structures. Four (4) cameras were employed, each recording two (2) driveways simultaneously.

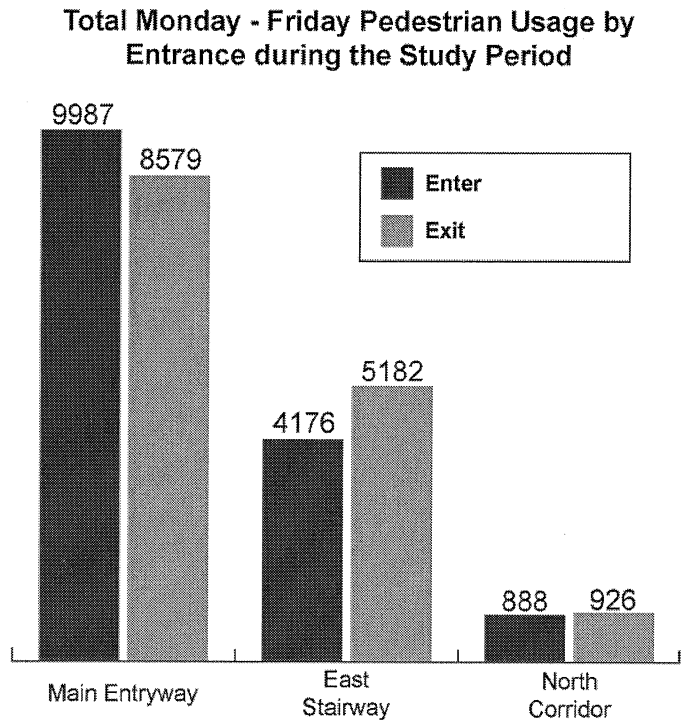
Figure 2: Total Weekday Pedestrian Usage by Entrance

Based on the results of the pedestrian count, shown in Figure 2, the main entryway was the most popular entrance. Over the course of the weekdays studied, the main entryway received more than twice as many pedestrians as the east stairway entrance.

One result showed the imbalance of entry and exit at certain locations. The study indicates a slight pedestrian preference to enter the building through the main entryway and exit through the east stairway.

Lastly, the North Corridor entry has a relatively small, but consistent pedestrian user base. The North Corridor entry is the closest entry to public transit.

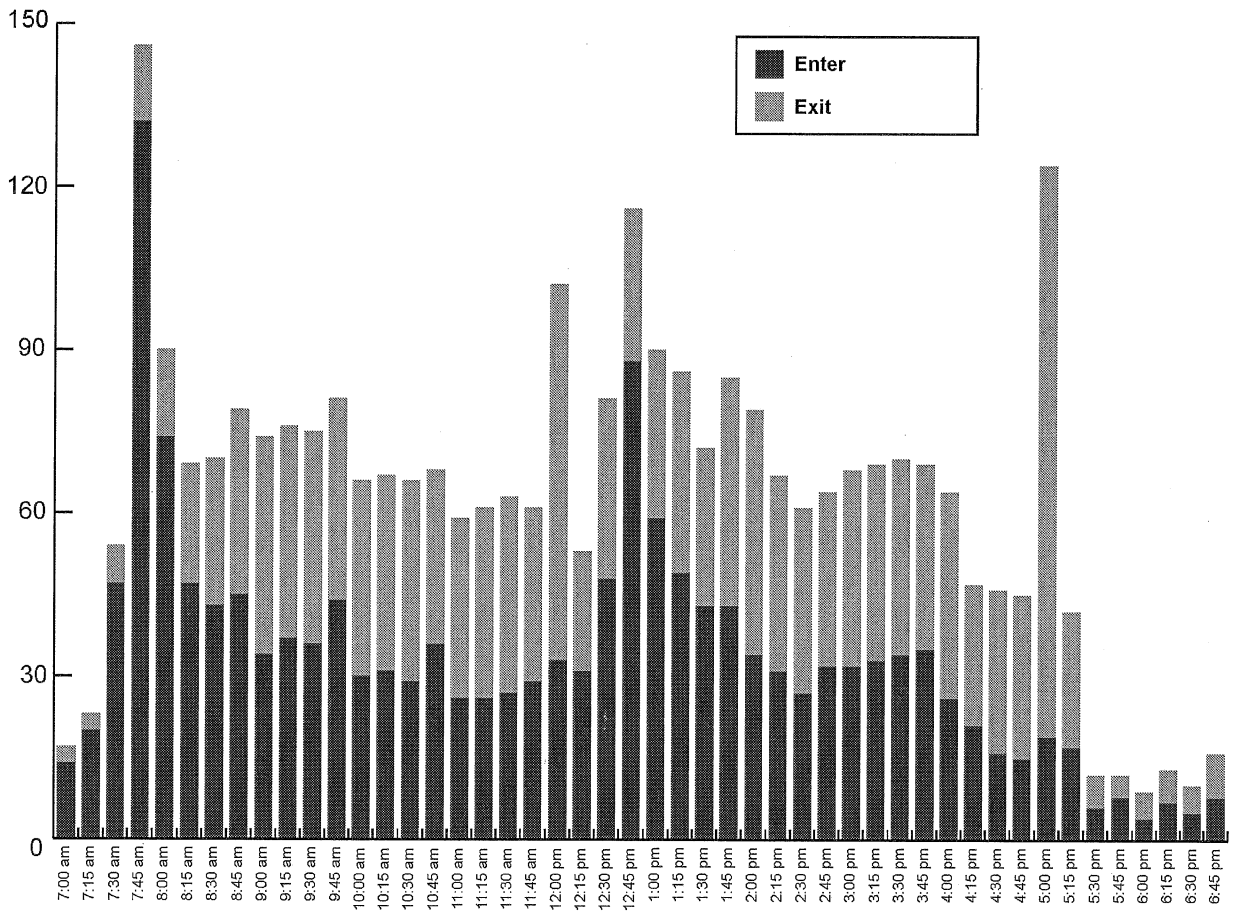
Figure 3: Average Weekday Pedestrian Ingress/Egress by 15-Minute Intervals – All Entrances

Average Weekday Pedestrian Ingress/Egress by 15-Minute Intervals - All Entrances

The data presented in Figures 4, 5, 6, and 7 show the average pedestrian traffic, by entry and aggregate, in 15-minute intervals, across all ten weekdays of the study. Four distinct peak times emerged. These peaks are, in order of largest to smallest: the beginning of the workday (7:45-8:00 am), the end of the workday (5:00-5:15 pm), returning from lunch (12:45-1:00 pm), and beginning of lunch (12:00-12:15 pm). The following graphics are broken down further to display entry and exit, with the beginning of the workday (7:45-8:00 am) and returning from lunch (12:45-1:00 pm) being the peak entry times. The highest amount of entries, 186 entries, occurred on Thursday, October, 13th during the beginning of the workday period (7:45-8:00 am).

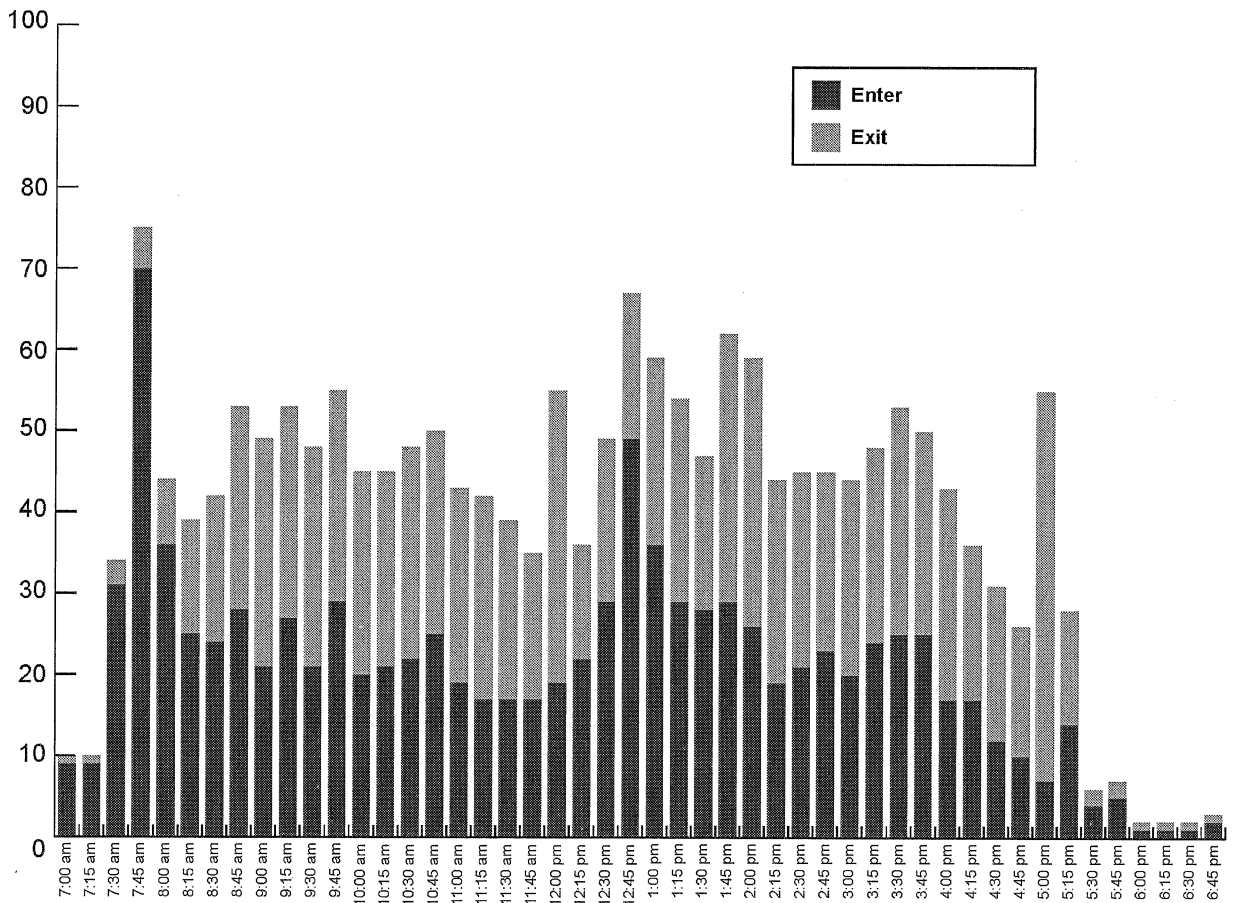
Figure 4: Average Weekday Pedestrian Ingress/Egress by 15-Minute Intervals – Main Entrance

Average Monday - Friday Pedestrian Ingress/Egress by 15-Minute Intervals - Main Entrance

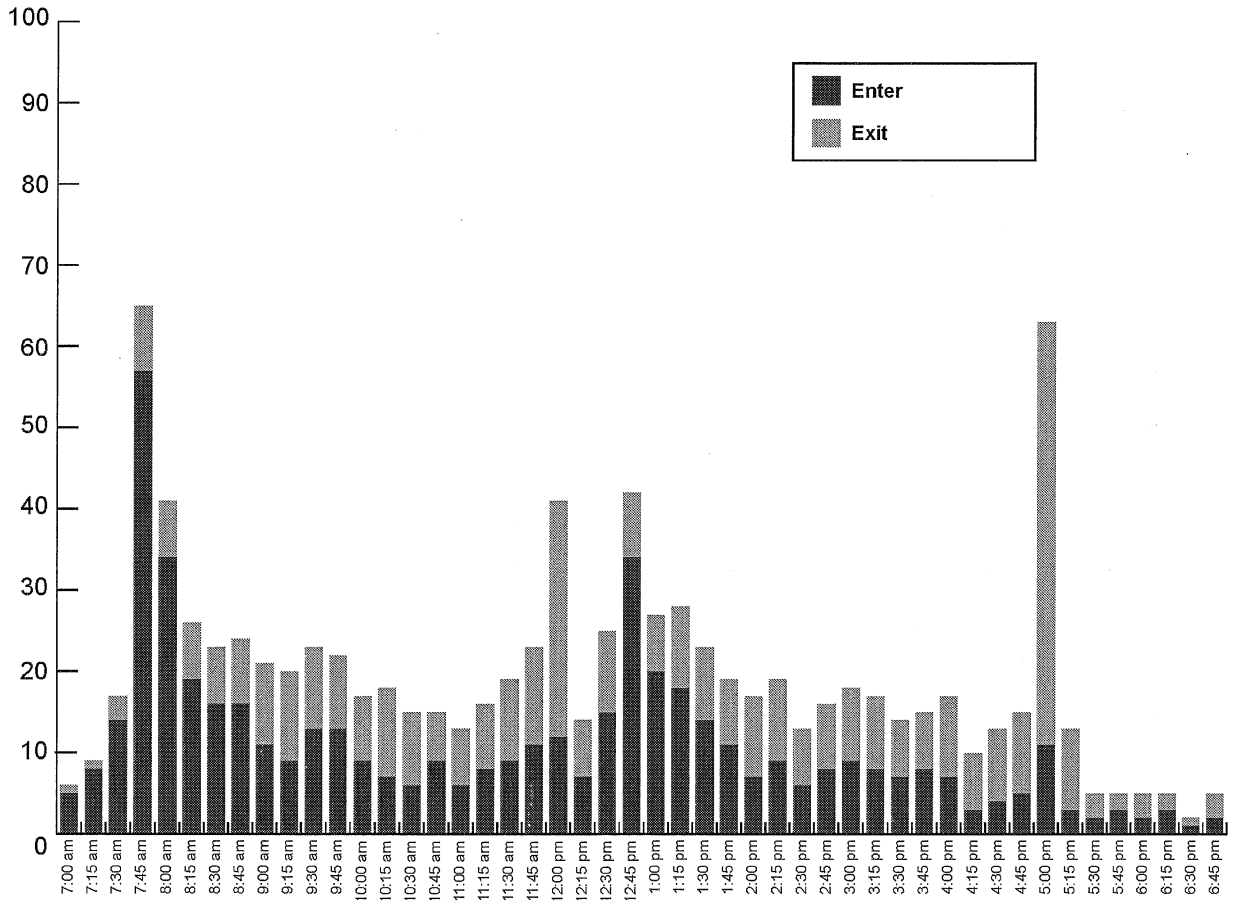
Figure 5: Average Weekday Pedestrian Ingress/Egress by 15-Minute Intervals – East Stairway

Average Monday - Friday Pedestrian Ingress/Egress by 15-Minute Intervals - East Stairway

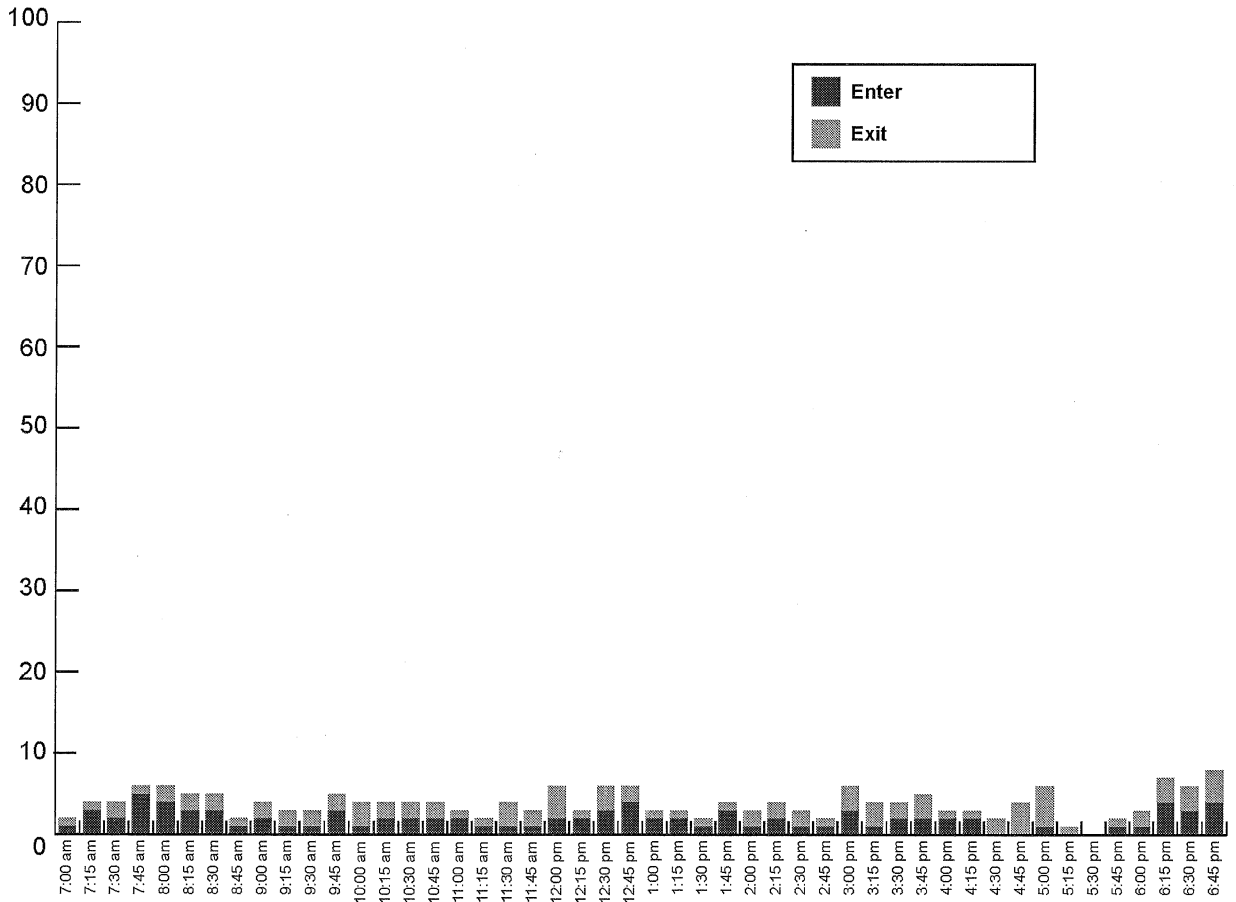
Figure 6: Average Weekday Pedestrian Ingress/Egress by 15-Minute Intervals – North Corridor

Average Monday - Friday Pedestrian Ingress/Egress by 15-Minute Intervals - North Corridor

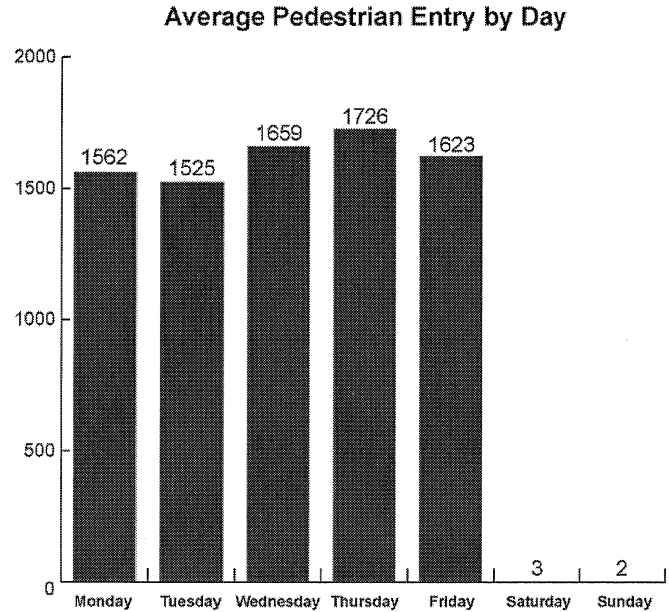
Figure 7: Average Pedestrian Entry by Day

Figure 7 shows the average number of pedestrian entries by day. The results for busiest day of the week are ranked below:

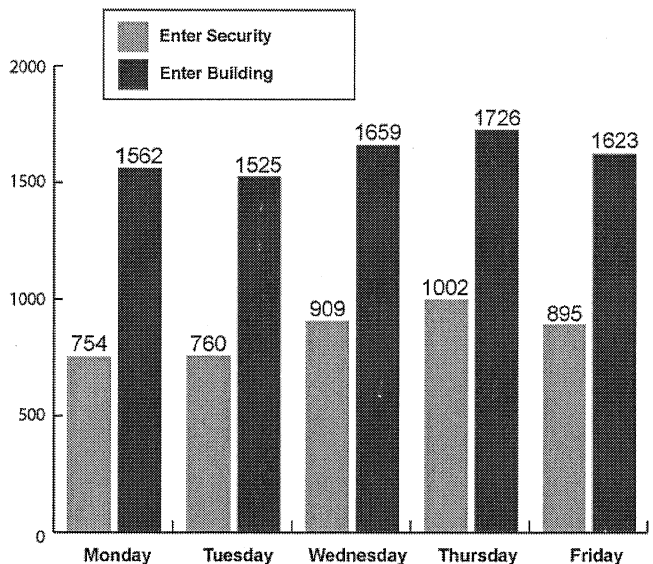
Figure 8: Average Weekday Pedestrian Activity by Day

During the weekday, shown in Figure 8 49-percent of pedestrians who entered the building also went through security. During traditional work hours (8:00 am – 5:00 pm), this percentage increased to 55-percent. This percentage increases even further during off-peak hours, when regular staff has already arrived, but residents are still traveling through security. The security data presented in Figures 9 and 10 shows the average pedestrian entries across all ten weekdays of the study based on 15-minute intervals. Two distinct peaks emerged, with the beginning of the workday (7:45-8:00 am) and returning from lunch (12:45-1:00 pm) being the peak entry times. The highest number of entries—101 persons—occurred on Thursday, October, 20th during the beginning of the workday period (7:45-8:00 am).

Average Weekday Pedestrian Activity by Day

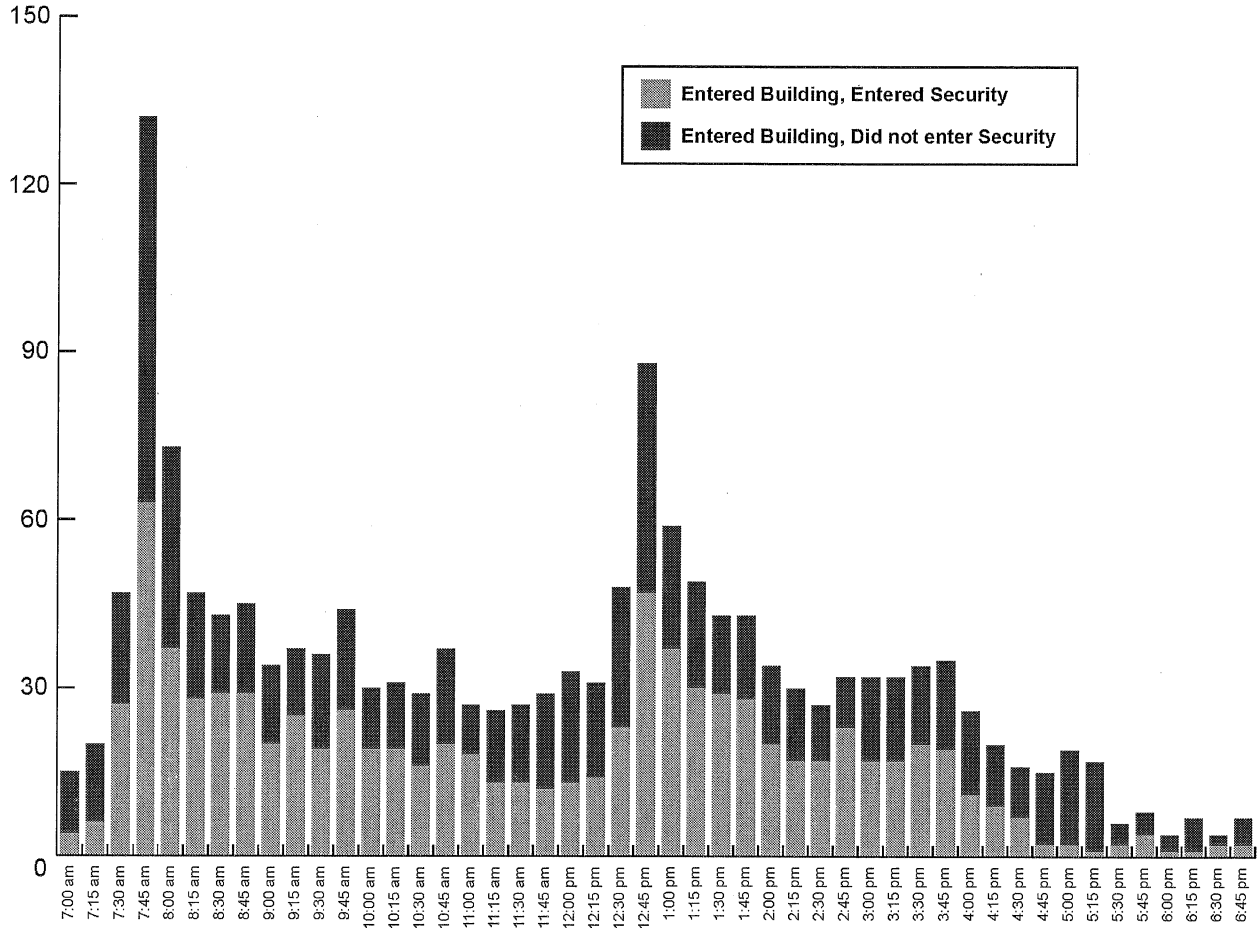
Figure 9: Average Weekday Pedestrian Security Ingress by 15-Minute Interval

Average Weekday Pedestrian Ingress by 15-Minute Interval - Security Usage

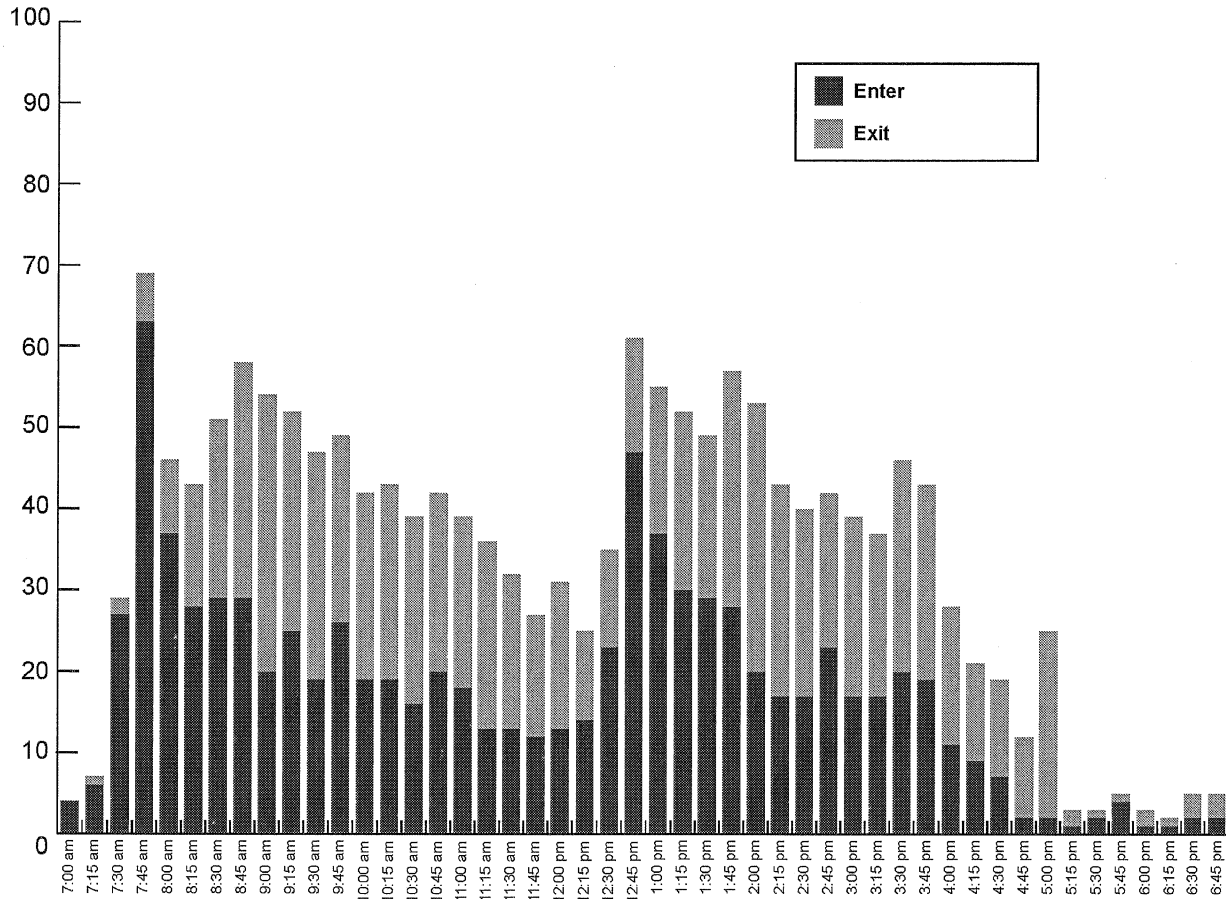
Figure 10: Average Weekday Pedestrian Ingress/Egress by 15-Minute Intervals – Security

Average Monday - Friday Pedestrian Ingress/Egress by 15-Minute Intervals - Security

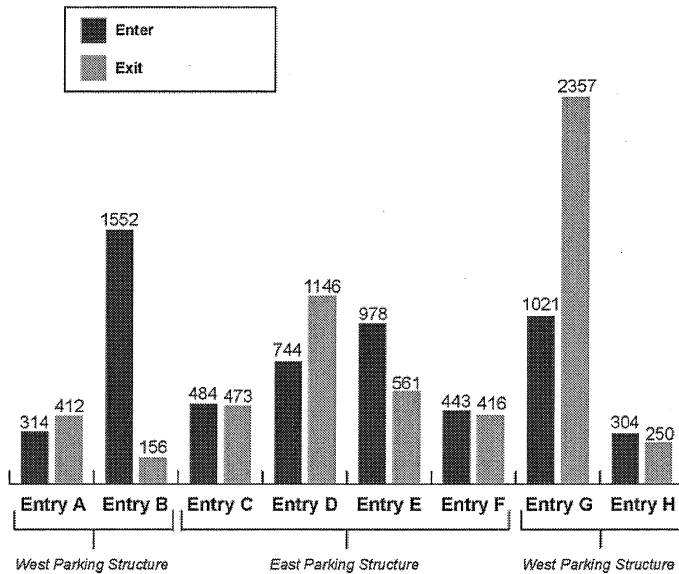
Figure 11: Total Weekday Traffic Usage by Entrance

Based on the results of the Traffic count, shown in Figure 11 the east parking structure (Entries C, D, E, F) was more frequented than the west parking structure (A, B, G, H). Over the course of the study, the west parking structure received 3,191 total vehicle entries, while the east parking structure received 2,649 total vehicle entries. Entries B, E, and G were the most popular for ingress, while entries G, D and E were the most popular for egress. Note that Entry B is signed for ingress only. On the following pages, Figures 14 and 15 breakdown the distribution between parking structures.

Total Weekday Traffic Usage by Entrance

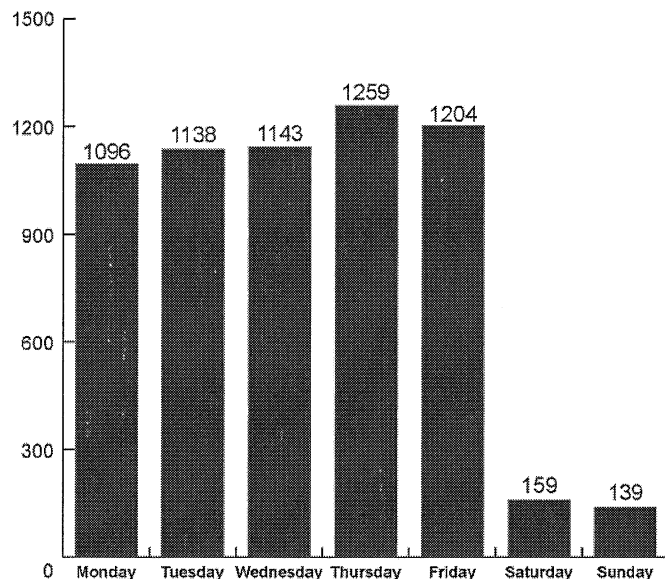
Figure 12: Total Traffic Ingress by Day

Daily traffic usage yielded slightly different results than the pedestrian count. The results of the study, shown in Figure 12 give the following ranking for busiest traffic days:

Total Traffic Ingress by Day

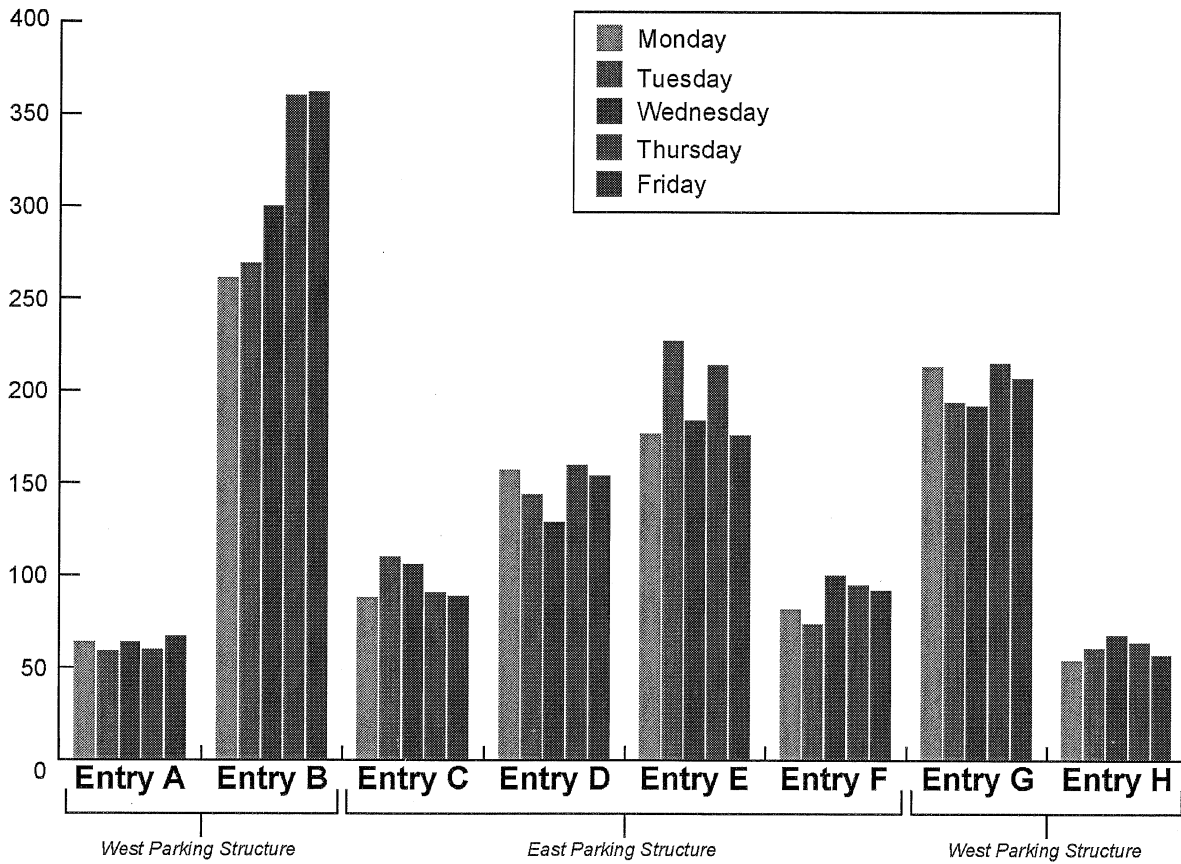
Figure 13: Weekday Traffic Ingress by Entry

Figure 13 further breaks down the weekday traffic ingress by entry.

Weekday Traffic Ingress by Entry

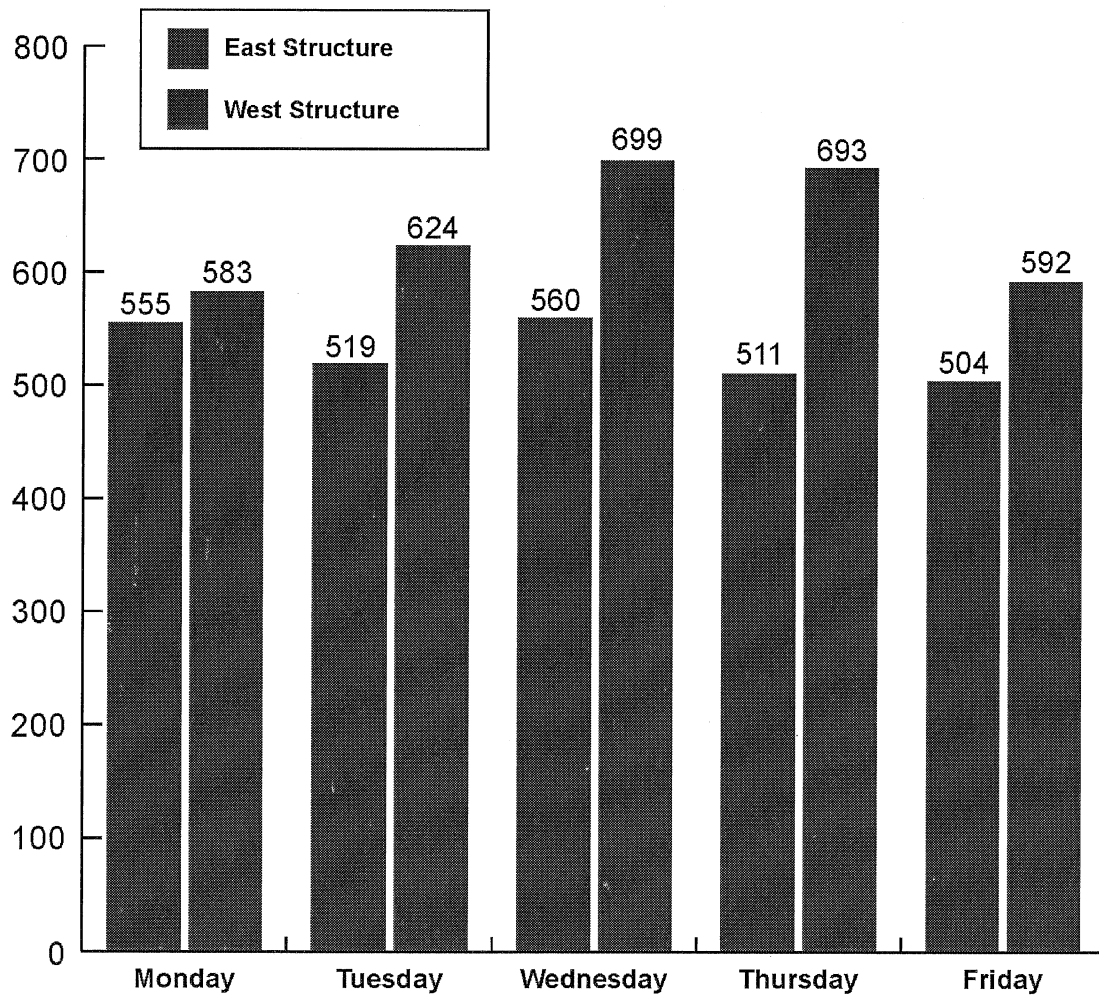
Figure 14: Weekday Traffic Ingress by Parking Structure

Total Traffic Ingress by Parking Structure by Day

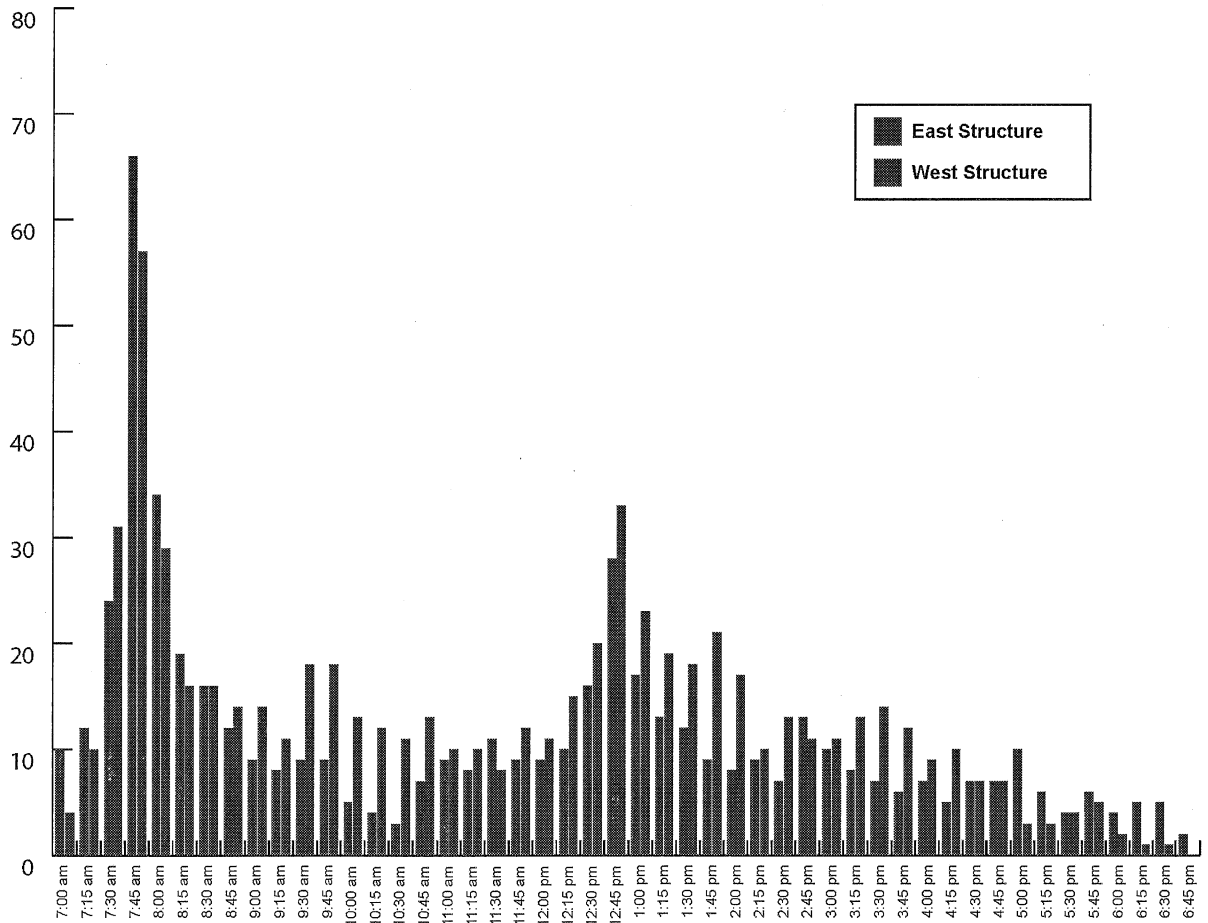
Figure 15: Average Weekday Traffic Ingress by 15-Minute Intervals by Parking Structure

Average Monday - Friday Traffic Ingress by 15-Minute Intervals by Parking Structure

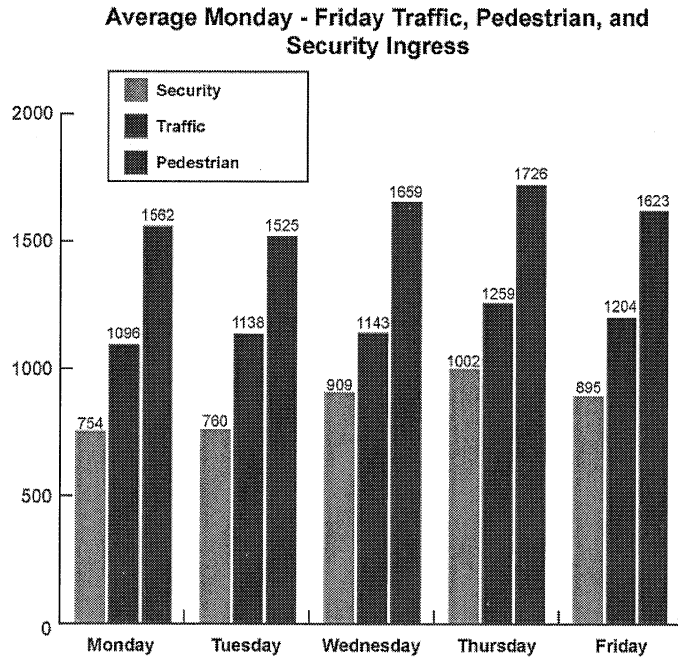
Figure 16: Average Weekday Traffic and Pedestrian Ingress

The traffic, pedestrian, and security data presented in Figure 16 shows that a majority of people traveling to the Rock County Courthouse arrive by automobile. Most notable about the data illustrated in Figure 16 is that the County Building experiences approximately 1.4 persons per vehicle parked on-site. This number will be important in determining future parking needs for the planned improvements.

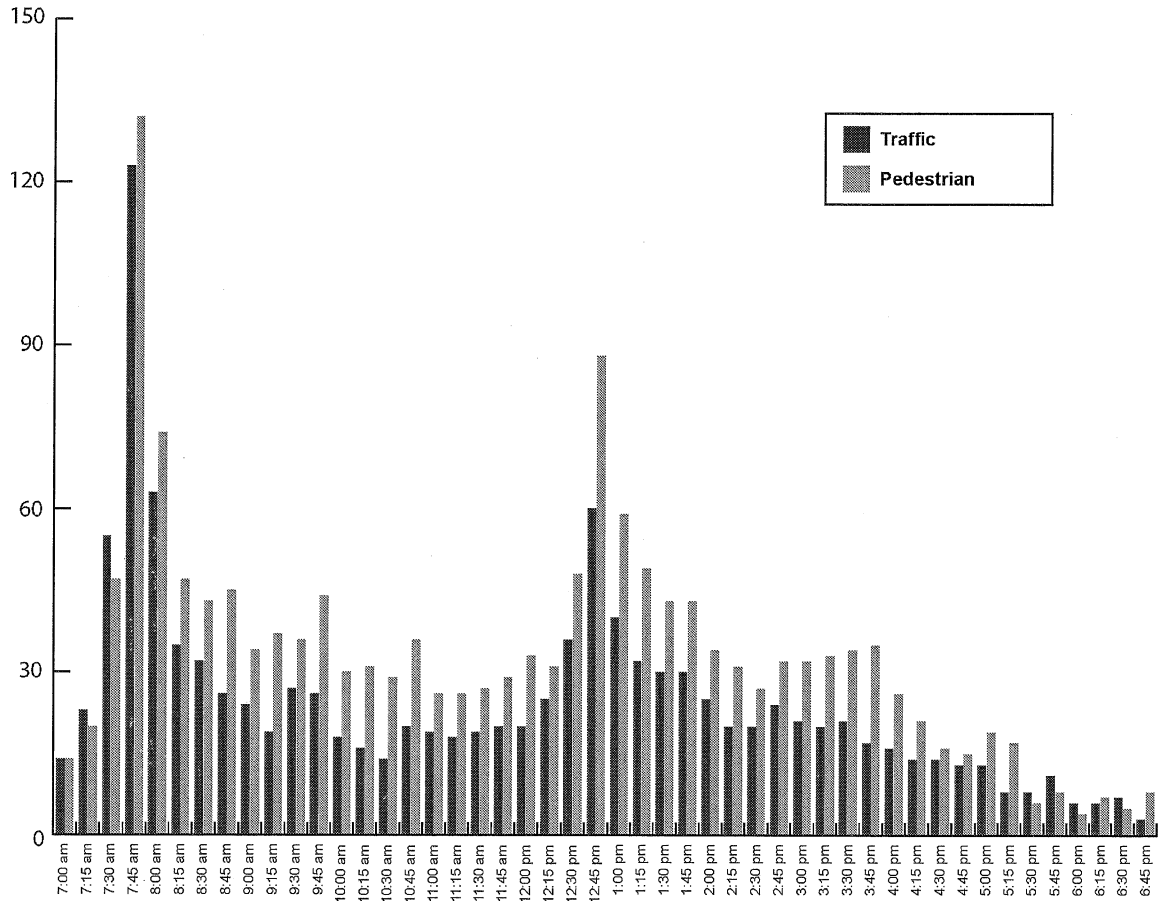
Figure 17: Average Weekday Traffic and Pedestrian Ingress - All Entrances

Figure 17 on the following page, breaks down the average weekday pedestrian and traffic ingresses by 15-minute intervals. The results between the two are similar. The largest difference occurs during the returning from lunch period (12:45-1:00 pm). This could potentially be a result of workers walking to lunch or eating outside.

Average Weekday Traffic and Pedestrian Ingress - All Entrances

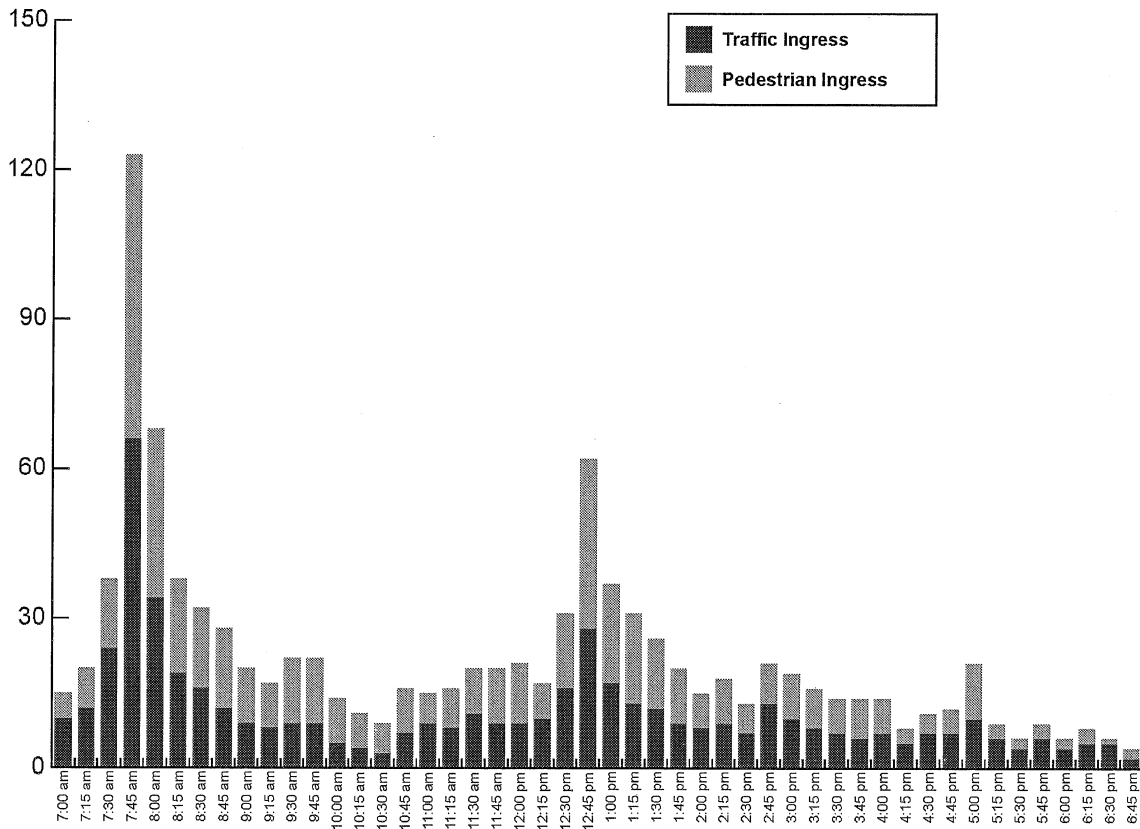
Figure 18: Average Weekday Traffic and Pedestrian Ingress by 15-Minute Intervals – East Entrance

Average Traffic and Pedestrian Ingress by 15-Minute Intervals - East Entrances

The Rock County Courthouse has approximately 389 stalls, 224 in the East Structure and 165 in the West Structure. Figures 18 shows the pedestrian and traffic activity of the East Parking Structure and the East Stairway. Figure 19 shows the pedestrian and traffic activity of the West Parking Structure and the Main Entryway. The arrival and departures of the County Staff are clearly event from the breakdown.

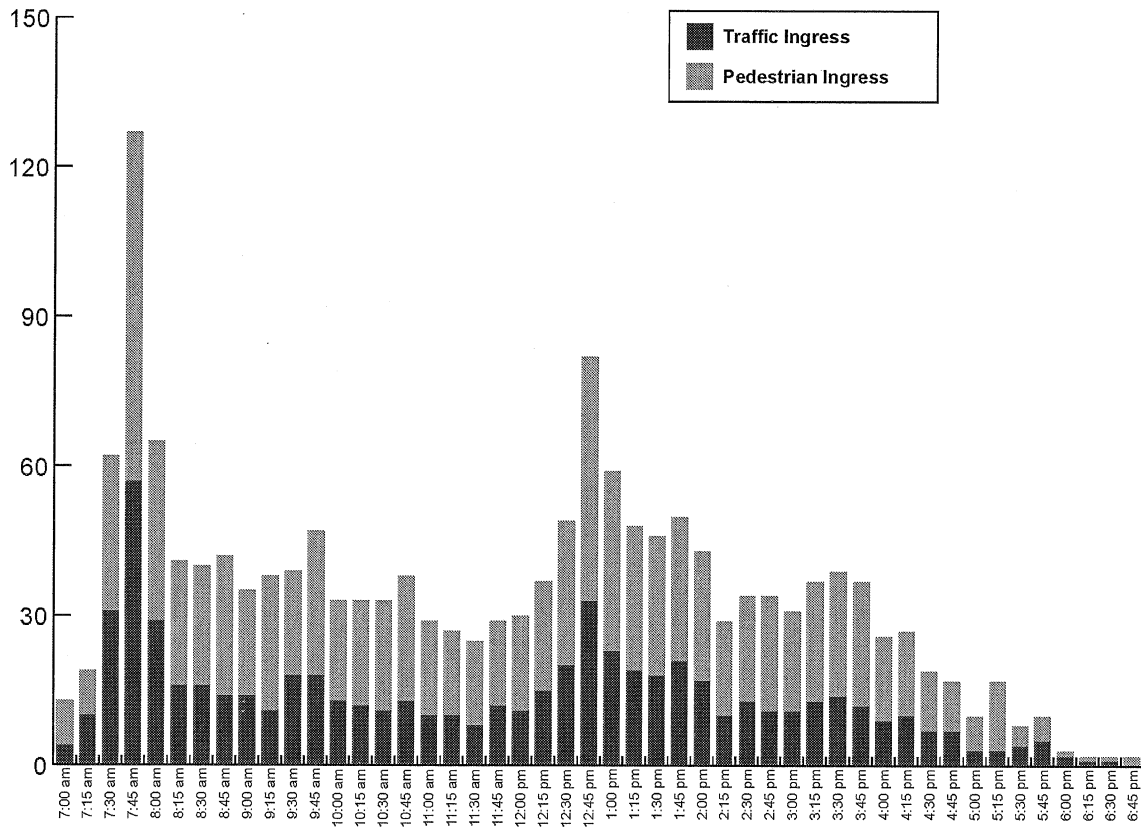
Figure 19: Average Weekday Traffic and Pedestrian Ingress by 15-Minute Intervals – West Entrance

Average Traffic and Pedestrian Ingress by 15-Minute Intervals - West Entrances
