U.S. PUBLIC LAND SURVEY MONUMENT RECORD

T. 1 N. - R. 12 E. of the 4th P.M.

BELOIT TWP
ROCK COUNTY WI

SHEET 1 OF 2
CORNER CODE A-13(3)

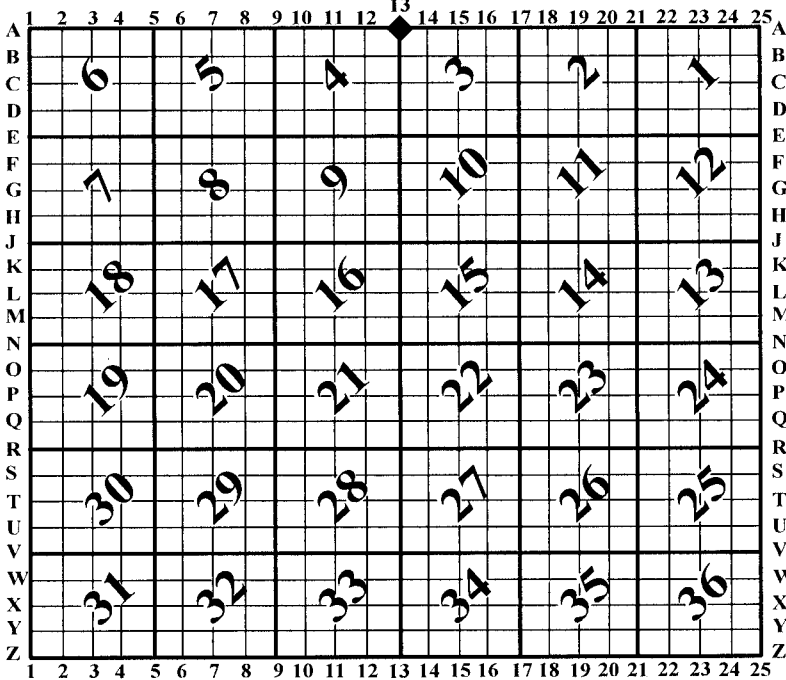
CORNER CODE INDEX

(PLACE "◆" SYMBOL AT PROPER PLSS CORNER LOCATION)

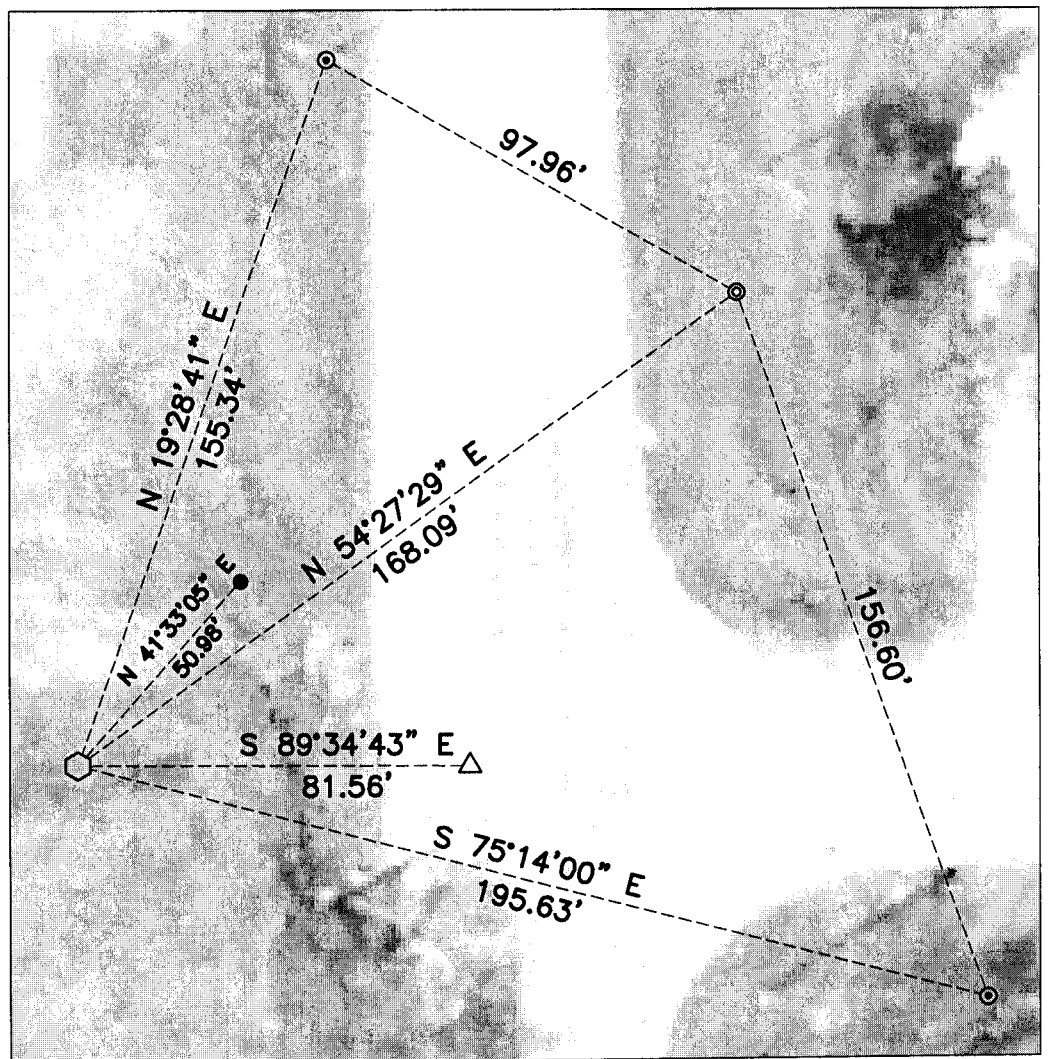
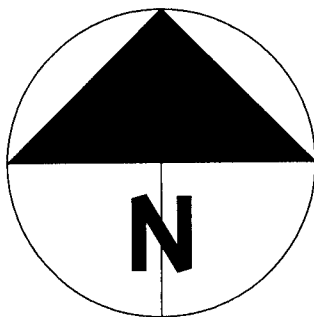
(a) LEGEND

D) Describe any material discrepancy between the location of the corner as restored or reestablished and the location of that corner as previously restored or reestablished by distance and direction. Show the discrepancy on the plan view drawing under (a), above. Show the distances between the corner as previously restored or reestablished and (1) the corner as restored or reestablished, and (2) to at least 4 of the witness monuments shown on the drawing in (a), above.

The rebar I set in reasonable harmony with past references to this corner, as can best be determined. The 1999 road construction along with excavation for the ditch has made the comparison to existing monuments nearby difficult.

This corner location is in the middle of a drainage ditch formerly occupied by a large pile of trees, (Don Barnes tie-sheet, 1998). The most recent tie-sheet only had a computed location for the corner and a tie distance of 81.80 from the Southeast corner of Section 33, (Rock), East of this location. Previous tie sheets had distances of 82.15, 81.80 81.84 and 82.5 feet between the Beloit and Rock corners. However, any of those surveys were dimensioned from the Rock corner that existed prior to Afton Road reconstruction in 1999. The railroad spike I found at that location was set by Robert Haakenson at that time. I set a rebar at the center of a well point found during the course of my fieldwork and referenced by R.H. Batterman on a January 14, 1939 survey. The well point is most likely the 2" pipe referred to in Volume 3, Pg. 552 mentioned by Barnes. My opinion is that the well point base is the best available evidence for this corners historical location.
