U.S. PUBLIC LAND SURVEY MONUMENT RECORD

T. 1 N. - R. 14 E. of the 4th P.M.

CLINTON TWP

ROCK COUNTY WI

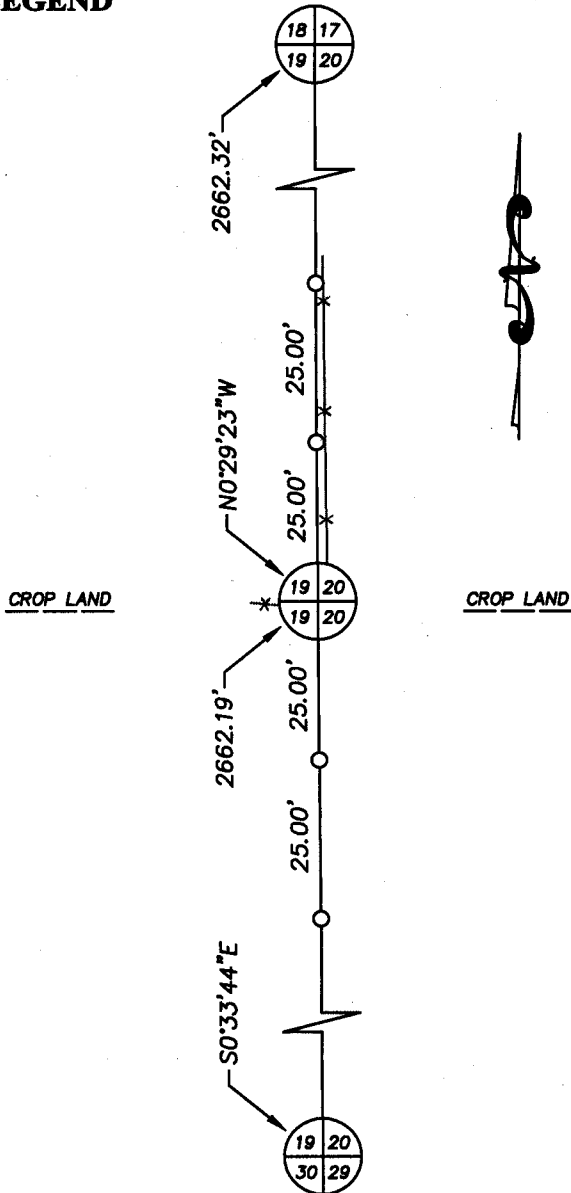
(a) LEGEND

SCALE: 1" = 100'

LEGEND:

- Cast Aluminum monument found.
- 3/4" X 24" solid round iron rod set, weighing 1.50 lbs per lineal ft.
- Existing fence line.

- (D) Describe any material discrepancy between the location of the corner as restored or reestablished and the location of that corner as previously restored or reestablished by distance and direction. Show the discrepancy on the plan view drawing under (a), above. Show the distances between the corner as previously restored or reestablished an (1) the corner as restored or reestablished, and (2) to at least 4 of the witness monuments shown on the drawing in (a) above.
