U.S. PUBLIC LAND SURVEY MONUMENT RECORD

T. 1 N. - R. 14 E. of the 4th P.M.

CLINTON TWP
ROCK COUNTY WI

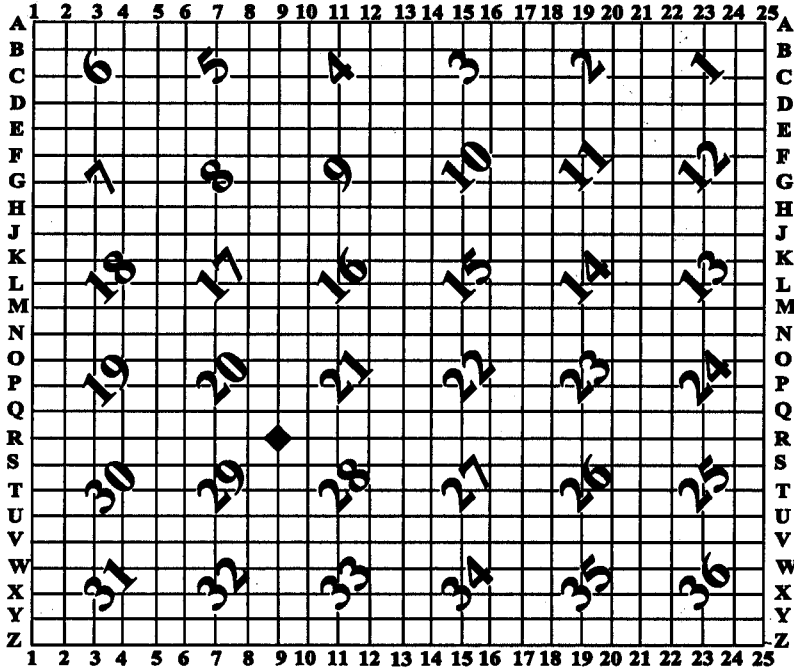
CORNER CODE INDEX

(PLACE "◆" SYMBOL AT PROPER PLSS CORNER LOCATION)

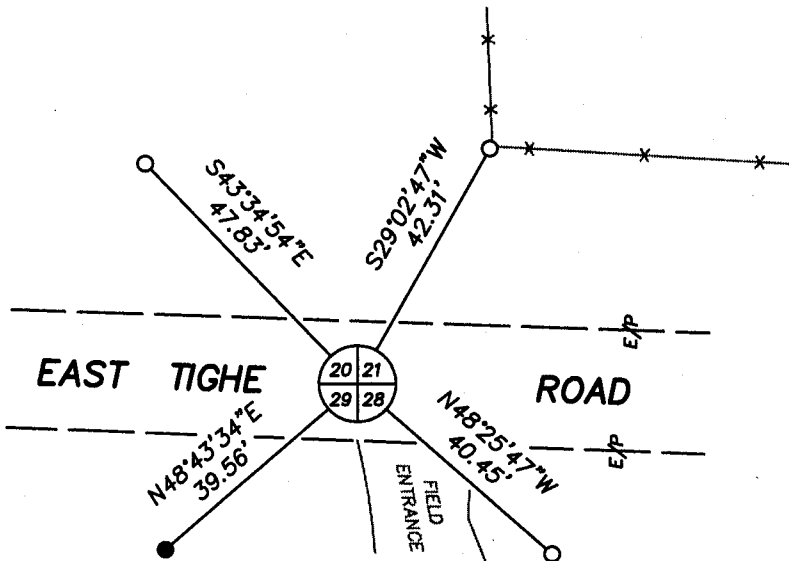
(a) LEGEND

SCALE: 1" = 30'

Cast Aluminum monument found.

1 1/2" iron pipe found.

3/4" X 24" solid round iron rod set,
weighing 1.50 lbs per lineal ft.

Existing fence line.

Edge of pavement.

This monument location was previously established by Rock County Surveyor Donald Barnes, on July & August 1976, as shown on County Surveyor Records Volume 5, Page 196. I found a Berntsen Cast Aluminum monument flush with the existing paved surface, (1) existing witness monument was found and I set (3) new witness monuments as shown.

- (D) Describe any material discrepancy between the location of the corner as restored or reestablished and the location of that corner as previously restored or reestablished by distance and direction. Show the discrepancy on the plan view drawing under (a), above. Show the distances between the corner as previously restored or reestablished an (1) the corner as restored or reestablished, and (2) to at least 4 of the witness monuments shown on the drawing in (a) above.
