U.S. PUBLIC LAND SURVEY MONUMENT RECORD

T. 2 N. - R. 14 E. of the 4th P.M.

BRADFORD TWP
ROCK COUNTY WI

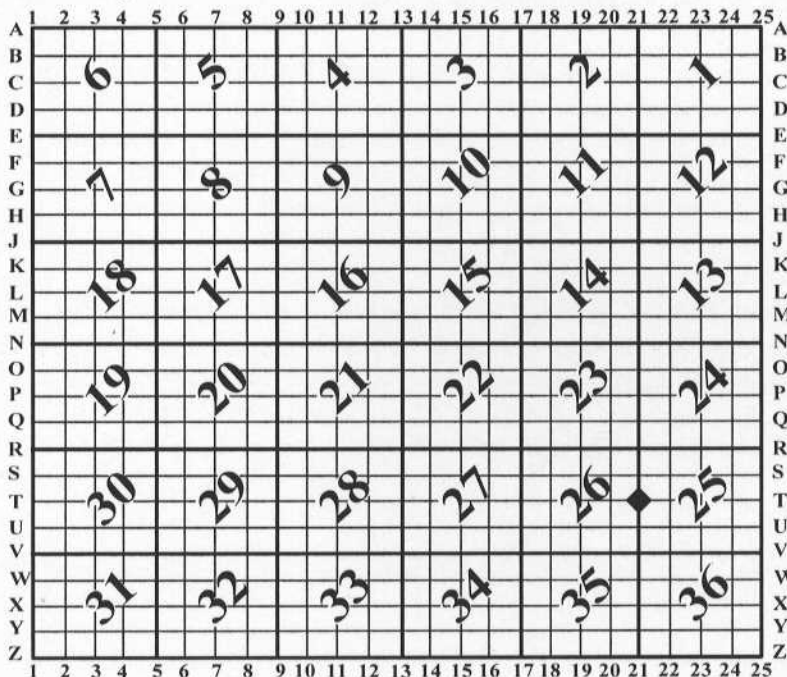
CORNER CODE INDEX

(PLACE "◆" SYMBOL AT PROPER PLSS CORNER LOCATION)

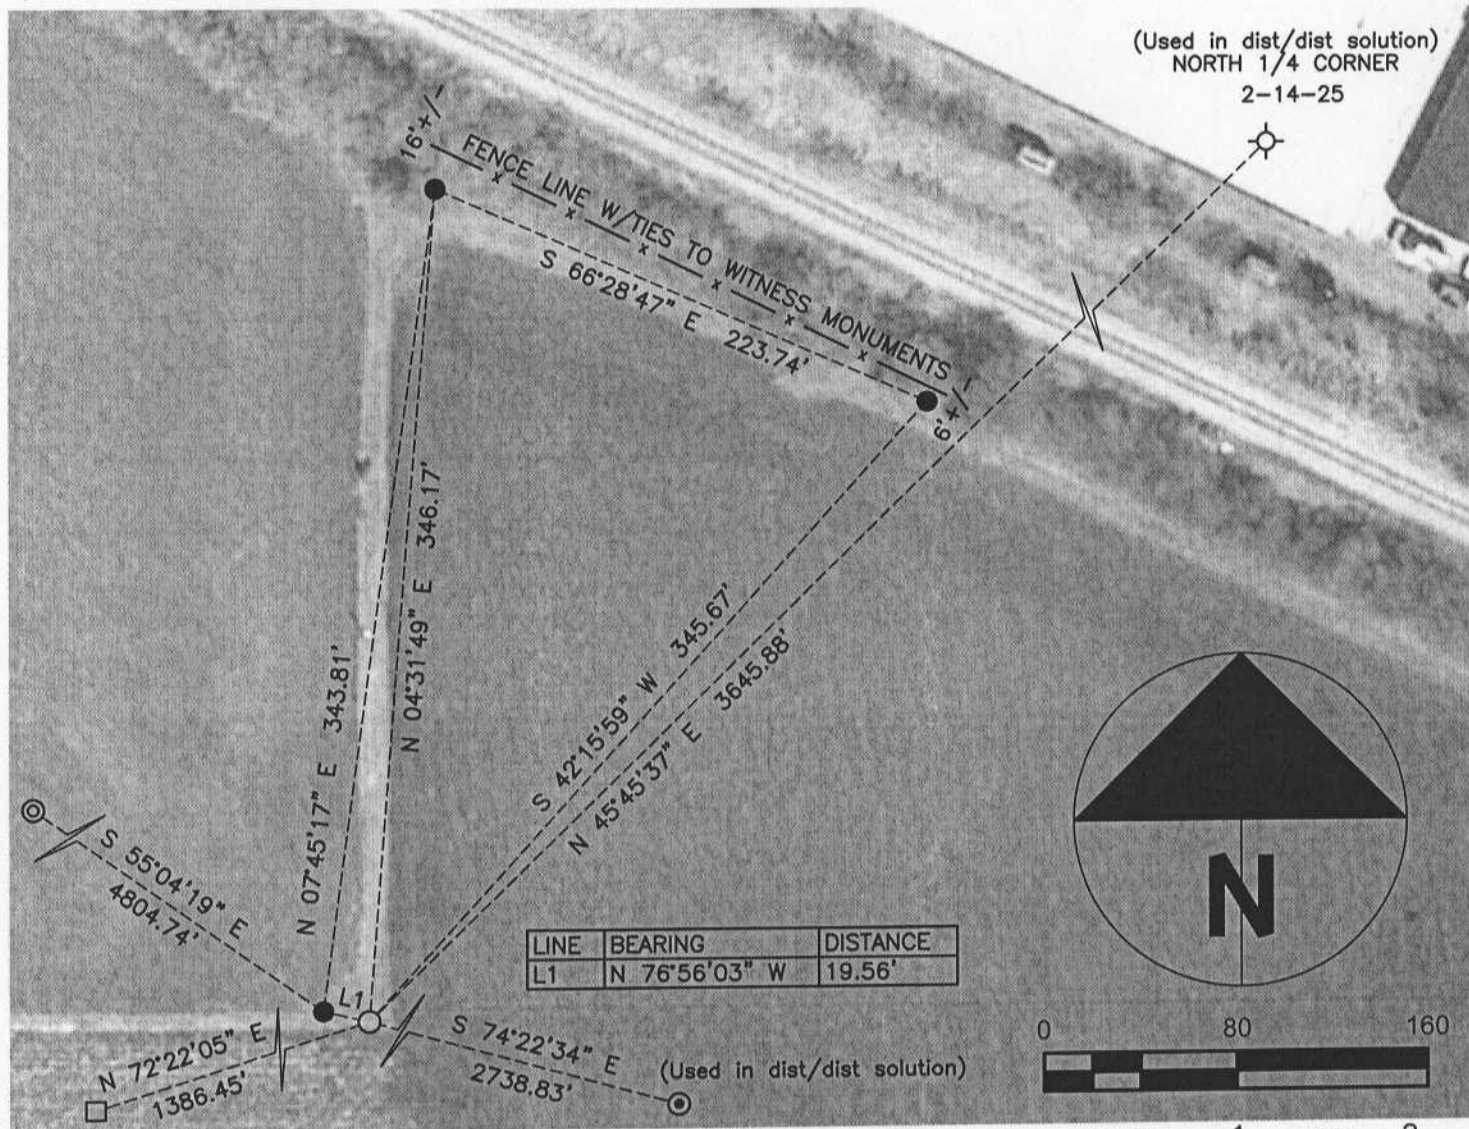
(a) LEGEND

- - 3/4" x 24" REBAR SET, (RED CAP WITH "PLSS WITNESS / S-2331")
- - ALUMINUM MONUMENT SET, (WEST 1/4 CORNER, 2-14-25)
- ⊙ - NAIL/FLASHER FOUND; PREVIOUS CTY. SURVEYOR TRAVERSE
- ⊗ - IRON PIPE FOUND; PREVIOUS CTY. SURVEYOR TRAVERSE
- - WISCONSIN DOT HMP MONUMENT FOUND, (BRADFORD S GPS)
- ⊕ - ALUMINUM MONUMENT FOUND

D) Describe any material discrepancy between the location of the corner as restored or reestablished and the location of that corner as previously restored or reestablished by distance and direction. Show the discrepancy on the plan view drawing under (a), above. Show the distances between the corner as previously restored or reestablished and (1) the corner as restored or reestablished, and (2) to at least 4 of the witness monuments shown on the drawing in (a), above.

The distance to the N1/4 is explained in B above. To prevent map clutter, the W1/4 to the NW corner distance is not shown but, differs from existing County coordinates by 0.29 feet. The county coordinate distance is not in harmony with past County data available; the "old" data is in harmony with today's survey results and this tie-sheet.
