U.S. PUBLIC LAND SURVEY MONUMENT RECORD

T. 1 N. - R. 14 E. of the 4th P.M.

CLINTON TWP
ROCK COUNTY WI

CORNER CODE: V-19(1)
(A.E. 7.08 REQUIREMENT)

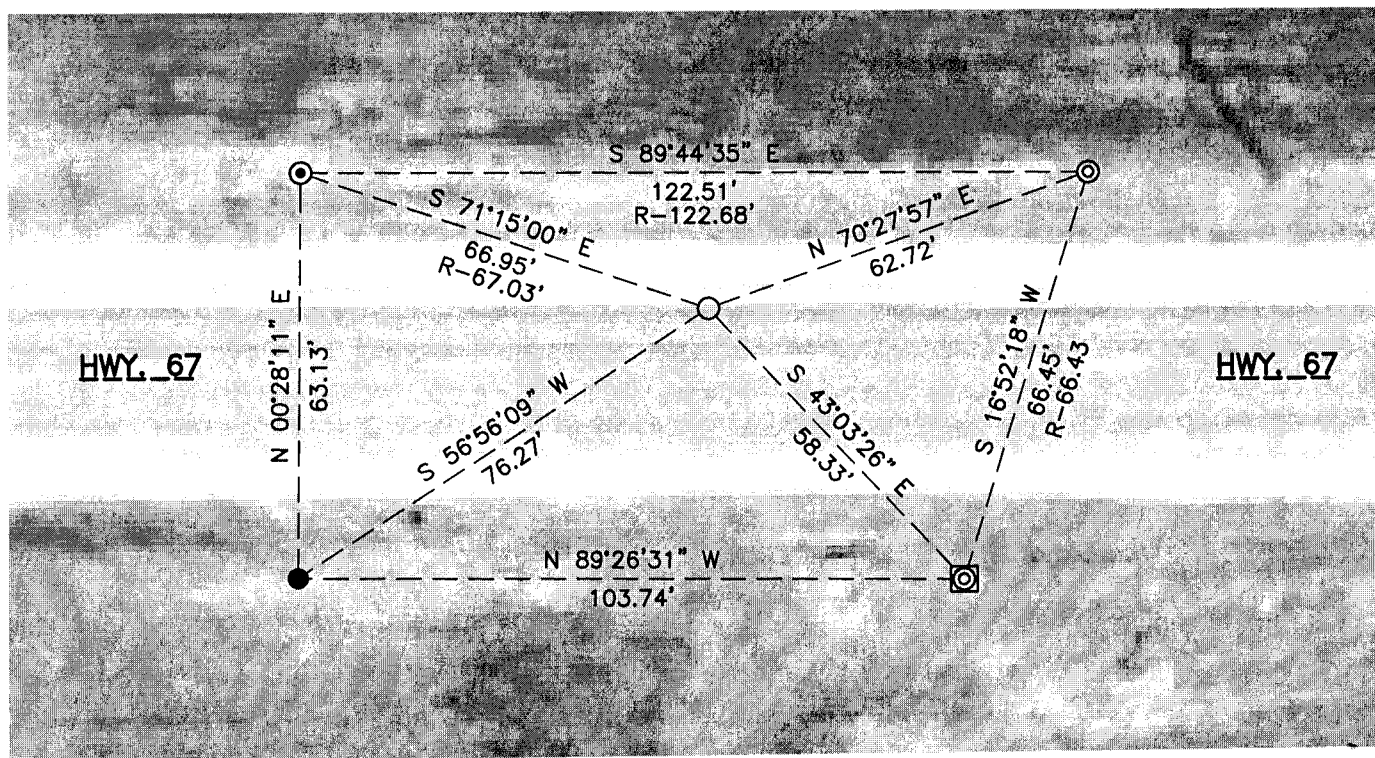
(a) LEGEND

- - 5/8" x 24" REBAR SET, (RED CAP W/"PLSS WITNESS")
- - COTTON GIN SPINDLE SET
- ⊙ - IRON REBAR FOUND
- ⊗ - IRON PIPE FOUND
- ⊕ - CAPPED IRON PIPE FOUND

Any discrepancies are noted on the face of the map with the most recently filed tie-sheets distances noted with an "R". Absent the "R" distance to a found monument, assume I match the existing tie-sheet distance. Bearing discrepancies are not noted.

In advance of Hwy. 67 resurfacing, (Hwy. 140 – Walworth County line), I set control and surveyed existing monuments, (exposed), and witnesses throughout the project. At this location I recovered three, (3), witness monuments from a tie sheet, (V-19), prepared by Don Barnes on May 10, 1994. I believe the Aluminum monument exists under the surface, (condition unknown), based on a metal detector. I calculated the position of the corner based on the witness monuments found.

Post construction and witnessed per the sketch, I set a cotton gin spindle at the corner.
