PUBLIC LAND SURVEY MONUMENT RECORD

For Public Land Survey Corners in: T. & N., R. ____E WI ADMINISTRATIVE CODE A-E 7.08 REQUIREMENT

CORNER CODE INDEX

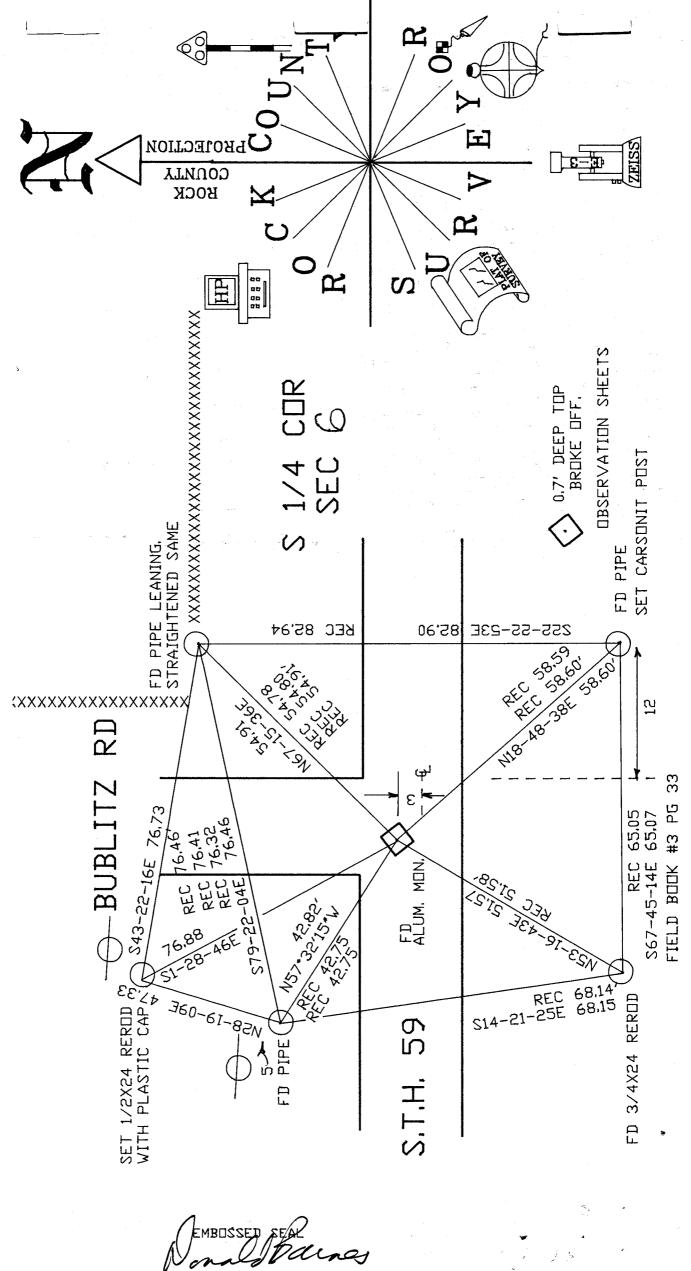
OBSERVATION SHEET	, 2
FIELD BOOKPAGE #	SHEET \bot OF $\overset{2}{=}$
SHOW A PLAN VIEW DRAWING DEPICTING THE CORNER MONUMENT ANI	SURROUNDING
PHYSICAL FEATURES, INCLUDING THE EXCAVATION AREA AND DEPTH.	-2(2)
PLANNING & ZONING COMMITTEE ADOPTED THE ABOVE FORM ON 12/2/1982	E-3 (2)

FOUND ALUMINUM MONUMENT WITH TOP BROKE OFF. MONUMENT IS ABOUT 0.7' DEEP.

- 1998 REIGEL E-11(1) I FOUND A 2" IRON PIPE AS OPPOSED TO AN ALUMINUM MONUMENT CALLED FOR ON CSM NO 650, VOL 18 PAGES 262-264. I VERIFIED ITS POSITION USING CSM NO 650 AND SET 4 TIES AS SHOWN.
