U.S. PUBLIC LAND SURVEY MONUMENT RECORD

T. 4 N. - R. 13 E. of the 4th P.M.

MILTON TWP

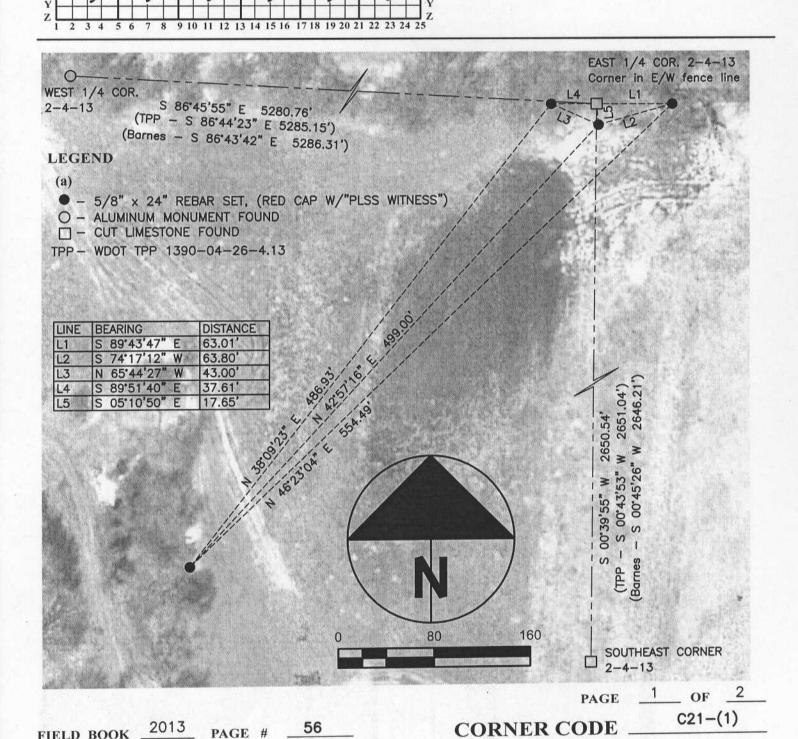
I accepted the cut stone as shown on the map and referenced per the sketch.

D) Describe any material discrepancy between the location of the corner as restored or reestablished and the location of that corner as previously restored or reestablished by distance and direction. Show the discrepancy on the plan view drawing under (a), above. Show the distances between the corner as previously restored or reestablished and (1) the corner as restored or reestablished, and (2) to at least 4 of the witness monuments shown on the drawing in (a), above.

The stone is referenced on an August '82 Don Barnes Monument Record however, no witness monuments were set at the time the record was filed. Most recently, the monument is referenced on a WDOT TPP Plat, (1390-04-26-4.13), with coordinates and bearings/distances to other PLSS corners flowing out from the same. Coordinates for the corner published by this office are in error and correspondence with the WDOT indicates coordinates, furnished by this office in 2006, were the basis for their platting. Current fieldwork misses the current coordinates by 4.55' N/S and 4.57' E/W. The referenced TPP plat has coordinates close to these, (1 ft. +/-, N/S), along with similar bearings /distances to other PLSS corners.
