## LAND U.S. PUBLIC SURVEY MONUMENT RECORD

T. 4N. R. 2 E. 4th P.M.

FULTON **ROCK COUNTY WI**

## FU M.P.649

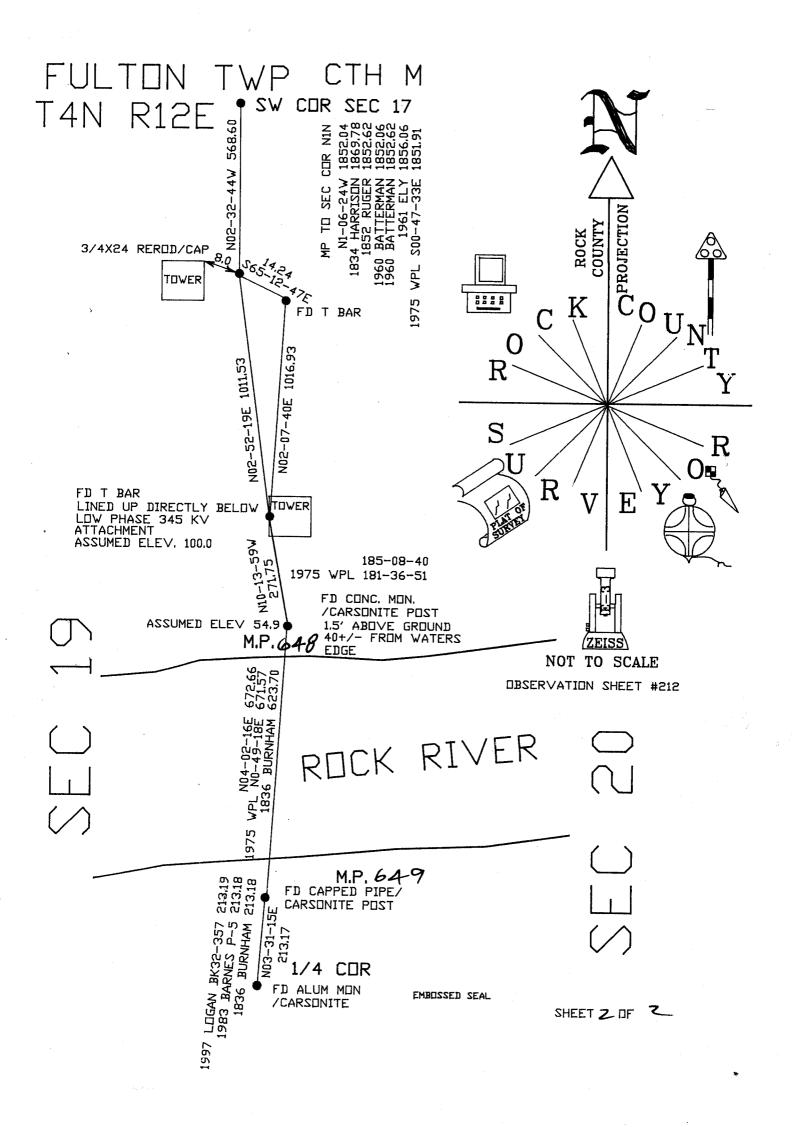
FIELD BOOK PAGE # SHOW A PLAN VIEW DRAWING DEPICTING THE CORNER MONUMENT AND SURROUNDING PHYSICAL FEATURES, INCLUDING THE EXCAVATION AREA AND DEPTH. PLANNING & ZONING COMMITTEE ADOPTED THIS FORM ON 12/2/1982

## FD CAPPED GAS PIPE IN N/S FENCE. SET CARSONITE POST.

## ACCEPTED GAS PIPE
