U.S. PUBLIC LAND SURVEY MONUMENT RECORD

T. 1 N., R. 11 E

NEWARK TWP
ROCK COUNTY WI

CORNER CODE J-15

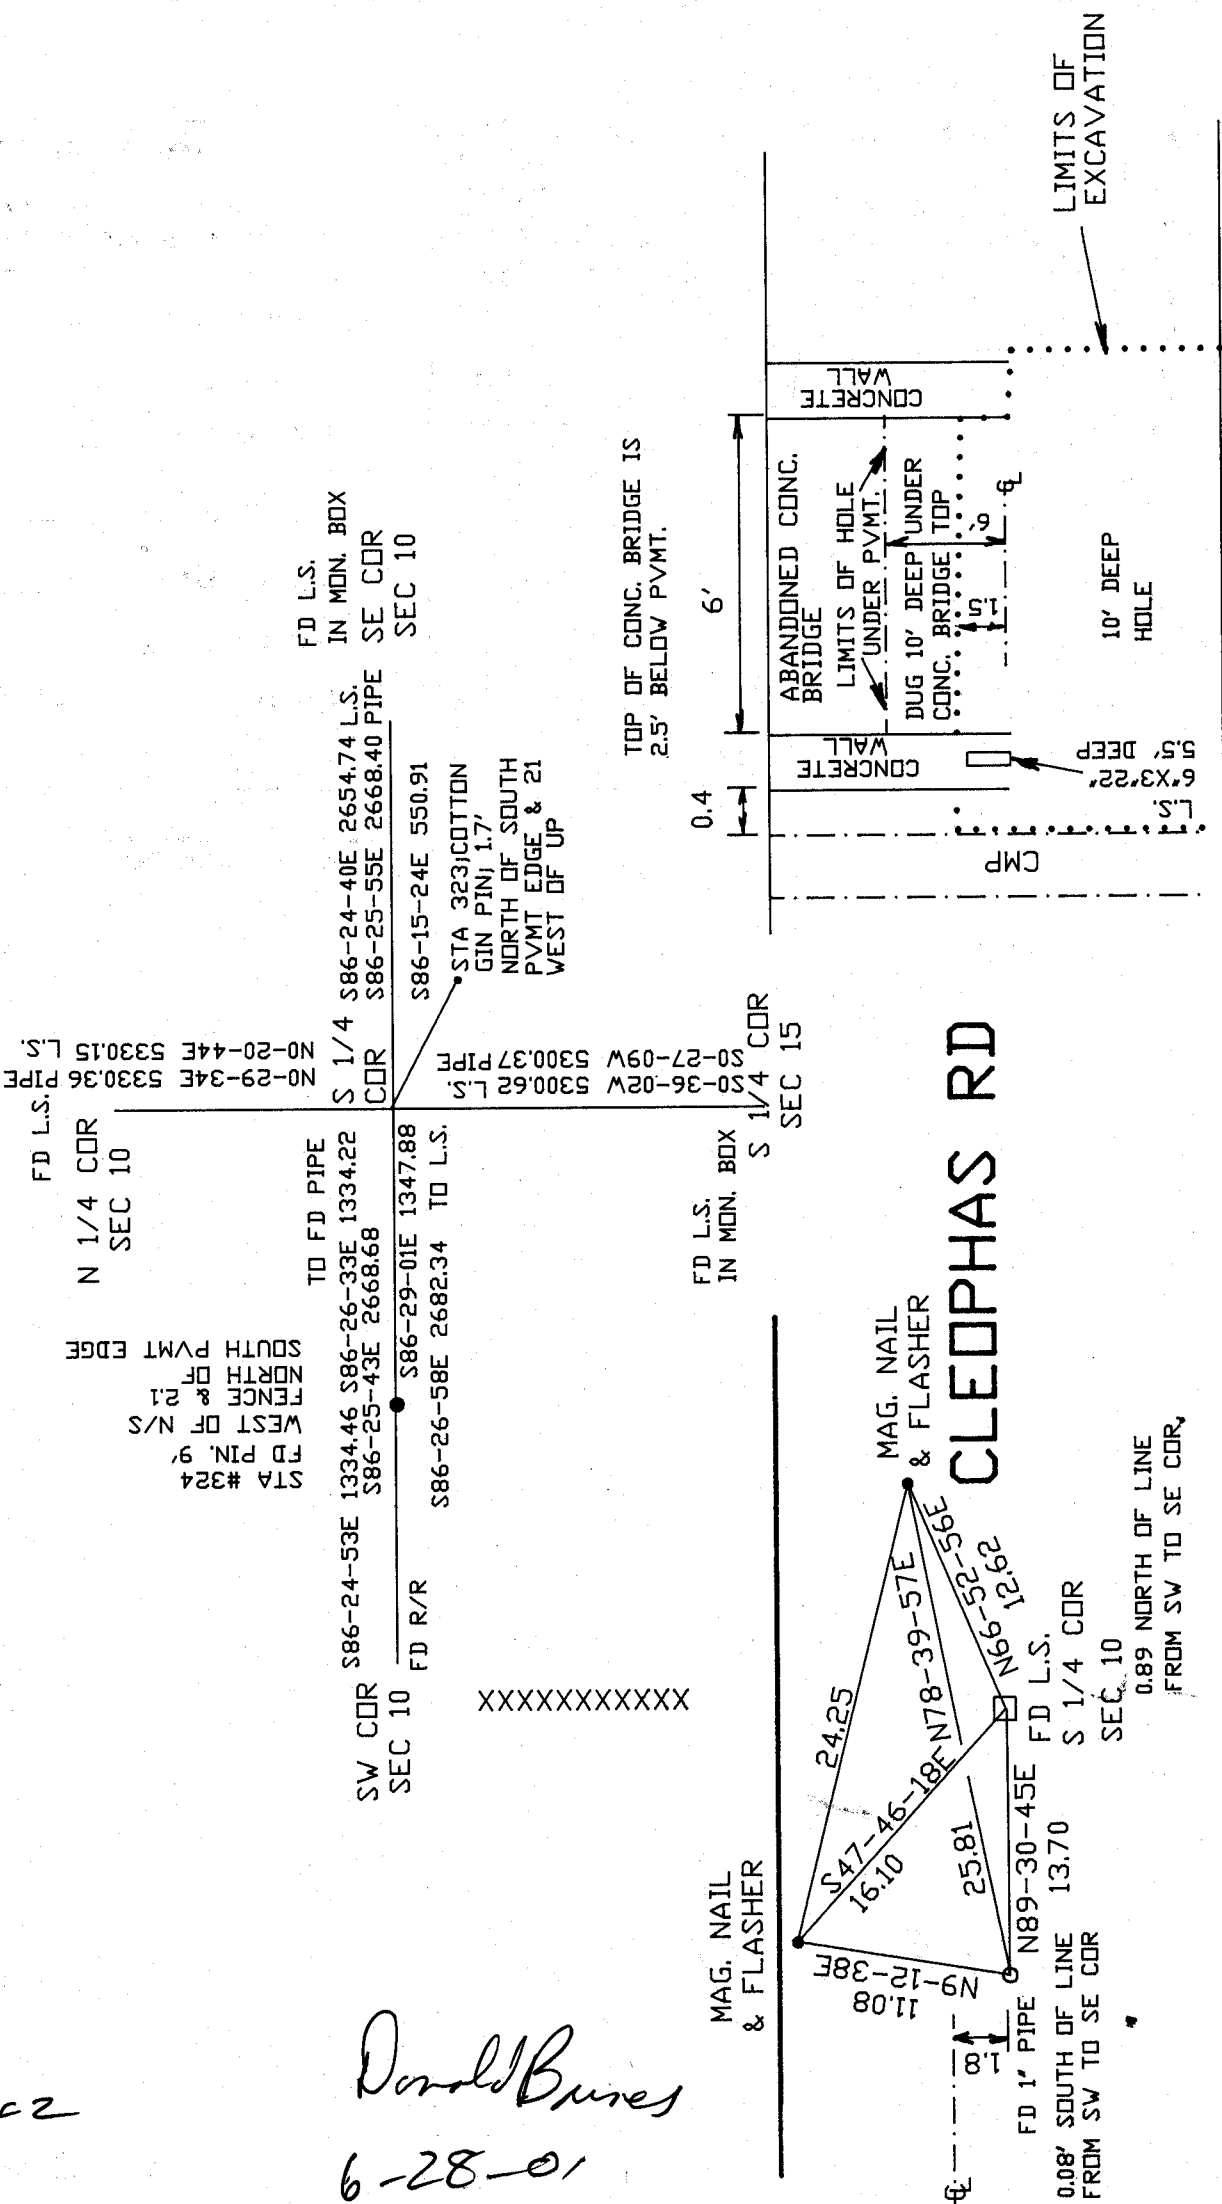
J-15

CLEOPHAS RD

MAG. NAIL & FLASHER

0.08' SOUTH OF LINE FROM SW TO SE COR
0.89' NORTH OF LINE FROM SW TO SE COR

FD 1" PIPE 1.5' SOUTH OF CENTER OF PVMT. & REFERENCE TIES. SINCE PIPE WAS 13.7' WEST OF COLLIN'S PRORATED DISTANCE & THE N/S FENCE, I EXCAVATED FOR THE STONE. AT 5.5' DEEP I FD A 6"X3"X22" PIECE OF THE CUT LIMESTONE LYING HORIZONTALLY IN THE BOTTOM OF THE WEST CONCRETE WALL OF AN ABANDONED CONCRETE BRIDGE. THE STONE HAD THIN DIRT LAYER AROUND THE EAST AND WEST SIDES AND THERE WAS A DIRT LAYER BELOW THE STONE. I SURMISE THE OLD BRIDGE THAT WAS CALLED FOR IN COLLIN'S FIELD NOTES WAS REPLACED WITH THE CONCRETE BRIDGE. INSTEAD OF DIGGING HOLES FOR EACH WALL OF THE CONCRETE BRIDGE THEY USED THE EXISTING ABANDONED WOOD BRIDGE HOLE AND WHEN THEY ENCOUNTERED THE CUT LIMESTONE THEY JUST POURED CONCRETE AROUND IT. ALSO I FOUND A LOT OF BARB WIRE IN THE HOLE.

ACCEPTED THE FOUND CUT LIMESTONE, WHICH IS IN HARMONY WITH COLLIN'S REMONUMENTATION DISTANCES AND THE CALL TO A BRIDGE AND THE N/S FENCE LINE.

THE FOUND PIPE IS ON AT SINGLE PROPORTIONATE DISTANCE WITH THE ORIGINAL GOVERNMENT MEASUREMENTS. THE RECORDS INDICATE THE PIPE WAS PROBABLY SET BY THE FORMER COUNTY SURVEYOR.
