## PUBLIC LAND SURVEY MONUMENT RECORD

For Public Land Survey Corners In: T. 4 N. R. 12 E. 4th P.M.						WI ADMINISTRATIVE CODE A-E 7.08 REQUIREMENT REV 10/23/2004 USMONREC.DWG		
A 1 2 3 4 5 6 B C D		ER CO			22 23 24 25 I	ROCK COUNTY WI		
E F G H J K L M N	8	9 <b>1</b> 6	<b>10</b>	\\\\\\\\\\\\\\\\\\\\\\\\\\\\\\\\\\\\\\	A S	North Elev		
O P Q R S T	20	28	3	73		LATITUDE ELLIPS. HT		
V W X Y Z	3	2	4 15 16 17	18 19 20 21	36	NAD83(91)NETWORK ADJ. YR G GPS (X) TRAVERSE (X)		
1 2 3 4 5 6 7 8 9 10 11 12 13 14 15 16 17 18 19 20 21 22 23 24 25  PLACE MONUMENT SYMBOL AT PROPER  LOCATION ON ABOVE INDEX

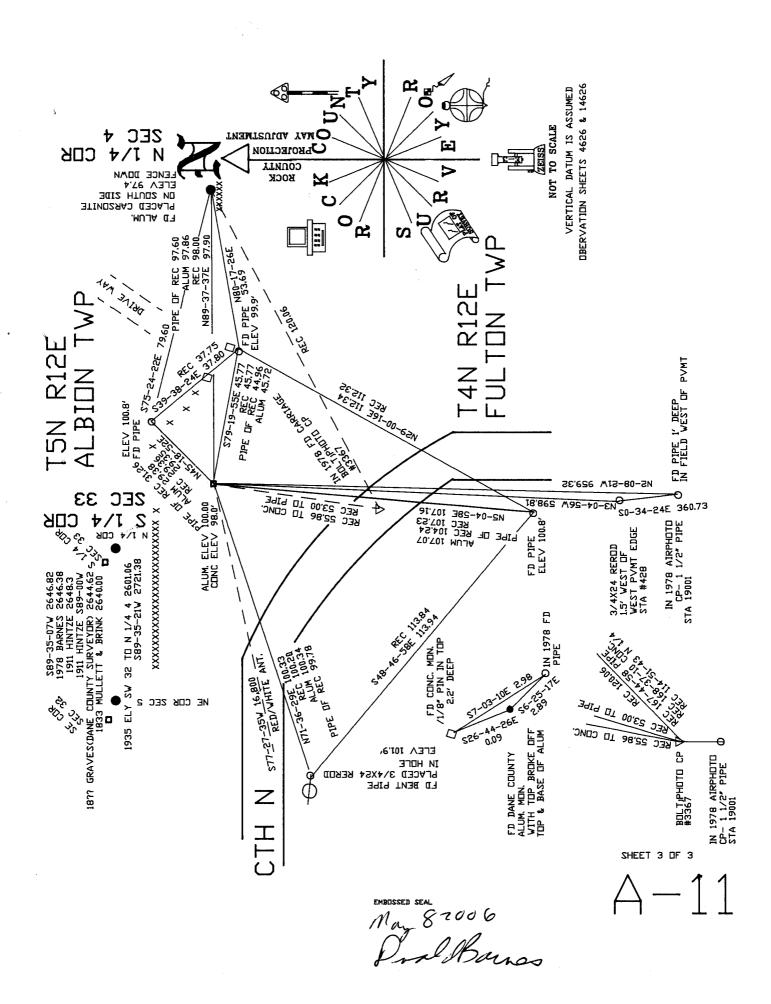
CORNER CODE A-11

FIELD BOOK \_\_\_\_\_ PAGE # \_\_\_\_ SHEET \_\_\_ OF \_\_\_\_ SHOW A PLAN VIEW DRAWING DEPICTING THE CORNER MONUMENT AND SURROUNDING PHYSICAL FEATURES, INCLUDING THE EXCAVATION AREA AND DEPTH.
PLANNING & ZONING COMMITTEE ADOPTED THIS FORM ON 12/2/1982

FD DANE COUNTY ALUM. MON. WITH TOP BROKE OFF NEAR S  $\frac{1}{4}$  COR SEC 33 & FD ROCK COUNTY ALUM. MON. AT N  $\frac{1}{4}$  COR SEC 4. DUG & FD 2.2' DEEP CONC. MON. WITH  $\frac{1}{8}$ " STEEL PLUG IN TOP @ S  $\frac{1}{4}$  COR SEC 33. PLACED 2 MAGNETS ON SOUTH SIDE OF CONC. @ N  $\frac{1}{4}$  COR SEC 4 PLACED CARSONITE POST ON SOUTH SIDE OF ALUM. MON. BROKEN ALUM MON WAS IN GOOD VERTICAL CONDITION.

IN 1978 FD PIPE S7-03-10E 2.98' OF CONC. MON.
FD BROKEN DANE COUNTY ALUM. MON. BASE IS S26-44-26E 0.09'
OF CONC. MON. REMOVED DANE COUNTY ALUM. MON. TO FIND
CONC. MON.
