U.S. PUBLIC LAND SURVEY MONUMENT RECORD

For Public Land Survey Corners In: T. £N. R. 12 E. 4th P.M. CORNER CODE INDEX A 2 3 4 5 6 7 8 9 10 11 12 13 14 15 16 17 18 19 20 21 22 23 24 B C	WI ADMINISTRATIVE CODE A-E 7.08 REQUIREMENT REV 10/23/2004 USMONREC.DWG TWP ROCK COUNTY WI
	D IF AVAILABLE E ROCK COUNTY COORDINATES PERFERRED F G
H J K L M N N N N N N N N N N N N N N N N N N	H North Elev K East
NO P Q Q Q Q Q Q Q Q Q Q Q Q Q Q Q Q Q Q	Hor. Datum Vert. Datum O P Q LATITUDE ELLIPS. HT
	R S LONGITUDE T U NAD83(91)NETWORK ADJ. YR
W X Y Z 1 2 3 4 5 6 7 8 9 10 11 12 13 14 15 16 17 18 19 20 21 22 23 24	W X GPS (X) TRAVERSE (X) Z BASED ON THE FOLLOWING CONTROL
PLACE MONUMENT SYMBOL AT PROPER LOCATION ON ABOVE INDEX CORNER MONUMENT (a)	WITNESS MONUMENT

OBSERVATION SHEET 2059			-
FIELD BOOK PAGE #	SHEET		
SHOW A PLAN VIEW DRAWING DEPICTING THE CORNER MONUMENT AND	D SURROUN	DING	
PHYSICAL FEATURES, INCLUDING THE EXCAVATION AREA AND DEPTH.			
PLANNING & ZONING COMMITTEE ADOPTED THIS FORM ON 12/2/1982		٠ ,	
CORNER	CODE	R - 3(1))

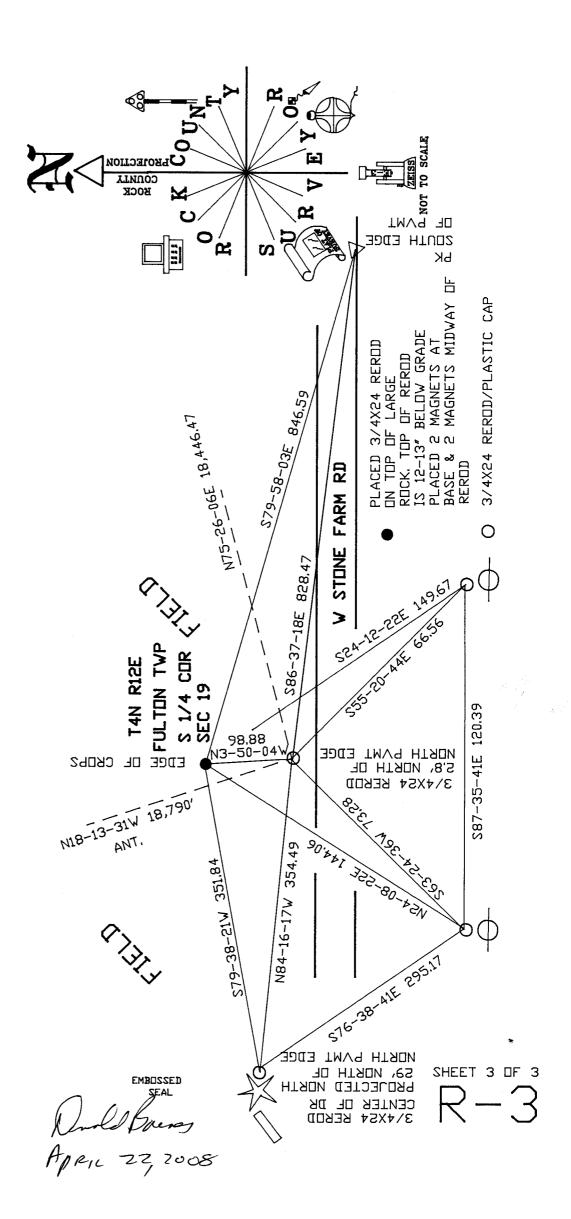
CORNER GODE R-3(1)

YES. I PRORATED THE DISTANCE FROM THE SE CORNER OF SEC 19 TO THE FD LIMESTONE AT THE MEANDER CORNER ON THE WEST SIDE OF THE RIVER. I USED BURNHAM'S 1836 DISTANCE OF 4280.10 AND MY DISTANCE OF 4325.91. THE 1/4 CORNER IS ON A LINE BETWEEN THESE CORNERS. MY DISTANCE TO THE SE CORNER IS 2668.27 AND THE DISTANCE TO THE MEANDER CORNER IS 2459.78
