U.S. PUBLIC LAND SURVEY MONUMENT RECORD

T. 4 N. - R. 13 E. of the 4th P.M.

ROCK COUNTY WI

Corner code: L-17

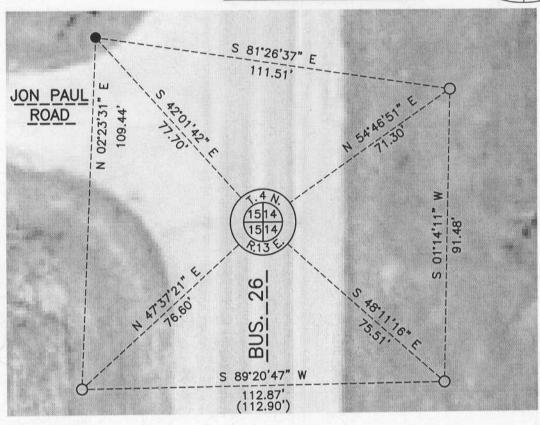
(a) LEGEND

● - 3/4" x 24" REBAR SET, (RED CAP W/"PLSS WITNESS")

O' - ALUMINUM WDOT MONUMENT, IN CONCRETE, FOUND

(#) - PREVIOUS TIE-SHEET DIMENSION

COTTON GIN SPINDLE, (CGS), SET (ALUMINUM MONUMENT OF RECORD FOUND, 2 FT., +/-, SOUTH)

I found the aluminum monument and 3 witnesses per the L17(2) Monument record, (Barnes – 1994). The same record indicates the aluminum monument in the roadway is not the PLSS corner location; Barnes never states that he set a monument at what is referred to as the "new position" on the tie-sheet. It appears that Barnes analyzed computations from previous work by Sunny, (1932), Ruger, (1871), and Batterman, (V. 5, Pg. 82), to arrive at the corner location. The Barnes L17(2) also says "monument record L17(1) call bearings and distances to the computed position that Sunny established is in error". I am unsure what error was discovered however, given the time dedicated to this in 1994, the fact that no surveys of record used the aluminum monument in the roadway and a recent WDOT TPP plat used Rock County coordinates, (new position), I perpetuated the "new positon" and set a cotton gin spindle. Witnesses were accepted/set per the map.

Previous tie-sheets have detailed the history of this corner. FOR REFERENCE ONLY, the coordinates for the aluminum monument found are: N-315157.01, E-516581.09
