## U.S. PUBLIC LAND SURVEY RECORD MONUMENT

T. 3 N. - R. 10 E. of the 4th P.M.

MAGNOLIA TWP ROCK COUNTY WI

C - 9(1)

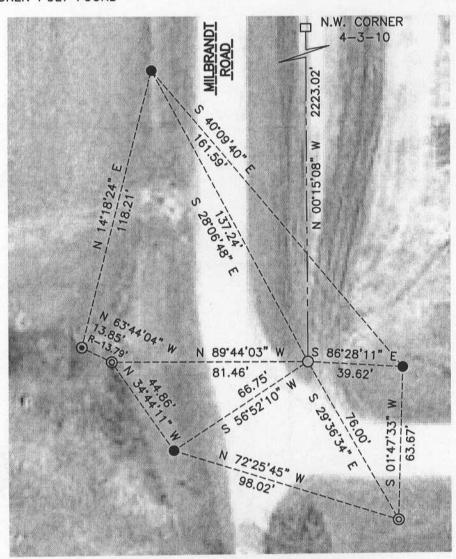
At this location I recovered three, (3), witnesses from a tie-sheet, (C9), prepared by Don Barnes on July 30, 1991. An aluminum monument was found removed and laying intact in the tree/fence line South of the corner, along with one old pipe. The 1991 tie-sheets notes the monument as destroyed. Once a position was calculated I dug and found two, (2), old nails within close proximity of my calculation. A "Spike nail" is noted on a CSM as being set, (V. 11, Pg. 584), but no tie-sheet for the same exists. Similarly, a "Spike nail" is noted as found on a CSM recorded in V. 20, Pg. 167. I also surveyed a disturbed poly monument at the NE corner of Section 4. At the NE corner, Barnes has a "Placed Poly" note on his 8/12/91 tie sheet filed in Volume 6, Pg. 421 of records. A distance of 2222.98 feet distance from the NE corner to the E1/4 corner is also shown. My distance for the same is 2223.02 feet and indicated on the face of the map.

I established the position of the corner based on two of my found witnesses and set an uncapped 5/8x24" rebar at the corner. The position is further substantiated by the 8/12/91 tie sheet prepared by Barnes. The top of the rebar is 3", +/-, below grade.

All current tie distances are shown with the most recent tie distances noted with an "R", if applicable.
