U.S. PUBLIC LAND SURVEY MONUMENT RECORD

For Public Land Survey Corners In: WI ADMINISTRATIVE CODE A-E 7.08 REQUIREMENT
T. 3 N. - R. 10 E. of the 4th P.M.

MAGNOLIA TWP

ROCK COUNTY WI

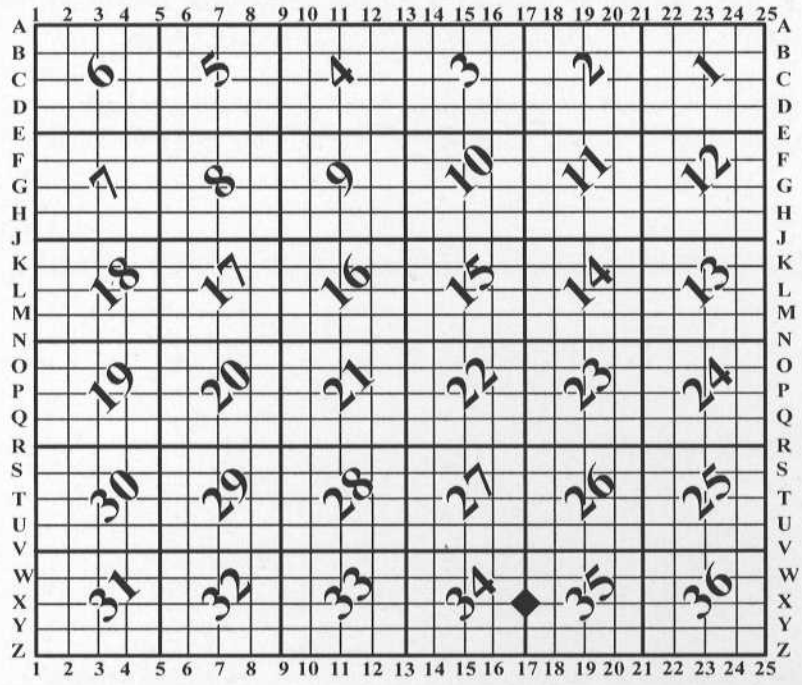
CORNER CODE INDEX

(PLACE "◆" SYMBOL AT PROPER PLSS CORNER LOCATION)

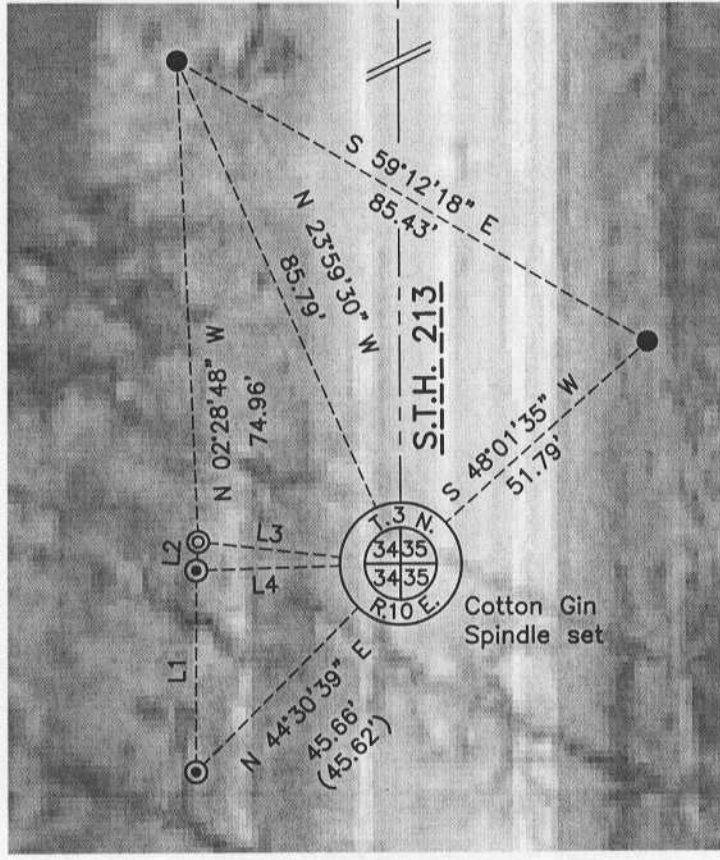
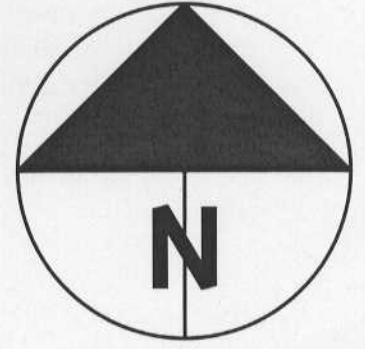
(a) LEGEND

- - 3/4" x 24" REBAR SET, (RED CAP W/"PLSS WITNESS, S-2331")
- ⊙ - CAPPED WDOT REBAR FOUND
- ⊙ - IRON PIPE FOUND
- (#) - PREVIOUS TIE-SHEET DIMENSION

Cotton Gin Spindle found

LINE	BEARING	DISTANCE	
L1	N 00°06'48" E	31.59'	(31.57')
L2	N 03°57'56" E	4.46'	
L3	S 83°42'44" E	31.83'	(31.86')
L4	S 88°16'01" W	31.96'	(32.04')

W
N 00°15'04" W
2653.84'
N

I calculated the PLSS corner from the most northerly and southerly witnesses by way of distance/distance intersection from the 1988 tie-sheet. A cotton gin spindle was set at the corner along with two additional witnesses per the sketch.

D) Describe any material discrepancy between the location of the corner as restored or reestablished and the location of that corner as previously restored or reestablished by distance and direction. Show the discrepancy on the plan view drawing under (a), above. Show the distances between the corner as previously restored or reestablished and (1) the corner as restored or reestablished, and (2) to at least 4 of the witness monuments shown on the drawing in (a), above.
