U.S. PUBLIC LAND SURVEY MONUMENT RECORD

T. 1 N. - R. 10 E. of the 4th P.M.

AVON TWP
ROCK COUNTY WI

CORNER CODE: A-21
(A.E. 7.08 REQUIREMENT)

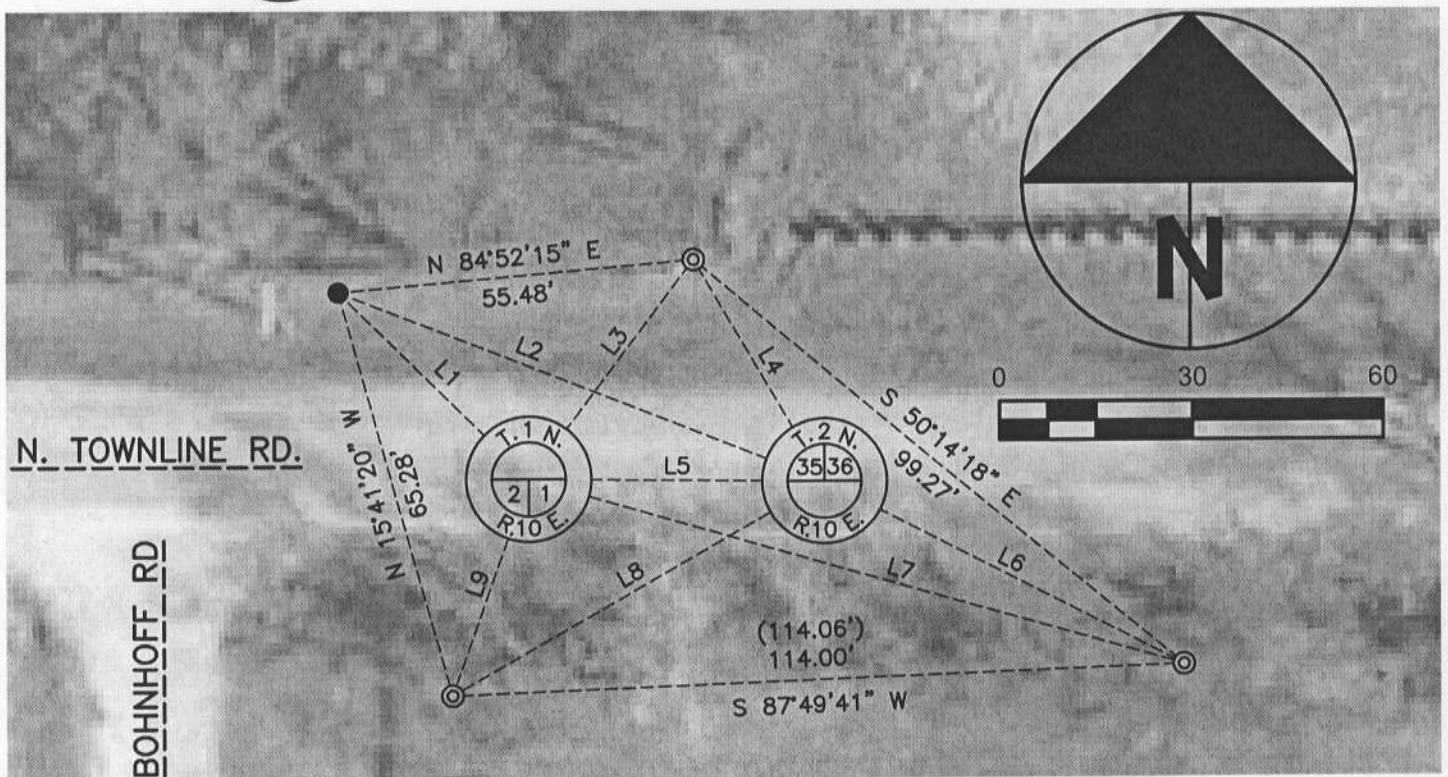
I found the cast iron monument and three witnesses per the 1987 A-21 monument record, (Barnes). Additionally, I found the aluminum monument, (beginning to corrode), at the SE corner of 35-2-10; I accepted all as found as they check within expected tolerances. One additional witness was set per the sketch.

The PLSS monuments, (Avon & Spring Valley), are situated 56 & 102 feet, +/-, east of the centerline of Bohnhoff Road. The South ¼ and SE 1/16 corners of 35-2-10 could result in a defensible solution moving the corners 22', +/-, west and within proximity of trees/fences to the south. Given the passage of time, acceptance of these locations since the 1957, (V. 3, Pg. 523 – RHB), lack of an original corner, (Barnes dug in '76 & '81), I accept the monuments as found.

I did not find a discrepancy between the corner restored and a previously documented corner location. Discrepancy being defined as *disagreeing* with a corner location, *not* as noting dimensional differences between current/former tie sheets due to measuring methods. The current and *most recent* tie-sheet dimensions filed for the corner are noted.
