U.S. PUBLIC LAND SURVEY MONUMENT RECORD

For Public Land Survey Corners In:
T. 2 N. - R. 12 E. of the 4th P.M.

ROCK Twp.
Rock County, WI.

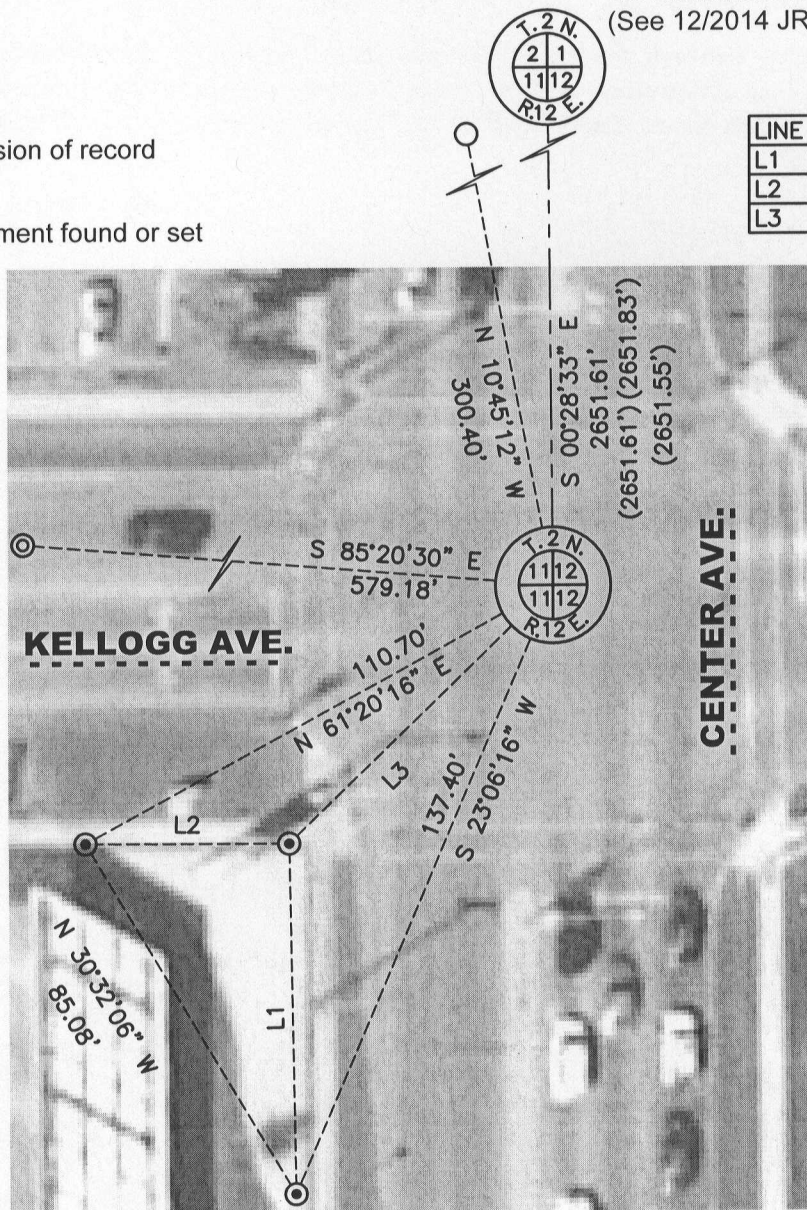
No monument found or set
(See 12/2014 JRH tie-sheet)

LINE	BEARING	DISTANCE
L1	N 00°53'53" W	73.07'
L2	S 89°42'30" E	42.08'
L3	N 45°55'26" E	76.64'

This intersection contains multiple utilities, traffic signals, pull boxes, etc. in some/all quadrants. I did not set a PLSS corner, show six ties to the location and provide WISCRS, Rock Datum, (NA2011), coordinates. Three ties are drill holes set in a retaining wall in the SW quadrant of the intersection. Setting the PLSS surface monument was traffic prohibitive and rebar ties were problematic given the amount of nearby buried utilities.
