# U.S. PUBLIC LAND SURVEY MONUMENT RECORD

For Public Land Survey Corners In:  
T. 2 N. - R. 12 E. of the 4th P.M.

ROCK Twp.  
Rock County, WI.

**CORNER CODE: E-21**  
(A.E. 7.08 REQUIREMENT)

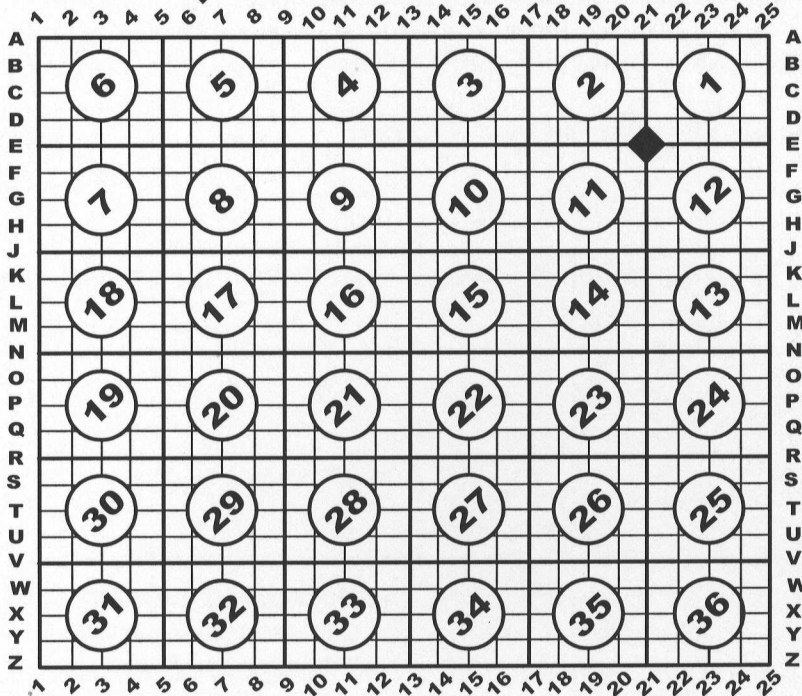
### CORNER CODE INDEX

(PLACE SYMBOL AT THE PLSS CORNER)

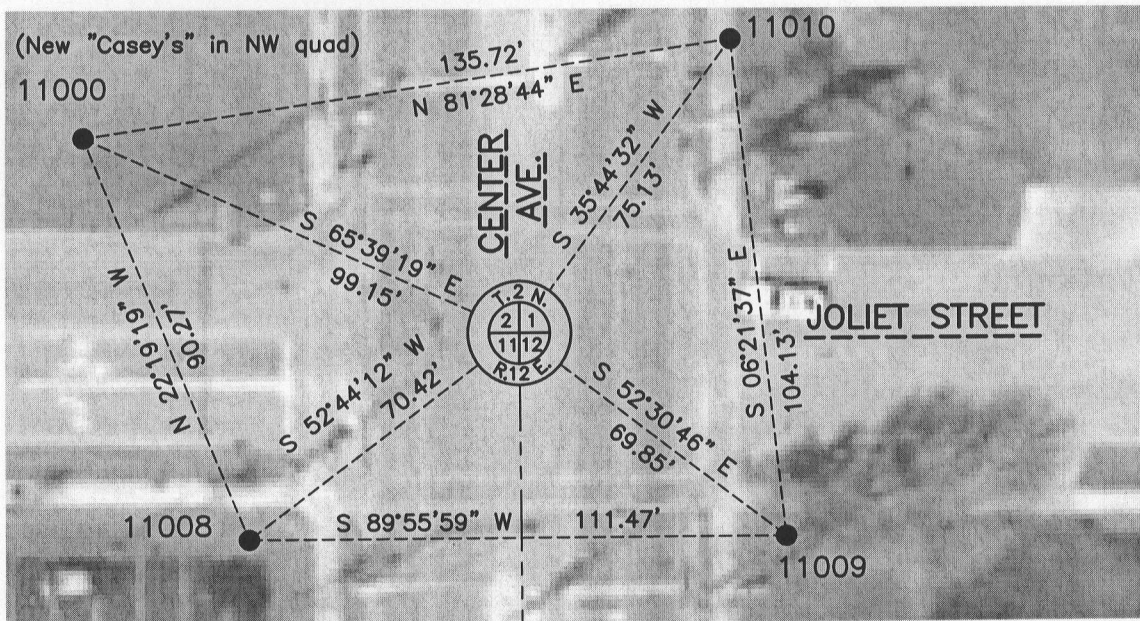
N 00°28'33" W  
2651.61'  
(2651.61')  
(2651.83')  
(2651.55')

COMPUTED LOCATION  
\*SEE JRH 2014 TIE-SHEET\*

This location has no surface monument and the last tie-sheet prepared, (Barnes-1991), pre-dates road construction at the intersection. I relied exclusively a survey prepared by Combs & Associates, (CSM V. 29, Pg.'s 179-181), in the northwest quadrant of the intersection to recreate the PLSS corner location. The distance to the NE corner of 11-2-12 is in harmony with the CSM & past a Barnes section line distance. Past section line distances are noted on the map. I did not dig for an aluminum monument at the PLSS corner.

I did not set a PLSS corner and show four ties to the location due to heavy traffic volume.
