U.S. PUBLIC LAND SURVEY MONUMENT RECORD

T. 1 N. - R. 10 E. of the 4th P.M.

AVON TWP
ROCK COUNTY WI

Corner code: A-19

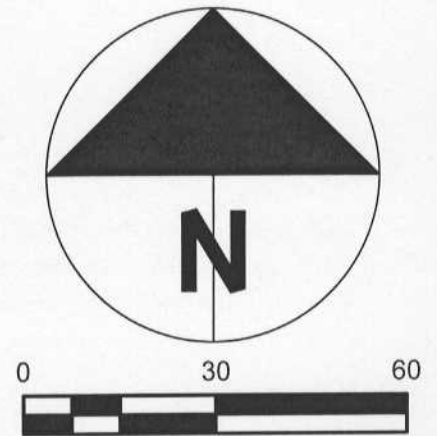
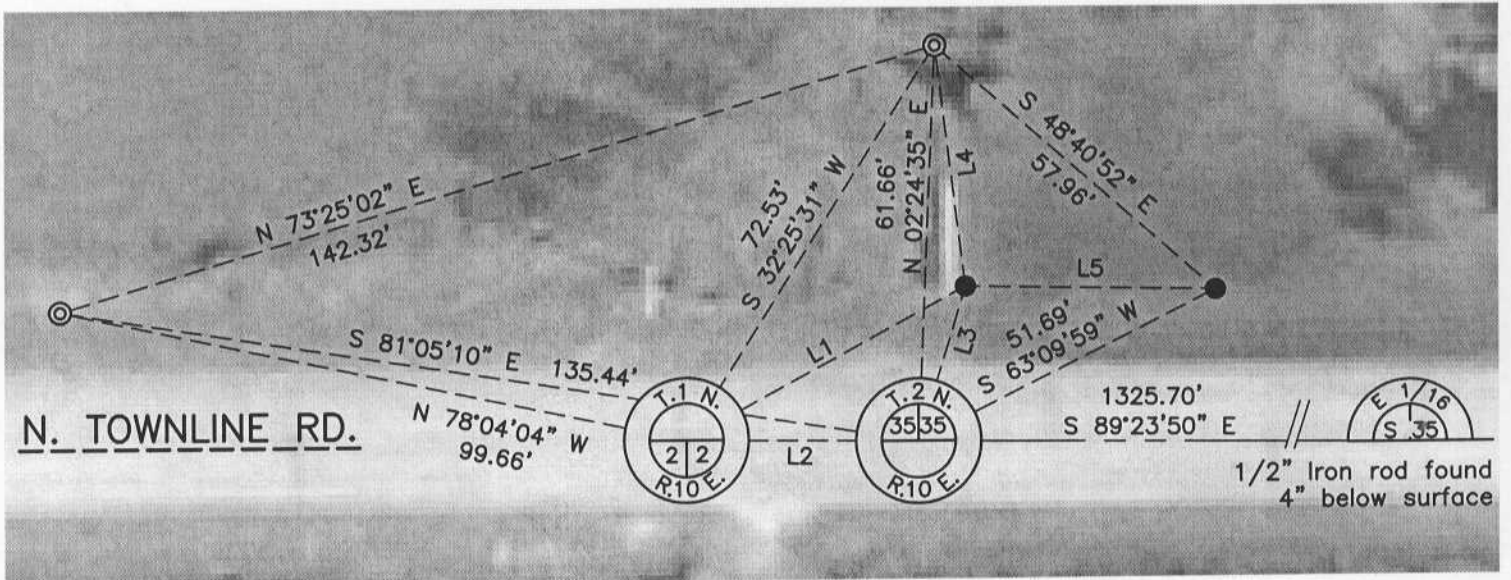
(a) LEGEND

I found a disturbed aluminum monument and two ties from the A-19 monument record prepared by Barnes, (1987). From the two ties I computed the corner location by distance/distance intersection and set a cotton gin spindle. I accepted the position given its proximity to the disturbed aluminum monument found and distance of 2664.04 to the NE corner of section 2; a Barnes V. 6, Pg. 446 record shows a distance of 2664.16 feet for the same. Furthermore, I set a cotton gin spindle at the S1/4 of 35-2-10 on-line between the N1/4 of 2-1-10 and E1/16 of Section 35-2-10; The aforesaid V. 6 record shows a 36.3 foot offset distance between the PLSS corners. My preference is to set the S1/4 of 35-2-10 on-line between the two nearest monuments of record, on the intended Town Line, as opposed to locating other PLSS monuments further away from the location and incorporating them into a solution.

I did not find a discrepancy between the corner restored and a previously documented corner location. Discrepancy being defined as *disagreeing* with a corner location, *not* as noting dimensional differences between current/former tie sheets due to measuring methods. The current and *most recent* tie-sheet dimensions filed for the corner are noted.
