# U.S. PUBLIC LAND SURVEY MONUMENT RECORD

T. 2 N. - R. 10 E. of the 4th P.M.

SPRING VALLEY TWP  
ROCK COUNTY WI

CORNER CODE: A-19(1)  
(A.E. 7.08 REQUIREMENT)

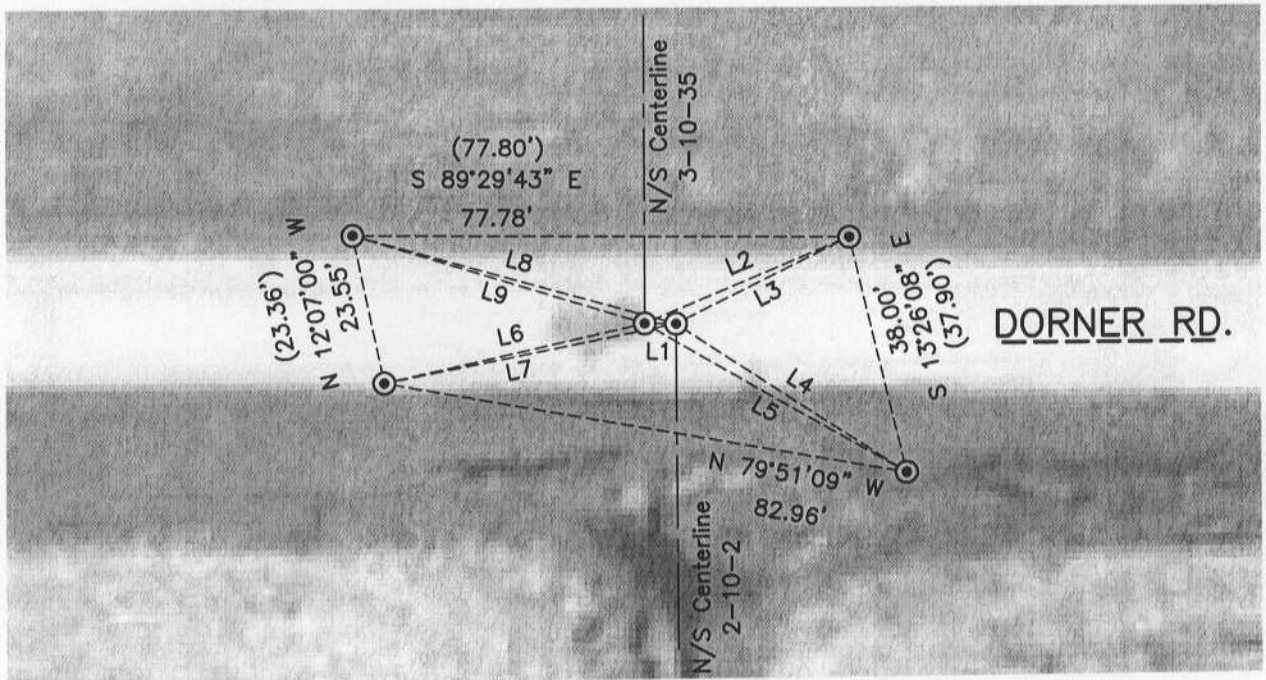
(a) LEGEND

- ⊙ - IRON REBAR FOUND
- (#) - PREVIOUS TIE-SHEET DIMENSION

LINE	BEARING	DISTANCE	
L1	N 89°03'52" W	4.93'	(4.93')
L2	N 67°28'27" E	34.68'	(34.68')
L3	S 63°45'12" W	30.22'	(30.18')
L4	S 56°42'46" E	42.99'	(43.02')
L5	N 59°54'46" W	47.22'	(47.25')
L6	S 77°28'59" W	41.79'	(41.72')
L7	N 78°53'32" E	46.60'	(46.56')
L8	N 74°30'07" W	52.58'	(52.54')
L9	S 73°01'05" E	47.83'	(47.77')

I found the rebar at the North ¼ of 2-10-2 as shown on tie-sheet A-19 filed in 1998. The top 4" +/- of the 24" rebar was bent over so I spun/straightened and reset; the top has been shaven from plowing so it looks like a ¼" x ¾" rod. I also found the four witness rods/rebar and South ¼ corner of section 3-10-35 shown on the same. All ties check to reasonable tolerances and I accepted the position of all monuments, as shown.

I did not find a discrepancy between the corner restored and a previously documented corner location. *Discrepancy* being defined as *disagreeing* with a corner location, *not* as noting dimensional differences between current/former tie sheets due to measuring methods. The current and *most recent* tie-sheet dimensions filed for the corner are noted.
