U.S. PUBLIC LAND SURVEY MONUMENT RECORD

T. 1 N. - R. 14 E. of the 4th P.M.

CLINTON

CORNER CODE: V-15(3)
(A.E. 7.08 REQUIREMENT)

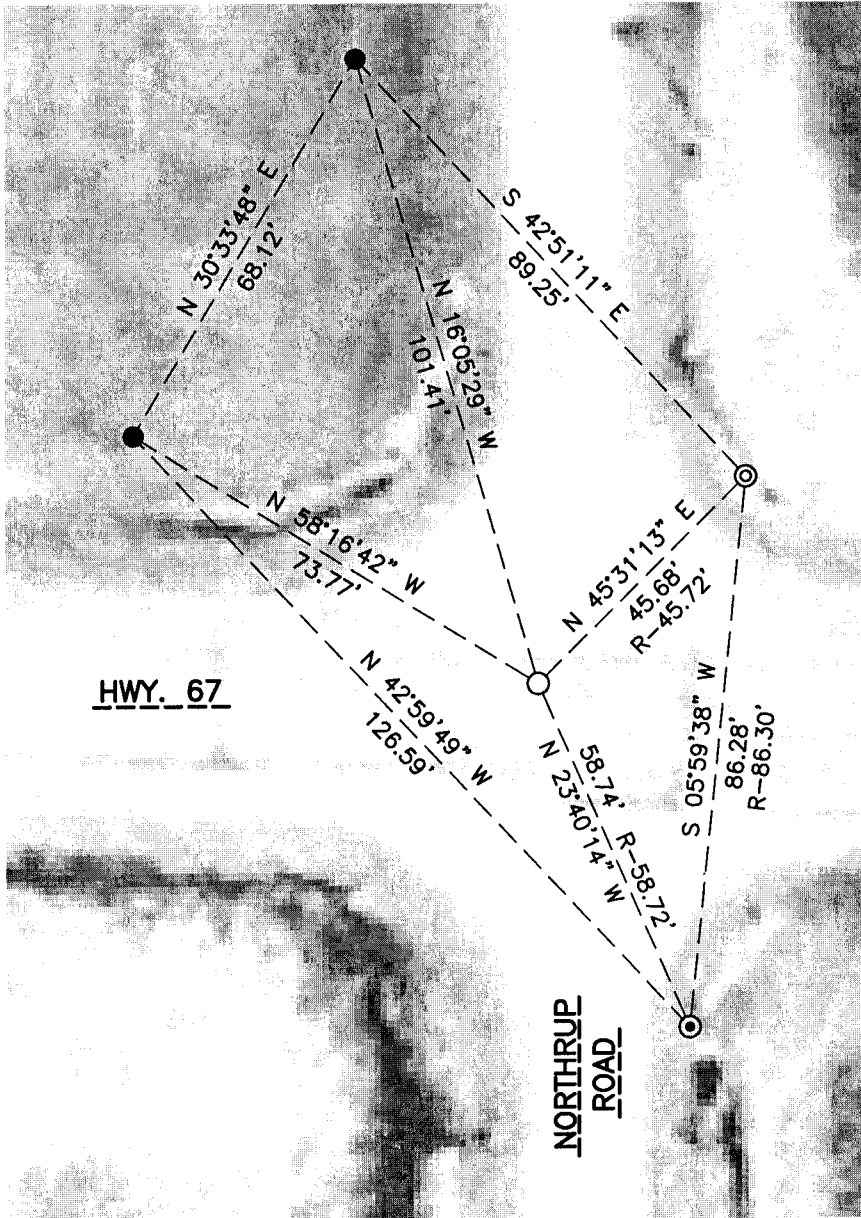
(a) LEGEND

In advance of Hwy. 67 resurfacing, (Hwy. 140 – Walworth County line), I set control and surveyed existing monuments, (exposed), and witnesses throughout the project. At this location I recovered the broken cast iron monument, (inside of pvc tube), and two, (2), witness monuments from a tie sheet, (V-15(2)), prepared by Don Barnes on May 10, 1994. Two other monuments were recovered however, one was bent and the other was covered by recent paving activities.

Post construction and witnessed per the sketch, I set a cotton gin spindle at the same location as the broken cast iron monument below.

Any discrepancies are noted on the face of the map with the most recently filed tie-sheets distances noted with an “R”. Absent the “R” distance to a found monument, assume I match the most recent tie-sheet distance. Bearing discrepancies are not noted.
