U.S. PUBLIC LAND SURVEY MONUMENT RECORD

For Public Land Survey Corners In: **WI ADMINISTRATIVE CODE A-E 7.08 REQUIREMENT**
T. 4 N. - R. 11 E. of the 4th P.M.

PORTER TWP
ROCK COUNTY WI

CORNER CODE: G-25
(A.E. 7.08 REQUIREMENT)

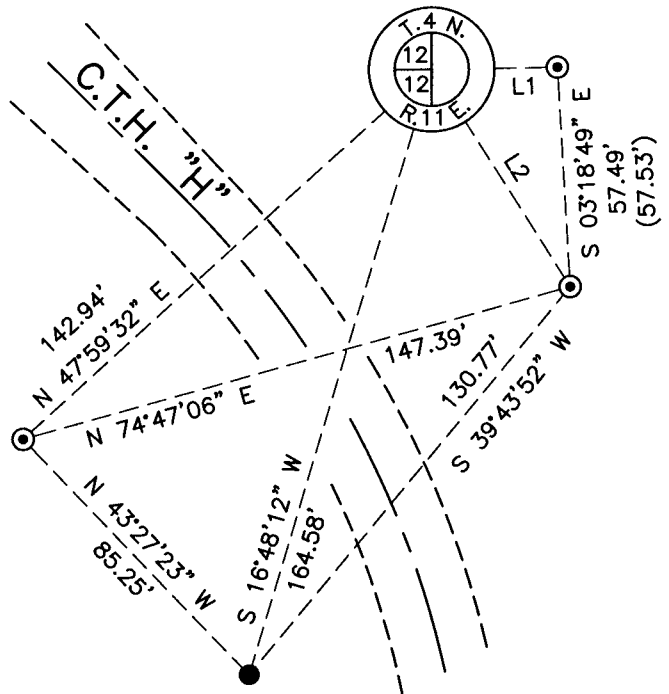
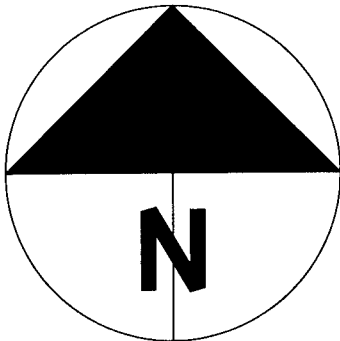
(a) LEGEND

LINE	BEARING	DISTANCE	
L1	N 89°17'03" E	32.68'	
L2	N 32°17'24" W	67.41'	(67.44')

I found 3 witnesses per my previous tie-sheet, (G25 - 7/11/14). I believe the aluminum monument exists 2 feet, +/-, below the fill material placed during recent construction. I excavated to the material I covered the aluminum monument with back in July and filled the area back in; the aluminum monument was not recovered during this field trip. I computed the PLSS corner location by distance/distance intersection from the westerly and northeasterly witnesses and set a 3/4"x24" iron rebar; the rebar is set into the compacted fill material at the former road bed grade. I set an orange carsonite post at the PLSS corner and one additional witness per the map.
