U.S. PUBLIC LAND SURVEY MONUMENT RECORD

T. 3 N. - R. 10 E. of the 4th P.M.

MAGNOLIA TWP
ROCK COUNTY WI

CORNER CODE: R-3
(A.E. 7.08 REQUIREMENT)

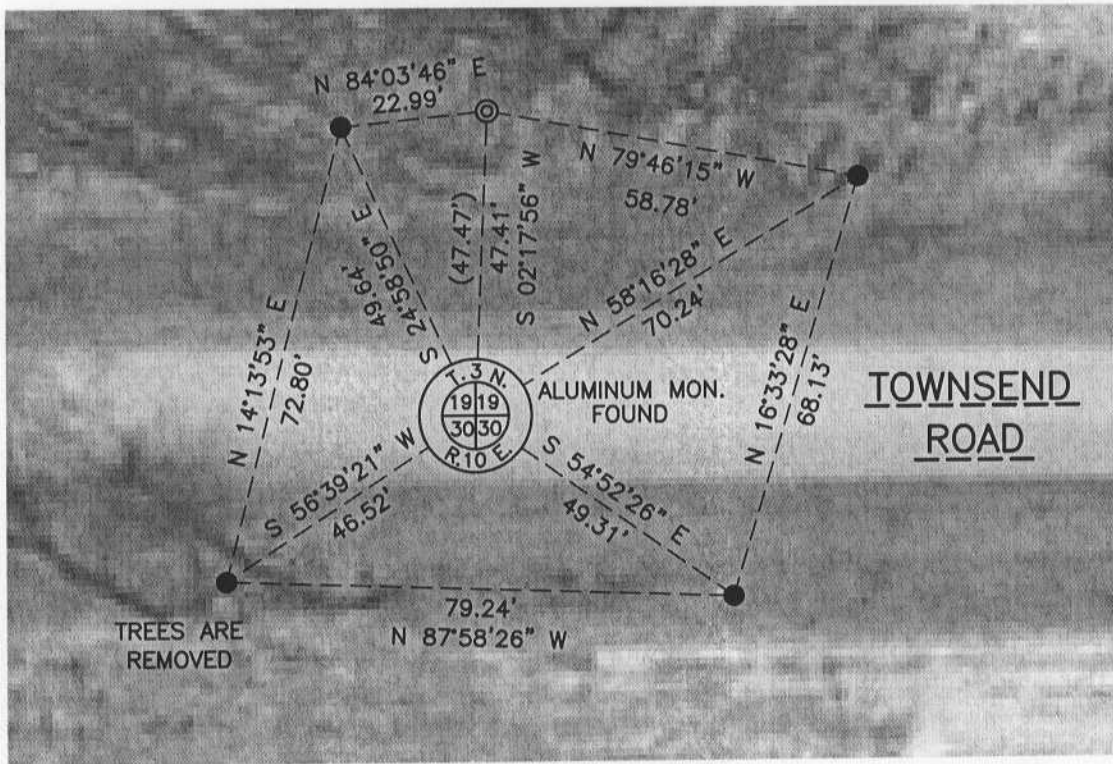
(a) LEGEND

- - 5/8" x 24" REBAR SET, (RED CAP W/"PLSS WITNESS")
- ⊙ - IRON PIPE FOUND & RESET, (1 ft. +/- South of fence post)
- (#) - PREVIOUS TIE-SHEET DIMENSION

I found the aluminum monument as set per the Volume 5, Page 395 tie-sheet, (Barnes); no witness monuments were shown on the tie sheet. I found two of the four witness pipes as shown on the Volume 4, Page 501 tie-sheet, (Lee). Both pipes were leaning however I straightened and re-set the pipe 47.5', +/-, north of the section corner; the pipe measures within reason to the former distance. I accepted the aluminum monument as found and set four new witnesses per the sketch.

I did not find a discrepancy between the corner restored and a previously documented corner location. *Discrepancy* being defined as *disagreeing* with a corner location, *not* as noting dimensional differences between current/former tie sheets due to measuring methods. The current and *most recent* tie-sheet dimensions filed for the corner are noted.
