U.S. PUBLIC LAND SURVEY MONUMENT RECORD

PLYMOUTH TWP

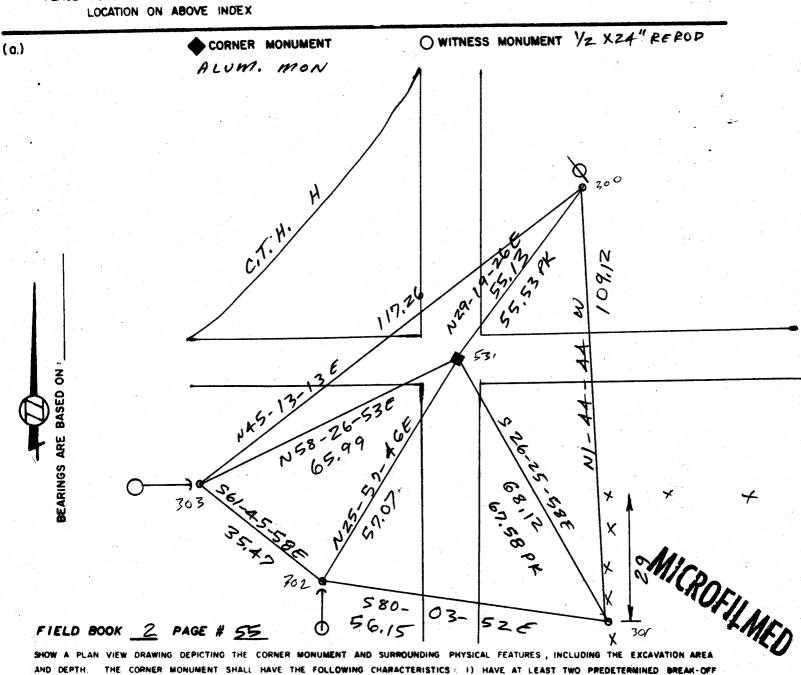
I FOUND PK AND ABOUT 2.3' DEEP FOUND CUT LIMESTONE. THE STONE WAS SPLIT LENGTH WISE. I REMOVED THE MIDDLE SECTION AND PLACE 1x24" PIPE HORIZONTALLY ON SOUTH SIDE OF STONE. PLACE ALUMINUM MONUMENT.

THERE IS A DISCREPANCY BETWEEN THE STONE AND THE PK THAT I FOUND. I ACCEPTED THE STONE. THE PK IS ABOUT .55 NORTH AND .23 WEST OF THE STONE.
