## RECORD

For Public Land Survey Corners in the J. 2 N., R. 10 E.

## CORNER CODE INDEX

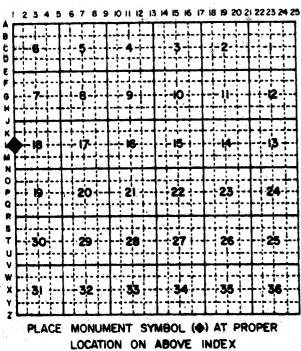
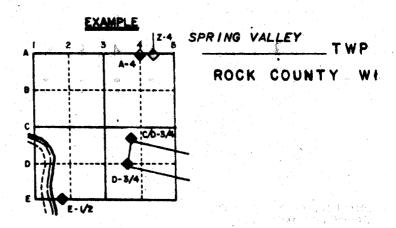
ACCEPTED FOUND PERPETUATED LOCATION.

TALARCZYK'S RJR SPIKE IS 2.63' NORTH AND 1.72' WEST OF THE LIMESTONES.

DISCREPANCY IS SHOWN IN THE MAP ON THE OTHER SIDE OF THE PAGE.

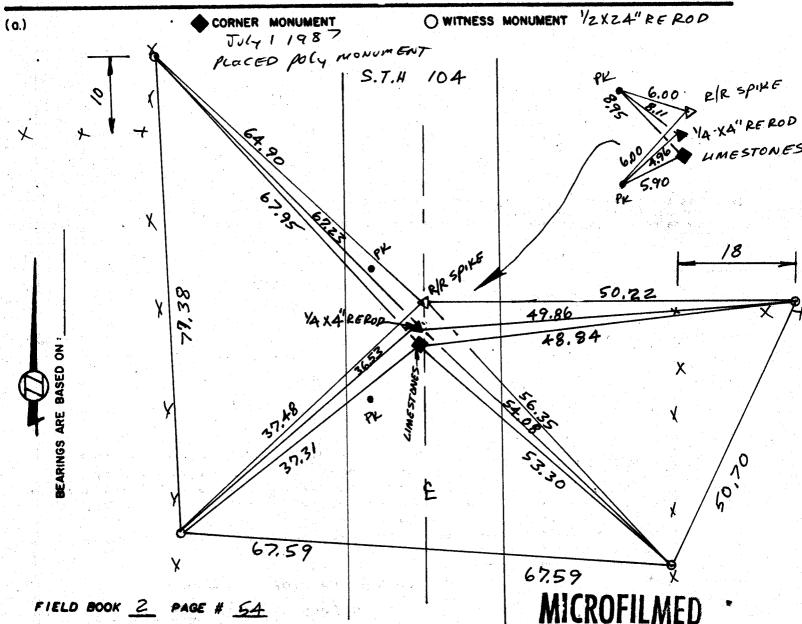
SHOW A PLAN VIEW DRAWING DEPICTING THE CORNER MONUMENT AND SURROUNDING PHYSICAL FEATURES, INCLUDING THE EXCAVATION AREA AND DEPTH. THE CORNER MONUMENT SHALL HAVE THE FOLLOWING CHARACTERISTICS: I) HAVE AT LEAST TWO PREDETERMINED BREAK-OFF POINTS. 2) IF BROKEN, LEAVE A PERMANENTLY MAGNETIZED REMNANT AT THE ORIGINAL POINT. 3) MUST BE EXTENDABLE. 4) THE CAP IS INSCRIBED: ROCK COUNTY SURVEY MONUMENT - PENALTY FOR DISTURBING MARKER. 5) OR AN EXISTING CUT LIMESTONE. AN IRON PIPE I'2" X 4'0" (MINIMUM) MAY BE USED IN AREAS WHERE GROUND WATER IS WITHIN ONE FOOT OF THE SURFACE. IF THE CORNER IS OCCUPIED BY AN IMPROVEMENT (MANHOLE, BURIED CABLE, ETC.) ANY DURABLE, DISTINCT MONUMENT MAY BE USED. CORNERS SHALL BE REFERENCED WITH AT LEAST 4 DURABLE WITNESS MONUMENTS. WITNESS MONUMENTS SHALL BE MADE OF CONCRETE, NATURAL STONE, IRON OR OTHER EQUALLY DURABLE MATERIAL, EXCEPT WOOD. DESCRIBE THE CORNER AND THE WITNESS MONUMENTS.
