U.S. PUBLIC LAND SURVEY MONUMENT RECORD

For Public Land Survey Corners in the

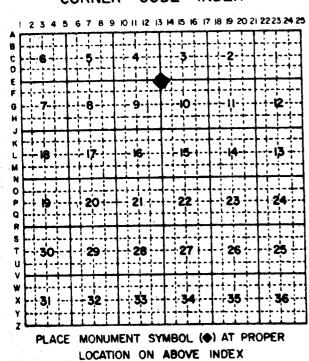
ORNER CODE:

SHOW A PLAN VIEW DRAWING DEPICTING THE CORNER MONUMENT AND SURROUNDING PHYSICAL FEATURES, INCLUDING THE EXCAVATION AREA AND DEPTH. THE CORNER MONUMENT SHALL HAVE THE FOLLOWING CHARACTERISTICS: I) HAVE AT LEAST TWO PREDETERMINED BREAK-OFF POINTS. 2) IF BROKEN, LEAVE A PERMANENTLY MAGNETIZED REMNANT AT THE ORIGINAL POINT. 3) MUST BE EXTENDABLE. 4) THE CAP IS INSCRIBED: ROCK COUNTY SURVEY MONUMENT - PENALTY FOR DISTURBING MARKER. 5) OR AN EXISTING CUT LIMESTONE. AN IRON PIPE IN A 4'O" (MINIMUM) MAY BE USED IN AREAS WHERE GHOUND WATER IS WITHIN ONE FOOT OF THE SURFACE. IF THE CORNER IS OCCUPIED BY AN IMPROVEMENT (MANHOLE, BURIED CABLE, ETC.) ANY DURABLE, DISTINCT MONUMENT MAY BE USED. CORNERS SHALL BE REFERENCED WITH AT LEAST 4 DURABLE WITNESS MONUMENTS. SHALL BE MADE OF CONCRETE, NATURAL STONE, IRON OR OTHER EQUALLY DURABLE MATERIAL, EXCEPT WOOD. DESCRIBE THE CORNER AND THE WITNESS MONUMENTS.

FOUND CUT LIMESTONE 23" DEEP. BROKE STONE LENGTH WISE, TOOK THE TOP 14", PLACED MAGNET & R/R SPIKE ON STONE. 2' WEST OF & NIS ROAD 1 SOUTH OF & E/W RD
