U.S. PUBLIC LAND SURVEY MONUMENT RECORD

T. 4 N. R. 13 E. 4th P.M.

MILTON TWP

CORNER CODE _____ J-19(2)

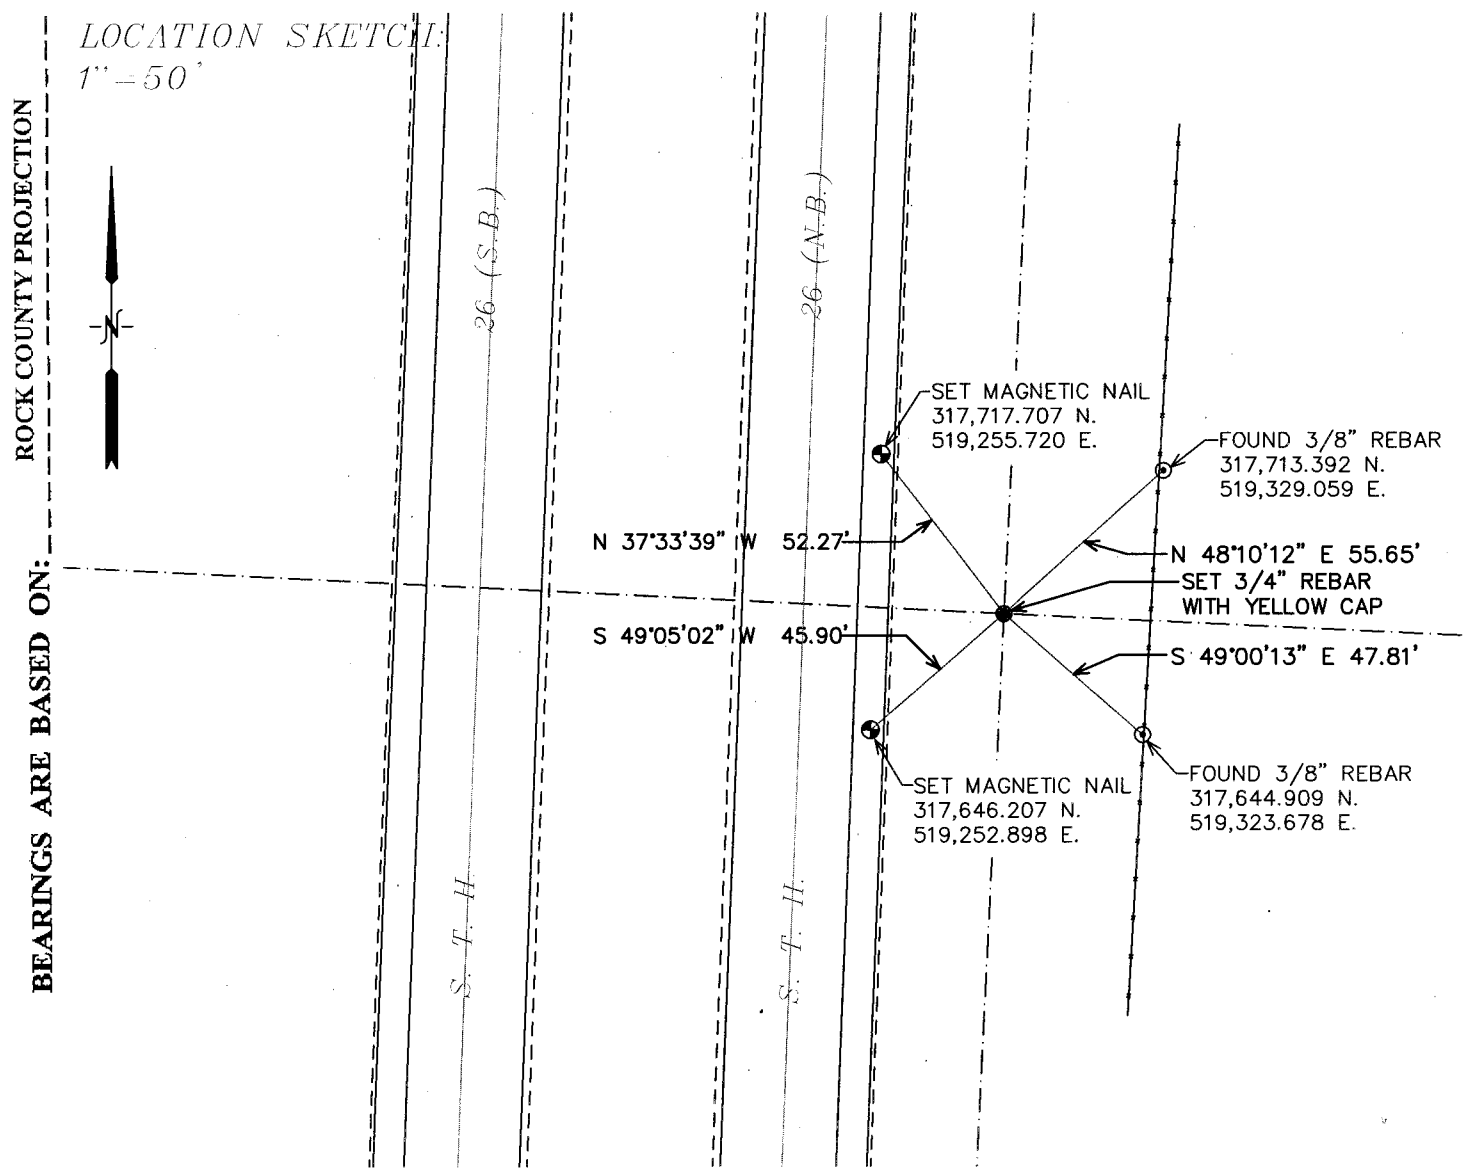
(a)

SHOW A PLAN VIEW DRAWING DEPICTING THE CORNER MONUMENT AND SURROUNDING PHYSICAL FEATURES, INCLUDING THE EXCAVATION AREA AND DEPTH.

Following highway reconstruction, set 3/4 inch rebar with yellow cap about thirty feet east of the east edge of pavement for the northbound lane of STH 26, which has been perpetuated from locating a previously existing cut limestone monument prior to construction as found by Donald Barnes, Rock County Surveyor, in May of 2012 as marking the location of the corner. Set two magnetic nails in the pavement shoulder and found two 3/4 inch rebars as witnesses following highway reconstruction as shown.

Found perpetuated location.

None.
