U.S. PUBLIC LAND SURVEY MONUMENT RECORD

T. 1 N. - R. 13 E. of the 4th P.M.

TURTLE TWP
ROCK COUNTY WI

CORNER CODE: J-3
(A.E. 7.08 REQUIREMENT)

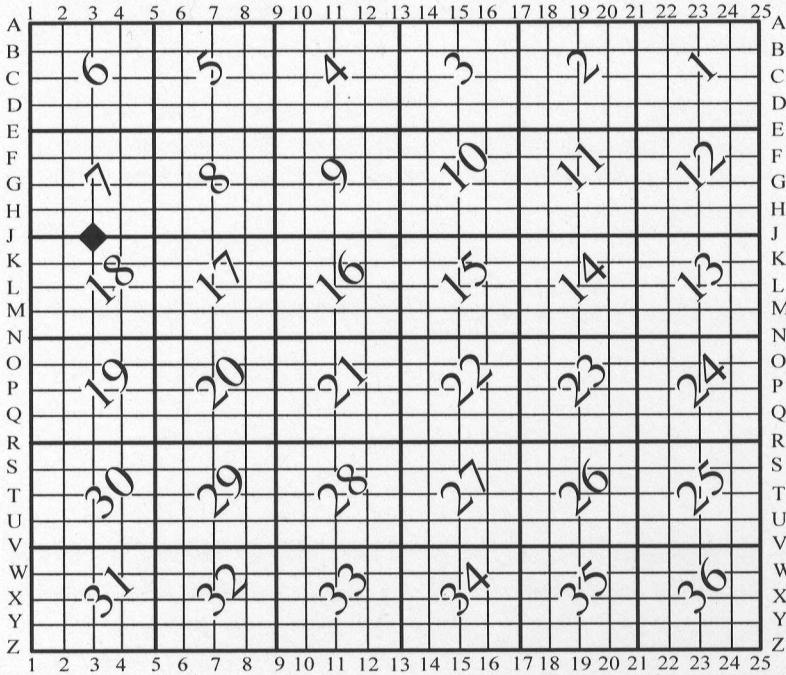
CORNER CODE INDEX

(PLACE "◆" SYMBOL AT PROPER PLSS CORNER LOCATION)

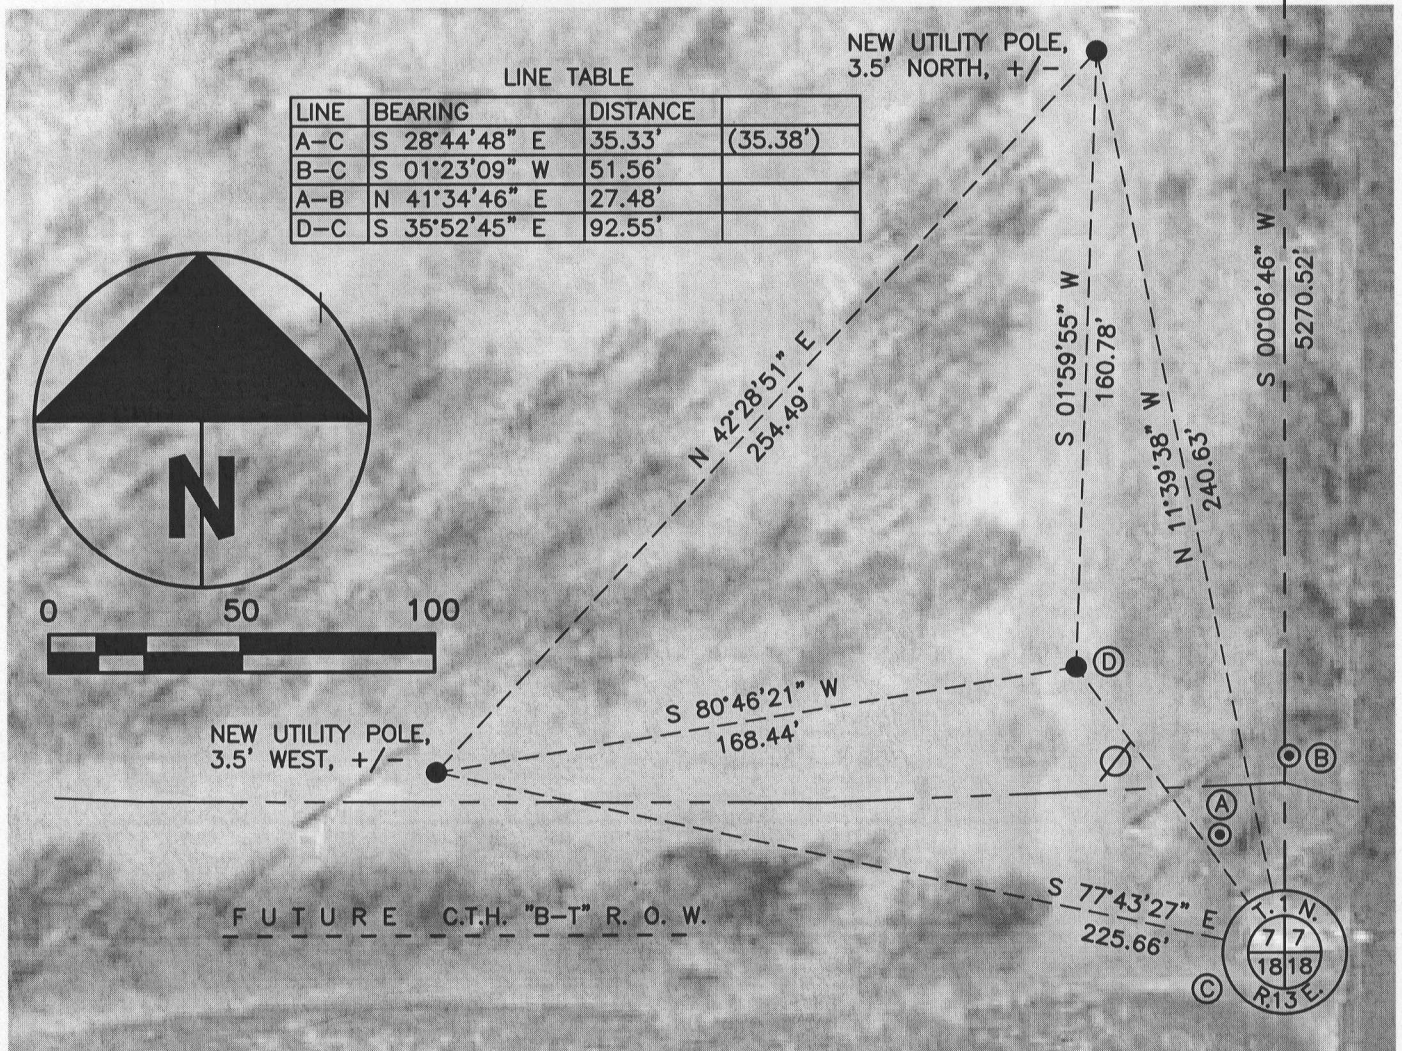
(a) LEGEND

- - 3/4" x 24" REBAR SET W/RED CAP
- ⊙ - IRON REBAR FOUND
- (#) - PREVIOUS TIE-SHEET DIMENSION
- ⊘ - UTILITY POLE, (NEW AS OF 2014)

- FOUND 2" IRON PIPE WITH AN IRON REBAR INSIDE (1.5', +/-, SE of Utility Tower SE leg)

FUTURE R.O.W. LIMITS

I found the pipe and two additional witnesses per the J-3 tie-sheet, (Barnes-1995). A ¾" rebar is inside and near the center of the 2" pipe. The witnesses are ¾" rebar not capped as indicated on Barnes tie-sheet however, the dimensions match those called by Barnes within expected tolerances. In addition, the N/S centerline of the section matches that as shown on the Town of Turtle E-3(1) tie-sheet, (Barnes-1995), within a second and 0.01'. I accepted the pipe, witnesses and set 3 additional ties per the map.

I did not find a discrepancy between the corner restored and a previously documented corner location. Discrepancy being defined as *disagreeing* with a corner location, *not* as noting dimensional differences between current/former tie sheets due to measuring methods. The current and *most recent* tie-sheet dimensions filed for the corner are noted.

This location will see substantial construction beginning 2015 with the CTH BT project, aka, Inman Extension. The Consultant preparing the plans has coordinated with the office to assure the PLSS monument is perpetuated. The contract/pay items for the project will call for witness monuments being cast-in-place with disks. I will replace/reference the PLSS corner post-construction.
