U.S. PUBLIC LAND SURVEY MONUMENT RECORD

For Public Land Survey Corners In:
 T. 4 N. R. 13 E. 4th P.M.

MILTON TWP

ROCK COUNTY WI

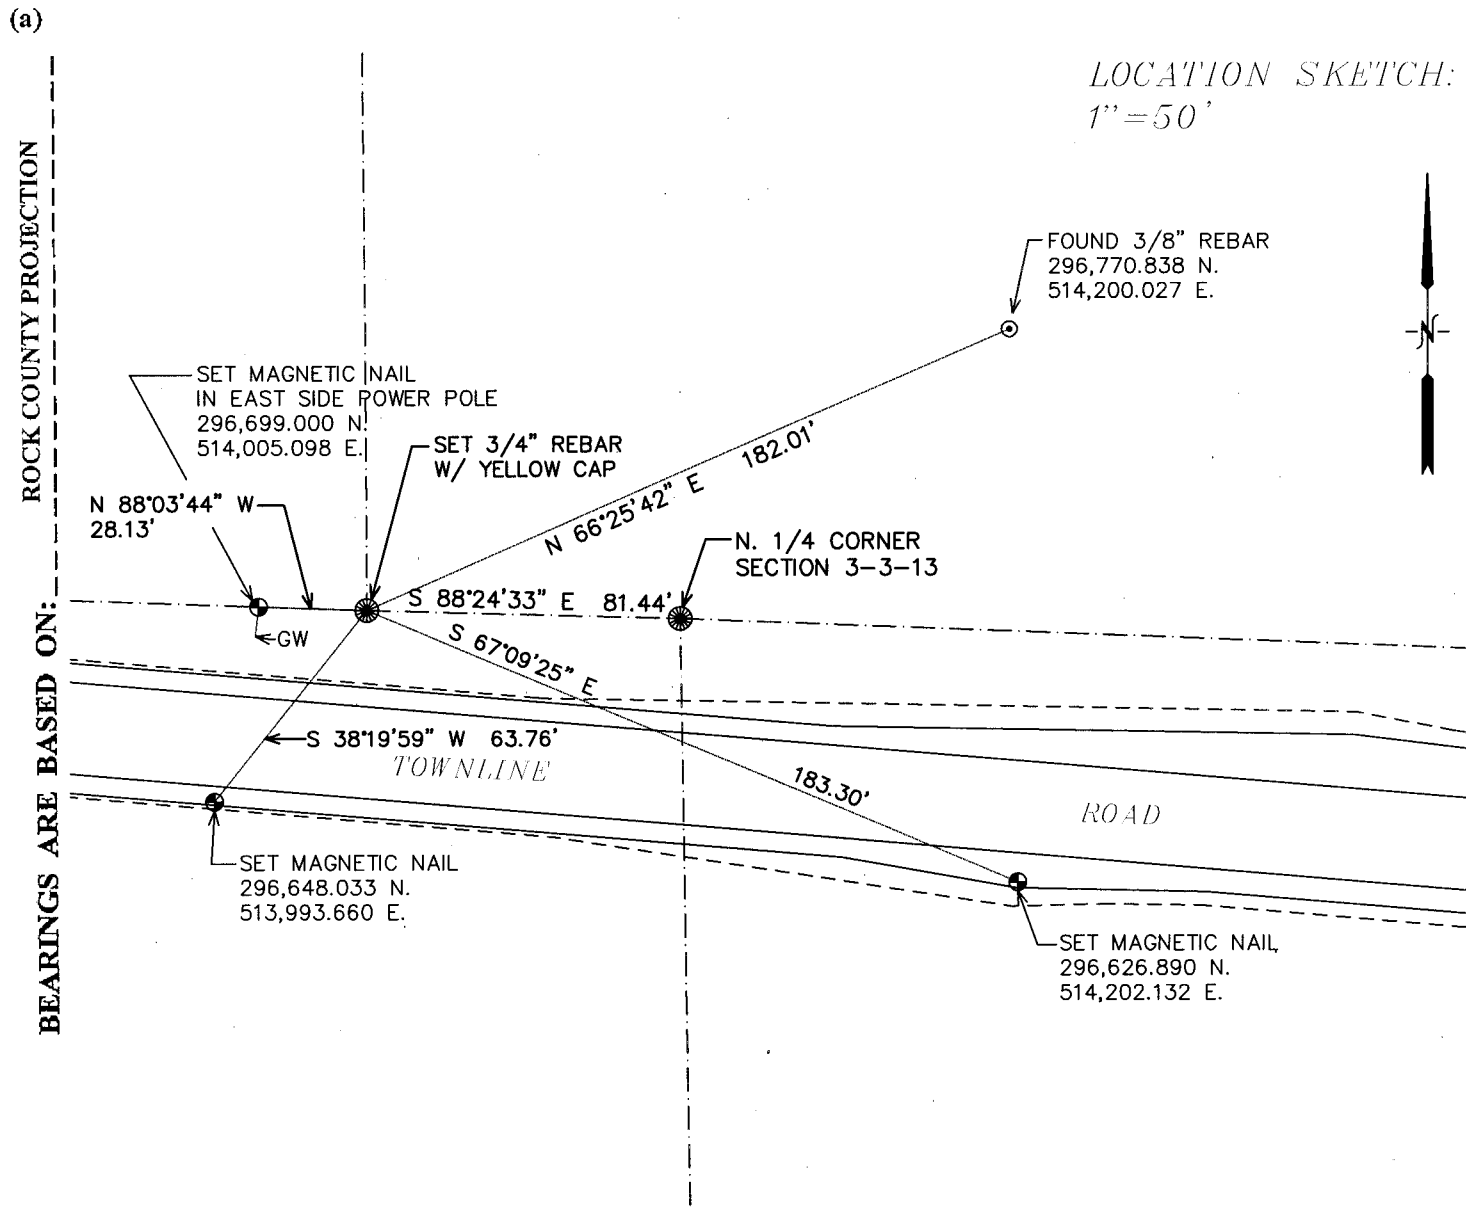
SHOW A PLAN VIEW DRAWING DEPICTING THE CORNER MONUMENT AND SURROUNDING PHYSICAL FEATURES, INCLUDING THE EXCAVATION AREA AND DEPTH.

Following highway reconstruction, set 3/4 inch rebar with yellow cap about twenty feet north of the edge of pavement of the northerly side of Townline Road, which has been perpetuated from locating a previously existing cut limestone monument prior to construction as found by Donald Barnes, Rock County Surveyor, in May of 2012 as marking the location of the corner. Found one 3/8 inch rebar, set one magnetic nails in the side of power poles, and set two magnetic nails in the pavement shoulder as witnesses following highway reconstruction as shown.

D) Describe any material discrepancy between the location of the corner as restored or reestablished and the location of that corner as previously restored or reestablished by distance and direction. Show the discrepancy on the plan view drawing under (a), above. Show the distances between the corner as previously restored or reestablished and (1) the corner as restored or reestablished, and (2) to at least 4 of the witness monuments shown on the drawing in (a), above.

None.
