## U.S. LAND **PUBLIC** SURVEY MONUMENT RECORD

SHEET 1 OF 3

G-9(2)

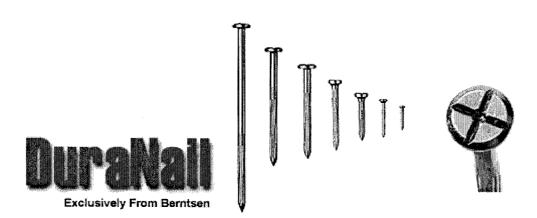
## **DuraNail**

This steel nail will not bend or break and will drive into the asphalt with ease. Not like other nails, it has a deep cross on its larger head along with a center punch. This magnetic nail comes in a variety of lengths. You will receive The Magnetizer with each bag of nails, which will realign the magnetic field after installation to make your DuraNail more detectable

AFTER REPAVING I SET A STEEL SURVEY NAIL IN THE PVMT SURFACE.

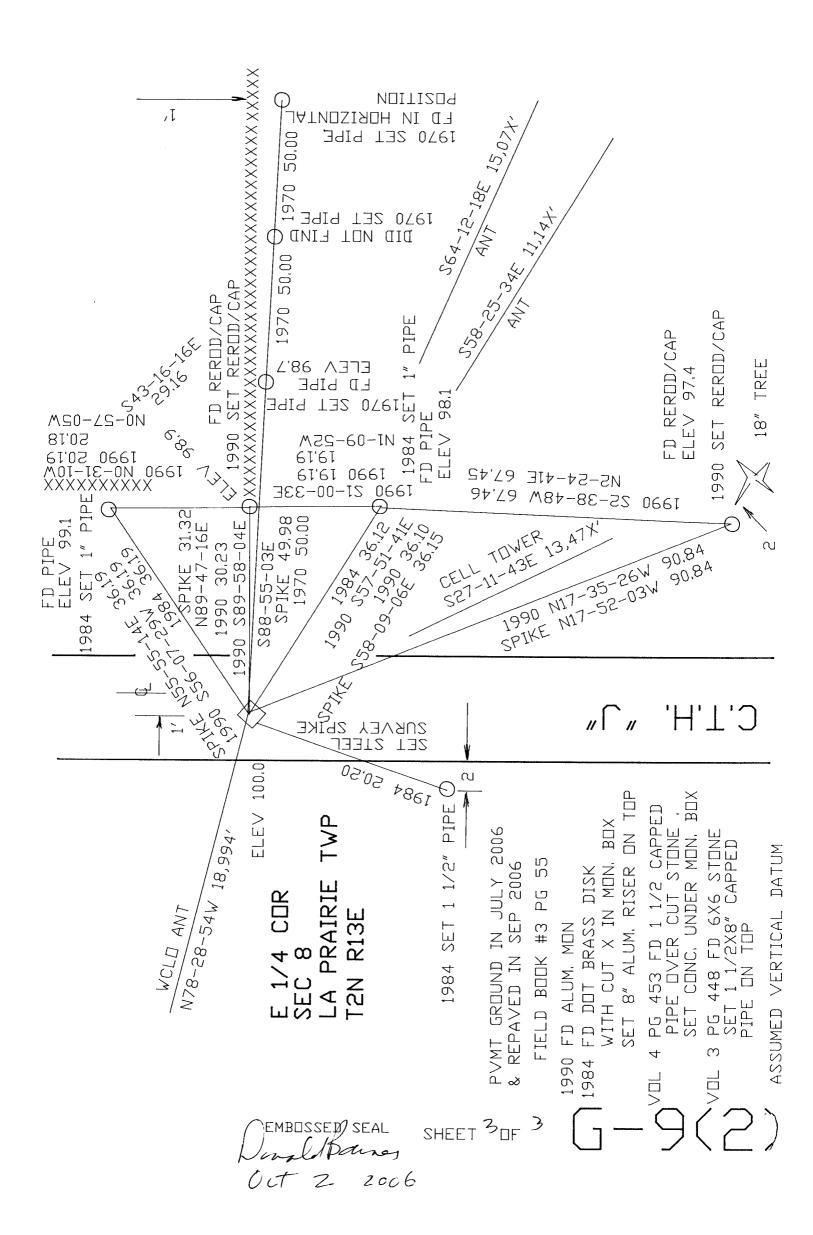
2 OF 3 (- -9(2)

PAVEMENT WAS GROUND IN JULY 2006 AND REPAVED IN SEPTEMBER.

MONUMENT BOX, CONCRETE MON/DISK, & LIMESTONE ARE STILL BELOW THE PVMT SURFACE.

THE STEEL SURVEY NAIL IS IN HARMONY WITH THE FD REFERENCE PIPES.
