U.S. PUBLIC LAND SURVEY MONUMENT RECORD

For Public Land Survey Corners In:
T. 1 N. R. 13 E. 4th P.M.
CORNER CODE INDEX

MILTON TWP

ROCK COUNTY WI

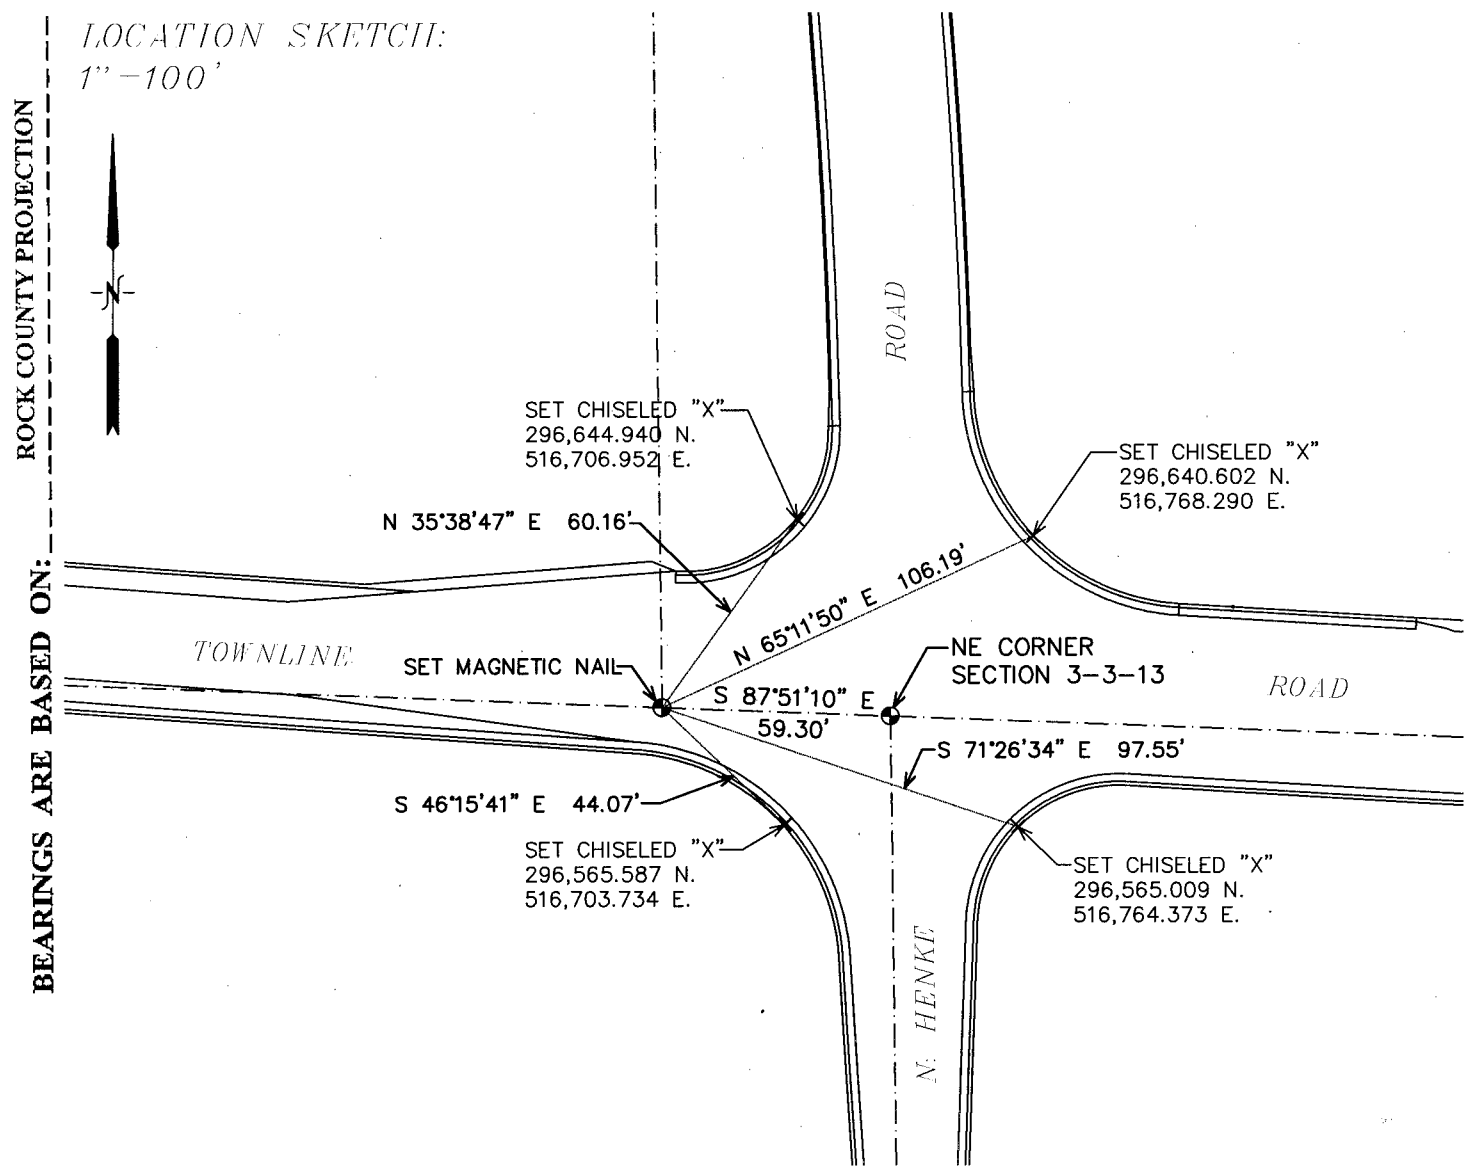
(a)

SHOW A PLAN VIEW DRAWING DEPICTING THE CORNER MONUMENT AND SURROUNDING PHYSICAL FEATURES, INCLUDING THE EXCAVATION AREA AND DEPTH.

Following highway reconstruction, set a magnetic nail in the asphalt roadway about thirteen feet north of the back of curb of the southwesterly radius at the intersection of Townline Road and N. Henke Road and, which has been perpetuated from locating a previously existing aluminum monument prior to construction as found by Donald Barnes, Rock County Surveyor, in May of 2012 as marking the location of the corner.
Set four chiseled "X"s in the back of curbed radiuses as witnesses following highway reconstruction as shown.
