U.S. PUBLIC LAND SURVEY MONUMENT RECORD

For Public Land Survey Corners In:
T. 4 N. R. 13 E. 4th P.M.

MILTON TWP

ROCK COUNTY WI

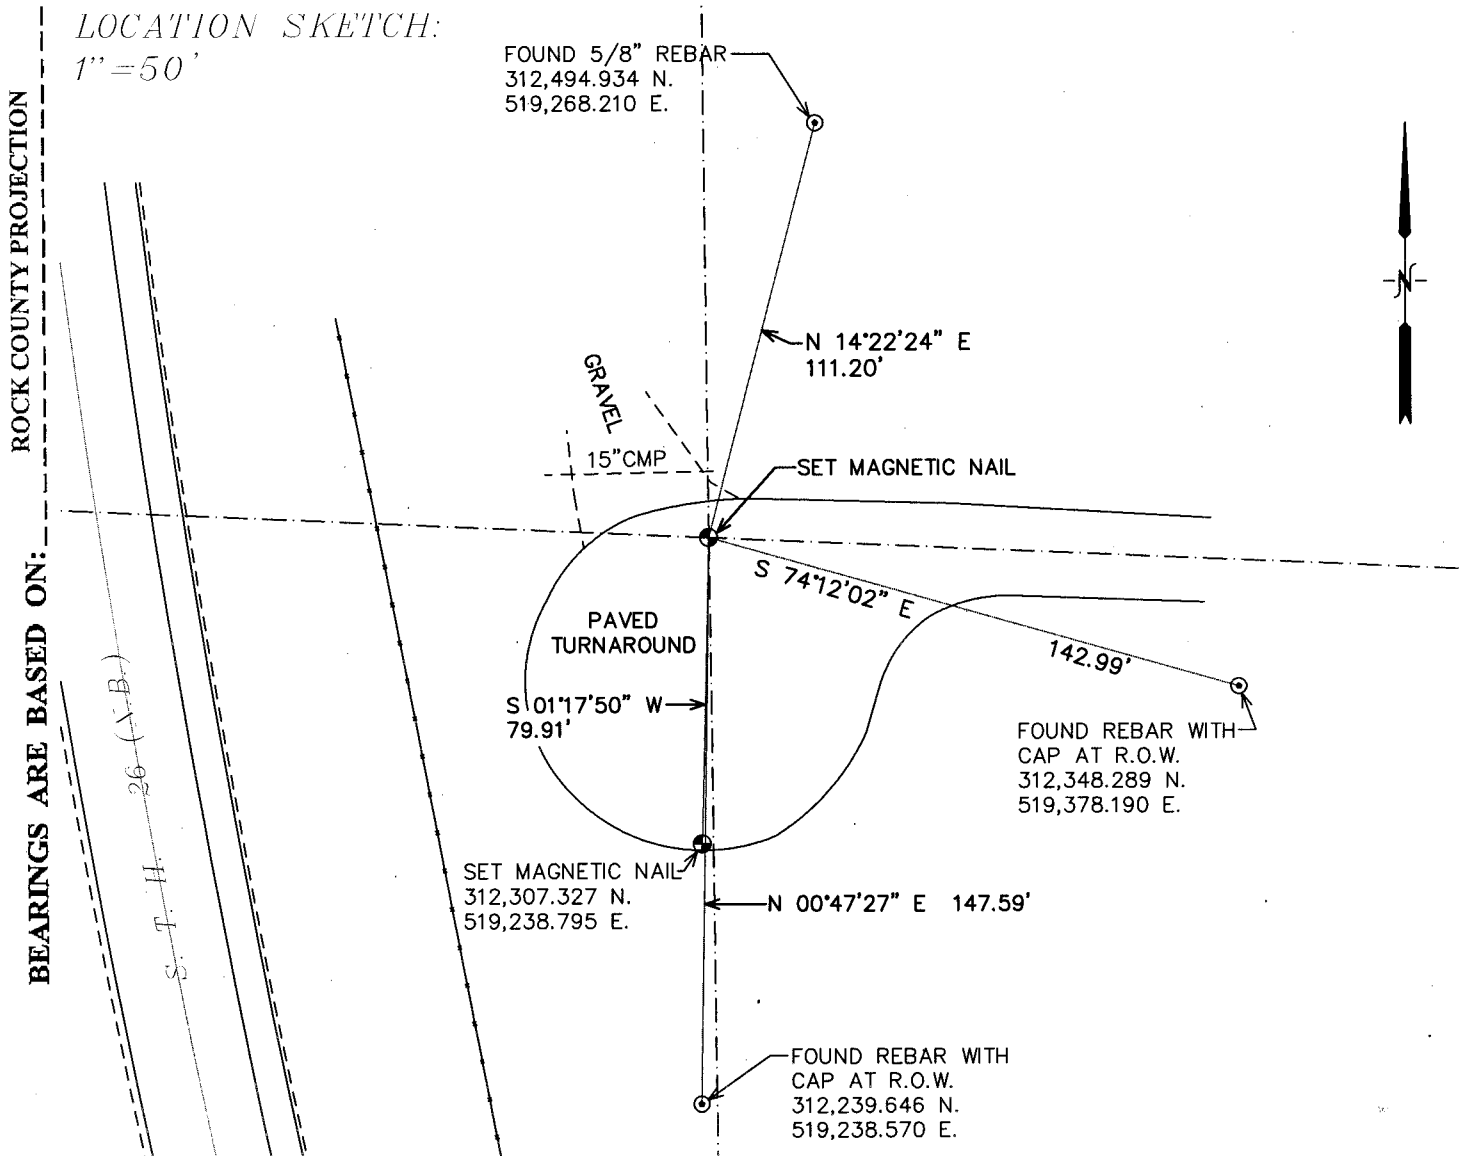
(a)

SHOW A PLAN VIEW DRAWING DEPICTING THE CORNER MONUMENT AND SURROUNDING PHYSICAL FEATURES, INCLUDING THE EXCAVATION AREA AND DEPTH.

Following highway reconstruction, set a magnetic nail in the asphalt roadway about nine feet south of the north edge of a turnaround off the east side of the northbound lanes of STH 26, which has been perpetuated from locating a previously existing 3/4 inch rebar prior to construction as found by Donald Barnes, Rock County Surveyor, in May of 2012 as marking the location of the corner. Found two rebars with caps at the right-of way, found one 5/8 inch rebar, and set one magnetic nail in the asphalt roadway as witnesses following highway reconstruction as shown.

Found perpetuated location.

None.
