U.S. PUBLIC LAND SURVEY MONUMENT RECORD

T. 3 N. R. 13 E. 4th P.M.

HARMONY TWP

CORNER CODE A-15(1)

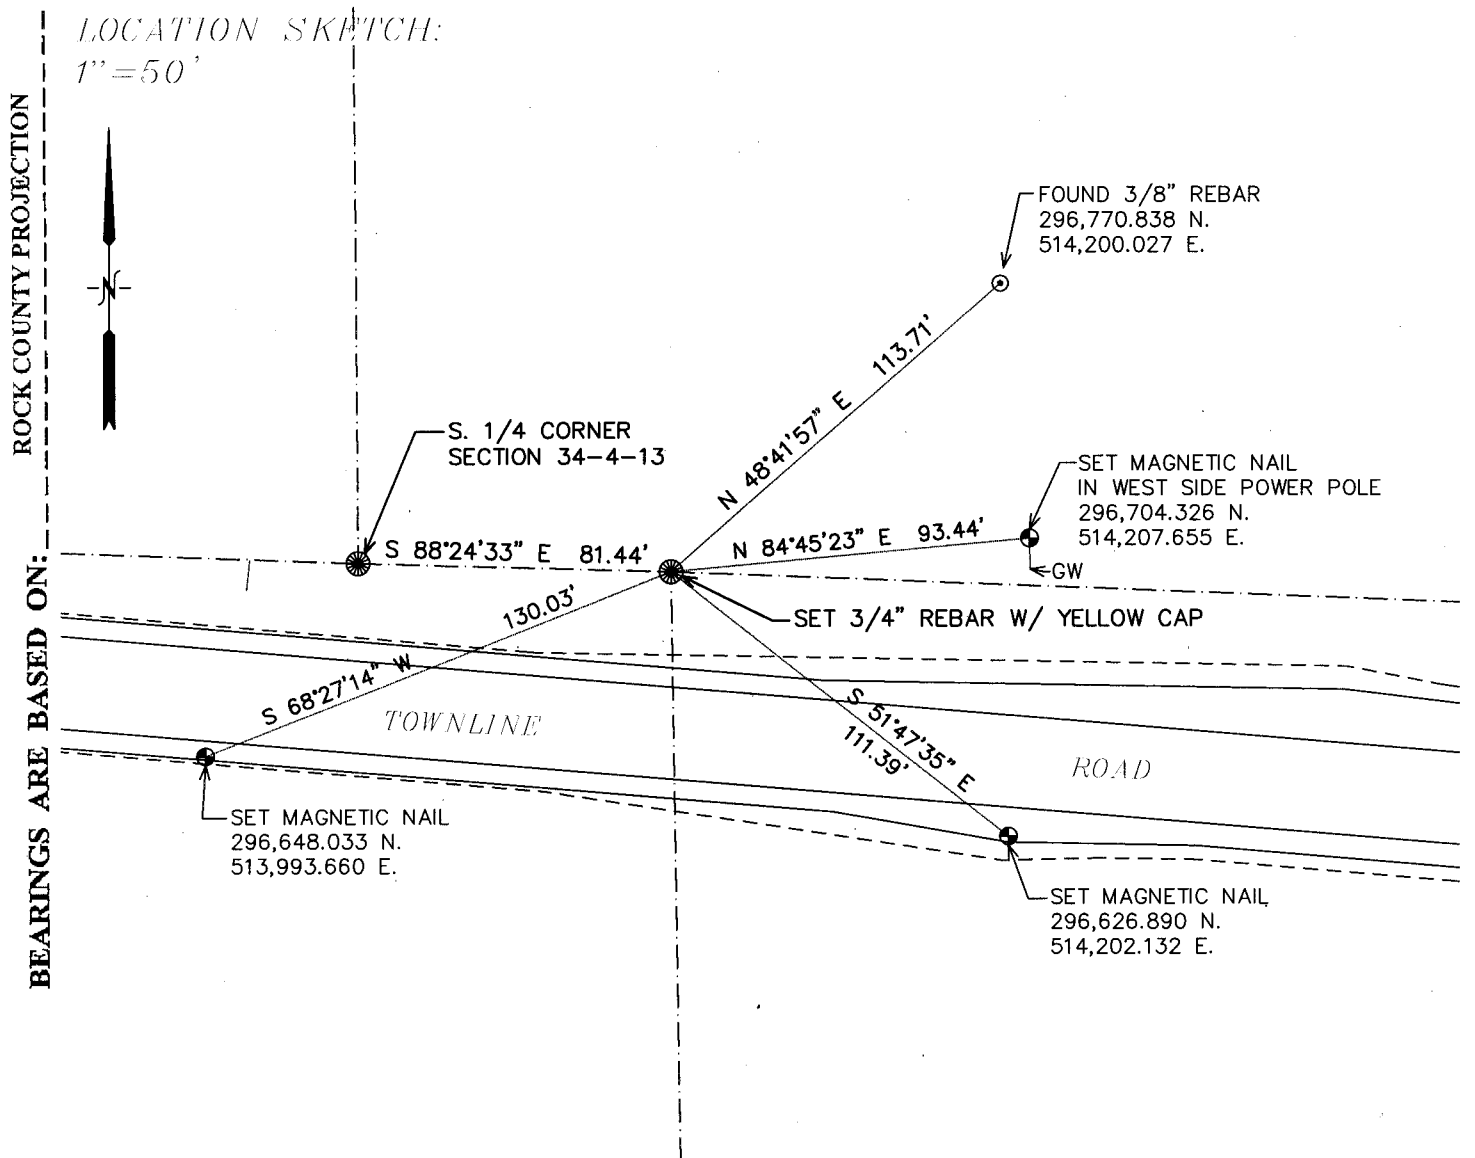
(a)

SHOW A PLAN VIEW DRAWING DEPICTING THE CORNER MONUMENT AND SURROUNDING PHYSICAL FEATURES, INCLUDING THE EXCAVATION AREA AND DEPTH.

Following highway reconstruction, set 3/4 inch rebar with yellow cap about twenty four feet north of the edge of pavement of the northerly side of Townline Road, which has been perpetuated from locating a previously existing cut limestone monument prior to construction as found by Donald Barnes, Rock County Surveyor, in May of 2012 as marking the location of the corner. Found one 3/8 inch rebar, set one magnetic nails in the side of power poles, and set two magnetic nails in the pavement shoulder as witnesses following highway reconstruction as shown.
