U.S. PUBLIC LAND SURVEY MONUMENT RECORD

T. 3 N. - R. 10 E. of the 4th P.M.

MAGNOLIA TWP
ROCK COUNTY WI

CORNER CODE: G-13(1)
(A.E. 7.08 REQUIREMENT)

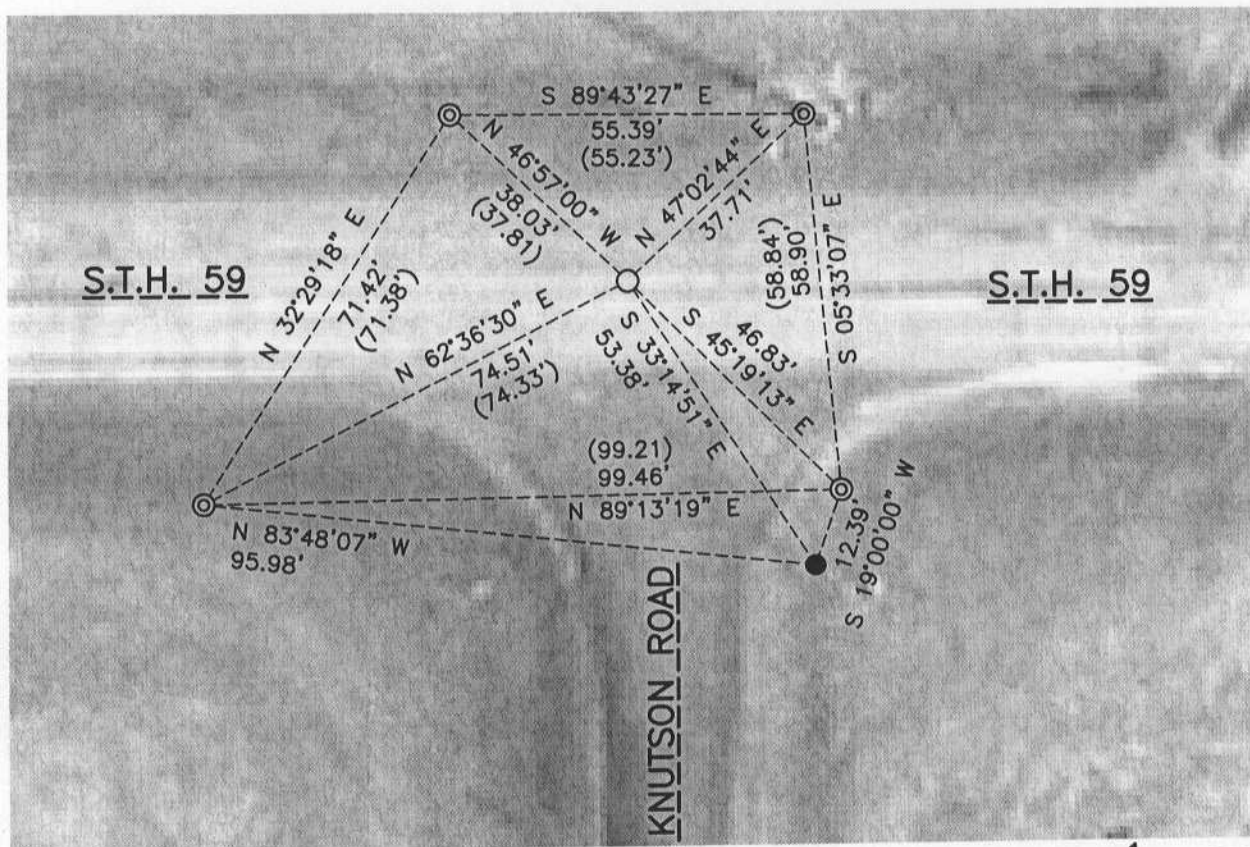
(a) LEGEND

At this location I found four witness pipes as shown on tie-sheet G-13 prepared by Don Barnes on May 18, 1989. Based the tie distances and a metal detector, I believe the aluminum monument exists under the relatively new Hwy. 59 pavement. By way of a distance/distance intersection from the two easterly witness pipes, I calculated the corner and set a cotton gin spindle per the map.

Any dimensional discrepancies are within acceptable tolerances and noted on the face of the map.
