U.S. PUBLIC LAND SURVEY MONUMENT RECORD

T. 3 N. - R. 10 E. of the 4th P.M.

MAGNOLIA TWP

ROCK COUNTY WI

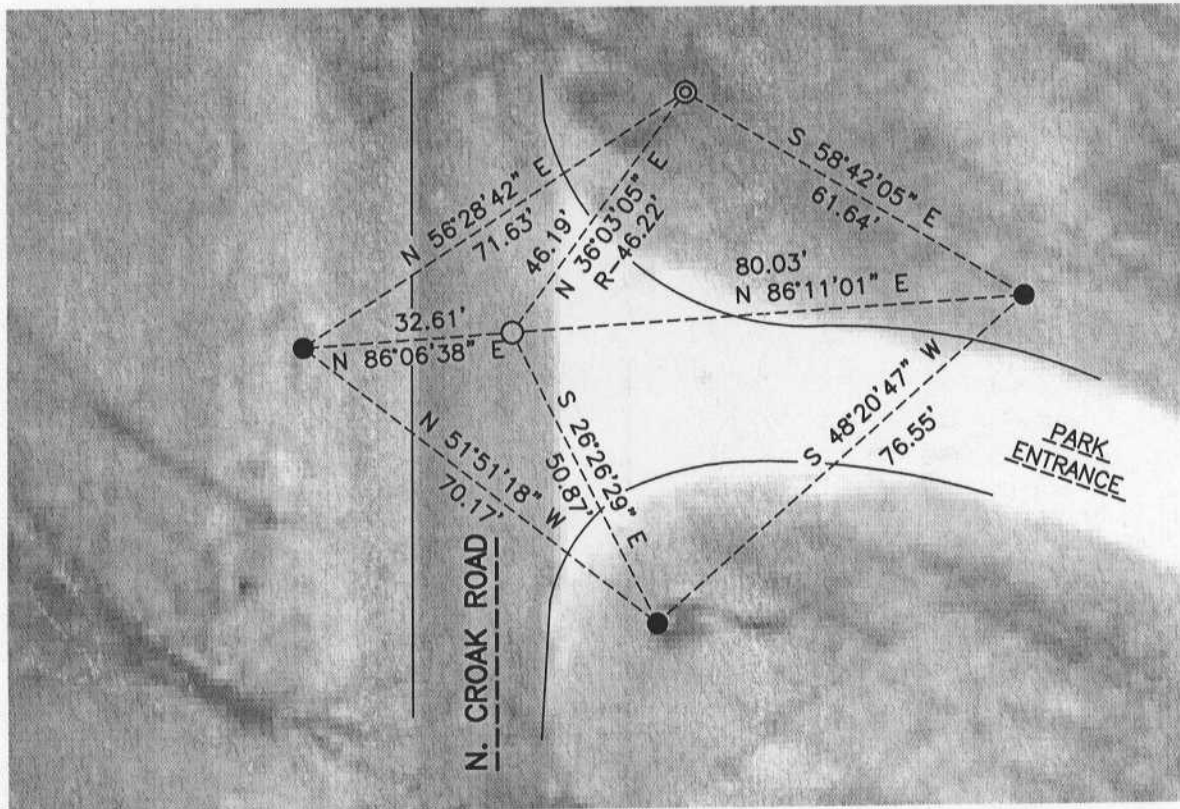
(a) LEGEND

- - 5/8" x 24" REBAR SET, (RED CAP W/"PLSS WITNESS")
- - ALUMINUM MONUMENT FOUND
- ⊙ - IRON PIPE FOUND

I found the aluminum monument and one undisturbed tie from the Volume 5, Page 397 tie-sheet prepared by Don Barnes. I accepted both monuments and set three additional witnesses per the sketch. Furthermore, my coordinates, WCCS-ROCK DATUM(NA2011), are within 0.1' North and South from those on a tie-sheet prepared by Don Barnes, (J-3), in 1995. The sole purpose of the '95 tie-sheet was to publish the coordinates for the corner.
