U.S. PUBLIC LAND SURVEY MONUMENT RECORD

T. 3 N. - R. 10 E. of the 4th P.M.

MAGNOLIA TWP
ROCK COUNTY WI

CORNER CODE: R-7(1)
(A.E. 7.08 REQUIREMENT)

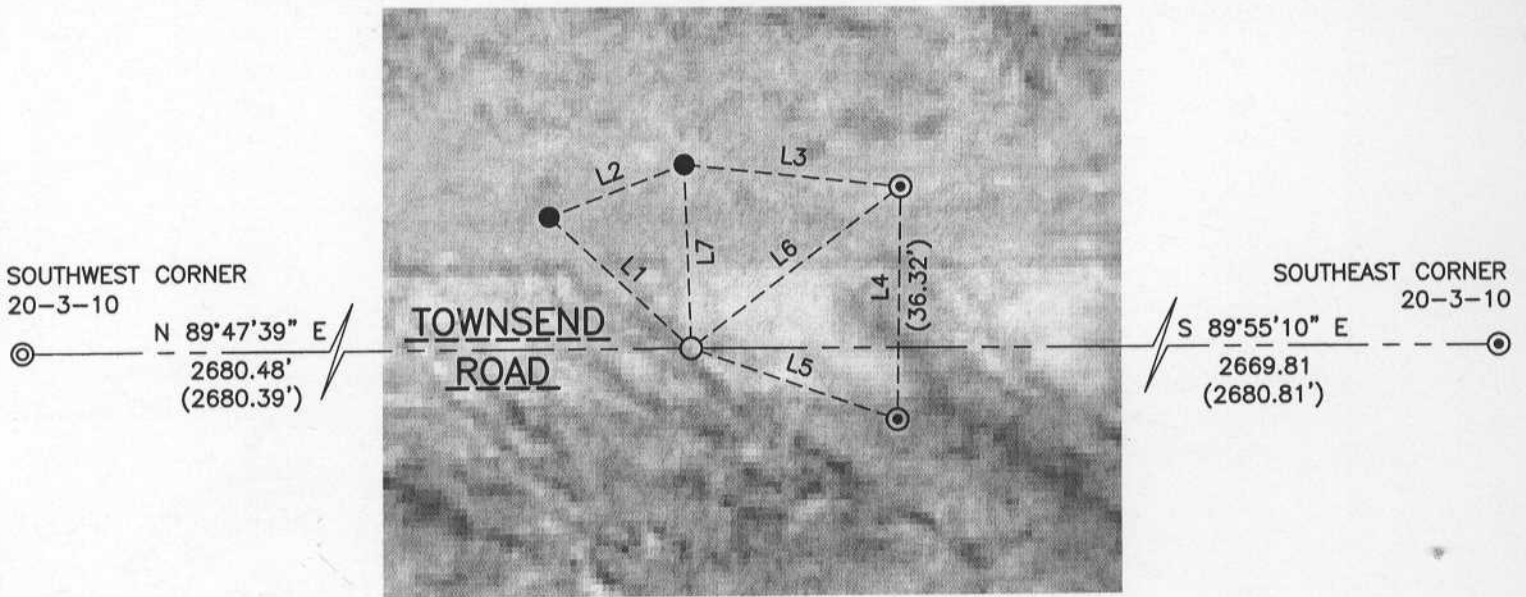
(a) LEGEND

LINE	BEARING	DISTANCE
L1	N 47°09'35" W	30.24'
L2	N 68°57'27" E	22.55'
L3	S 84°02'30" E	34.13'
L4	S 00°46'52" W	36.41'
L5	N 70°44'52" W	34.24'
L6	N 52°34'25" E	41.33'
L7	N 02°15'09" W	28.68'

I found two corner witnesses, the Southwest corner of 20-3-10 and the Southeast corner of 20-3-10 as shown on the R-7 tie-sheet filed in 1986. From the two corner ties I computed the PLSS corner location by distance/distance intersection; the result matches the calls to the SW and SE corners within expected tolerances. I set a survey nail over a broken cotton gin spindle at the corner, (broken by me attempting to set the same).

I did not find a discrepancy between the corner restored and a previously documented corner location. *Discrepancy* being defined as *disagreeing* with a corner location, *not* as noting dimensional differences between current/former tie sheets due to measuring methods. The current and *most recent* tie-sheet dimensions filed for the corner are noted.
